FIELD PHOTO FT-04 · LEVEL 1 · BACK-OF-HOUSE WALL W-12 · 2026-11-10 15:31

AS-BUILT ISOMETRIC — DOMESTIC WATER DROPS AT WALL PENETRATIONS

PROJECT: Sample Project — Mechanical Rough-In (DEMO-0142)			PREPARED BY: MIMETIC TECHNOLOGY	
DRAWING TITLE: AS-BUILT — DOMESTIC WATER DROPS AT WALL PENETRATIONS			LOCATION: Level 1 · Back-of-house wall W-12	
SOURCE PHOTO: FT-04 · 2026-11-10 15:31	DRAWN: FIELD TRACE AI	CHECKED: —	SCALE: N.T.S.	REV: A
STATUS: DRAFT — FOR REVIEW IN BLUEBEAM REVU 21.11			SHEET: FT-04

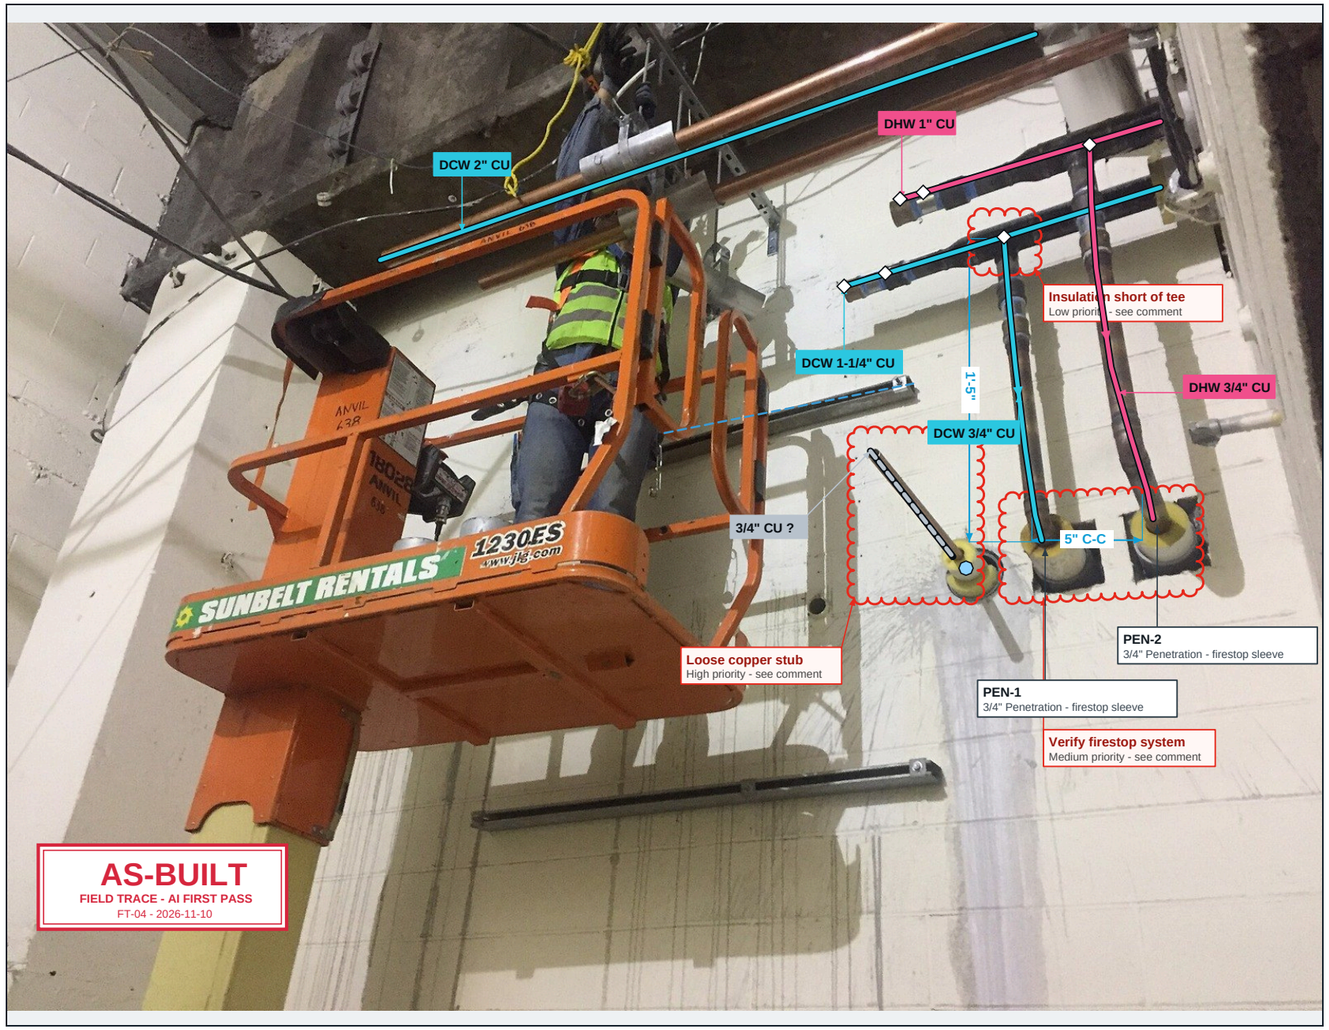
MARKUP SUMMARY — 28 MARKUPS · 3 ISSUES · 4 BELOW 70%

△1 Verify firestop system (Medium)
△2 Loose copper stub (High)
△3 Insulation short of tee (Low)
