FIELD PHOTO FT-06 · LEVEL B1 · CORRIDOR D CEILING · 2026-11-11 16:48

AS-BUILT ISOMETRIC — CEILING SPACE ABOVE CORRIDOR — LOW LIGHT

PROJECT: Sample Project — Mechanical Rough-In (DEMO-0142)			PREPARED BY: MIMETIC TECHNOLOGY	
DRAWING TITLE: AS-BUILT — CEILING SPACE ABOVE CORRIDOR — LOW LIGHT			LOCATION: Level B1 · Corridor D ceiling	
SOURCE PHOTO: FT-06 · 2026-11-11 16:48	DRAWN: FIELD TRACE AI	CHECKED: —	SCALE: N.T.S.	REV: A
STATUS: HELD — NEEDS FIELD VERIFICATION			SHEET: FT-06

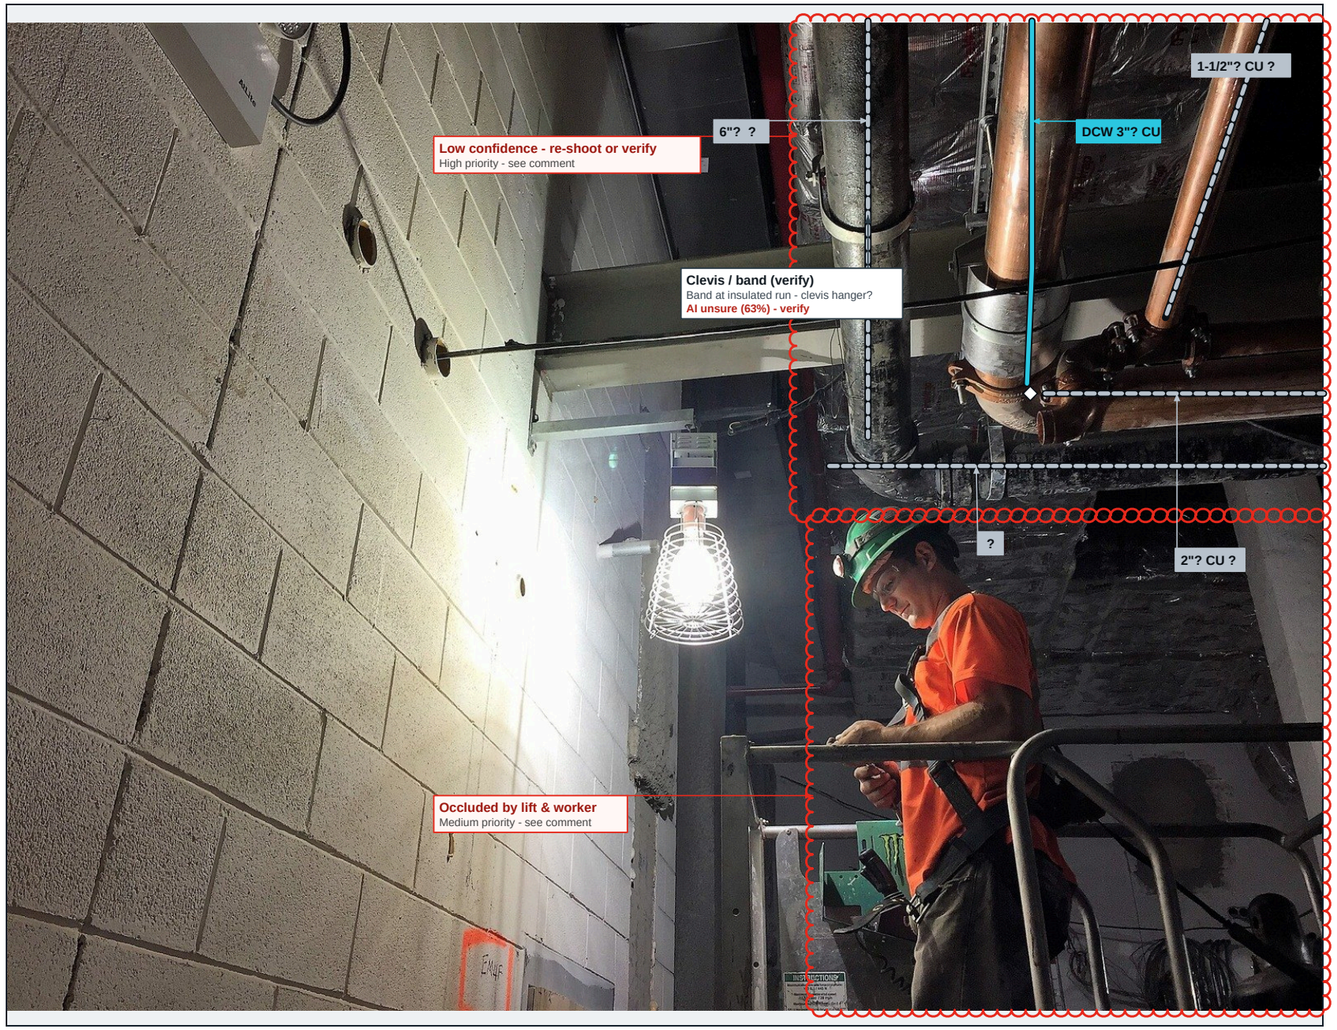
△1 Low confidence — re-shoot or verify (High)
△2 Occluded by lift & worker (Medium)

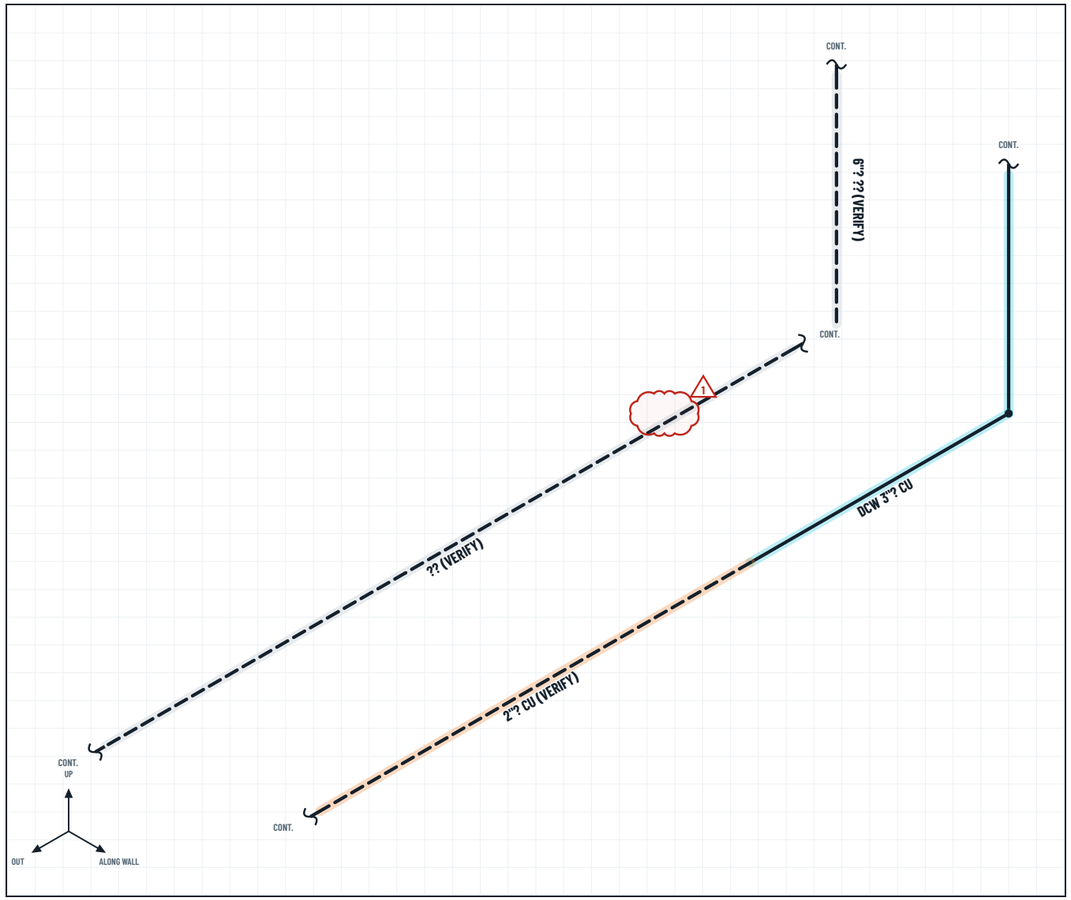
N.T.S. · DERIVED FROM PHOTO FT-06 · DIMENSIONS ESTIMATED
