FIELD PHOTO FT-10 · WOOD-FRAME FLOOR · PENETRATION · 2026-11-11 15:40

RUN SCHEDULE — CPVC SPRINKLER PIPE AT A FIRESTOP SLEEVE

PROJECT: Sample Project — Mechanical Rough-In (DEMO-0142)			PREPARED BY: MIMETIC TECHNOLOGY	
DRAWING TITLE: AS-BUILT — CPVC SPRINKLER PIPE AT A FIRESTOP SLEEVE			LOCATION: Wood-frame floor · penetration	
SOURCE PHOTO: FT-10 · 2026-11-11 15:40	DRAWN: FIELD TRACE AI	CHECKED: —	SCALE: N.T.S.	REV: A
STATUS: DRAFT — FOR REVIEW IN BLUEBEAM REVU 21.11			SHEET: FT-10

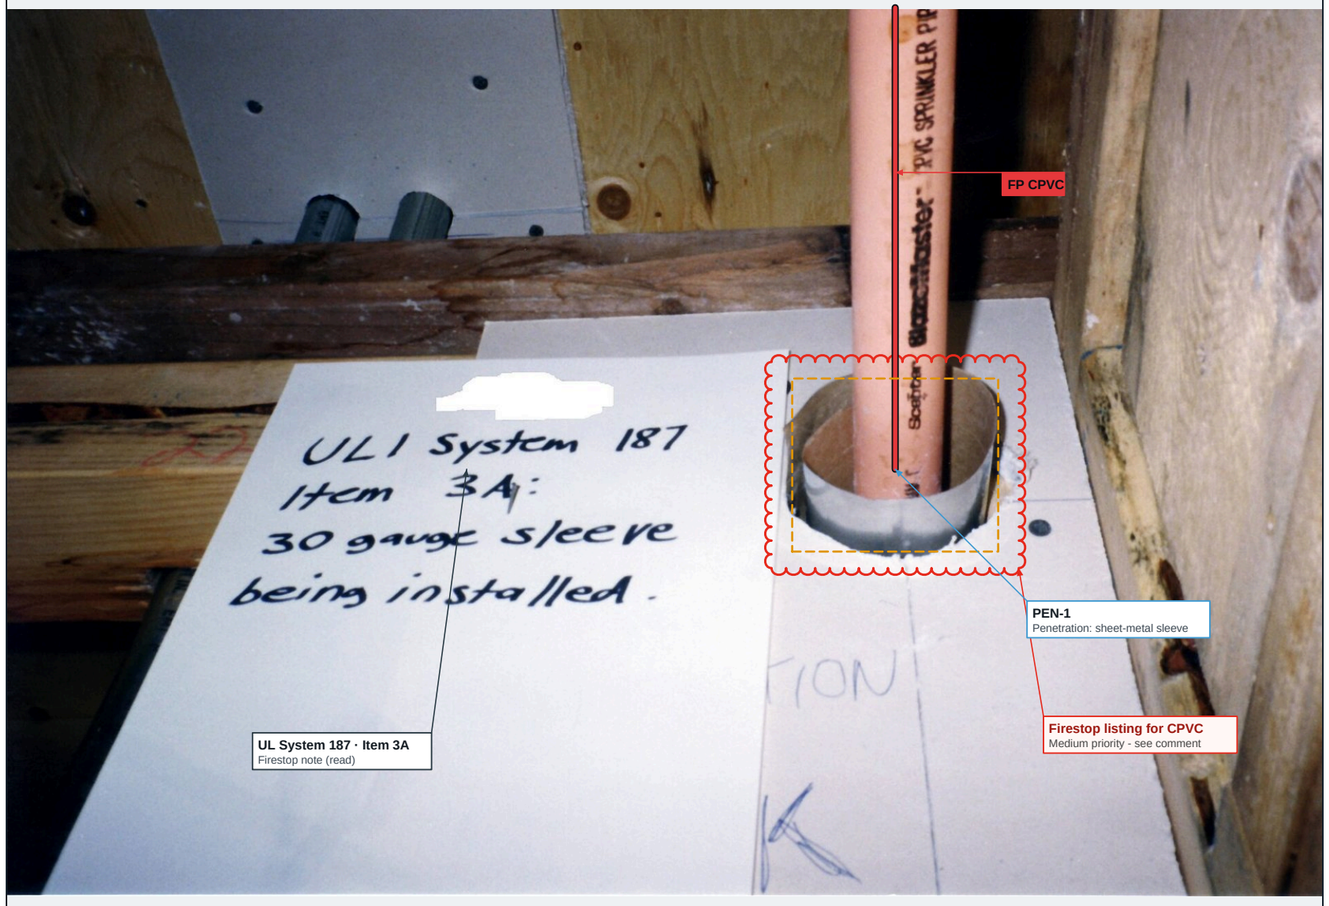
SUBJECT	LABEL	LAYER	STATUS	CONF.
Polyline	FP CPVC	Pipe Runs	None	90%
Pipe Tag	FP CPVC	Labels	None	90%
Penetration: sheet-metal sleeve	PEN-1	Hangers & Supports	None	88%

SUBJECT	LABEL	LAYER	STATUS	CONF.
Firestop note (read)	UL System 187 · Item 3A	Labels	None	80%
Cloud+	Firestop listing for CPVC	Issues	None	80%

Wall thickness is not visible from a photo. Rating and corrosion allowance need verification.

△1 Firestop listing for CPVC (Medium)
