FIELD PHOTO FT-04 · LEVEL 1 · BACK-OF-HOUSE WALL W-12 · 2026-11-10 15:31

AS-BUILT ISOMETRIC — DOMESTIC WATER DROPS AT WALL PENETRATIONS

| PROJECT: Sample Project — Mechanical Rough-In (DEMO-0142) | | | PREPARED BY: MIMETIC TECHNOLOGY | |
| DRAWING TITLE: AS-BUILT — DOMESTIC WATER DROPS AT WALL PENETRATIONS | | | LOCATION: Level 1 · Back-of-house wall W-12 | |

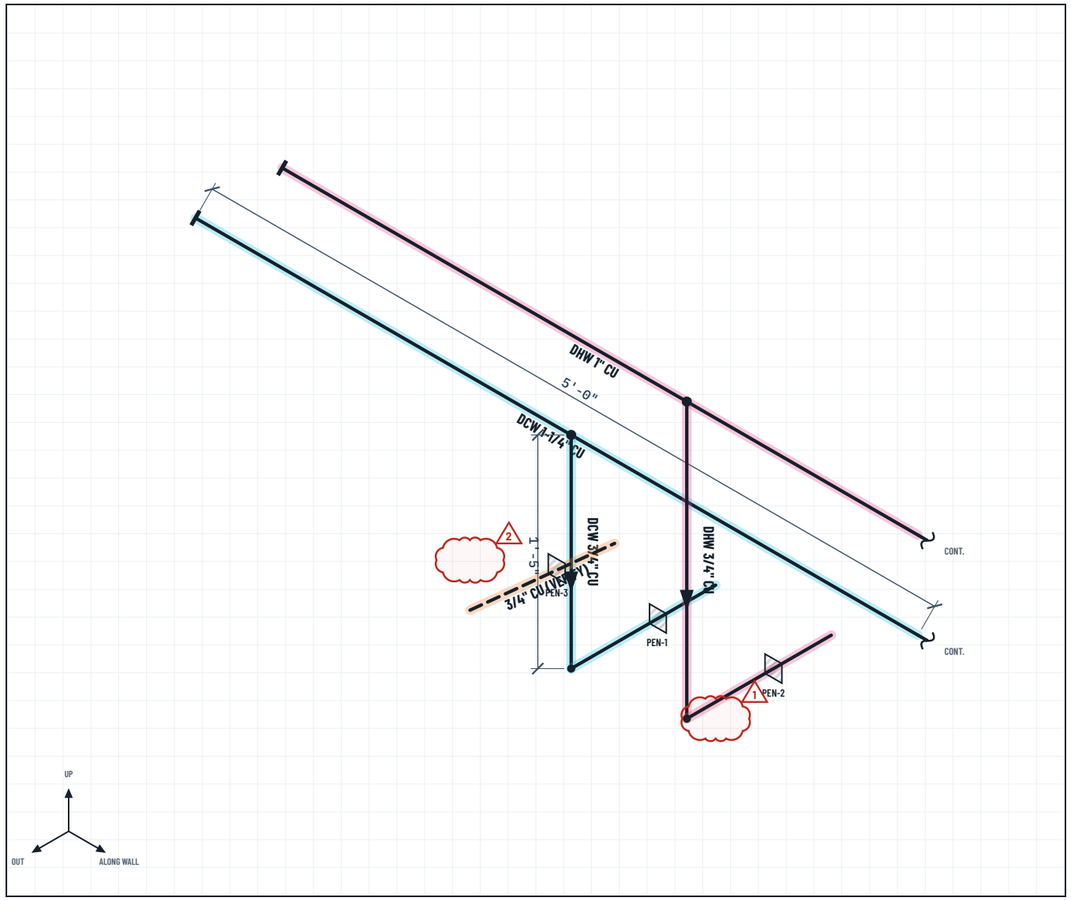
△1 Verify firestop system (Medium)
△2 Loose copper stub (High)
△3 Insulation short of tee (Low)
