FIELD PHOTO FT-08 · PROCESS AREA · UTILITY RACK · 2026-11-11 10:05

RUN SCHEDULE — PROCESS RACK — STAINLESS AND JACKETED LINES

PROJECT: Sample Project — Mechanical Rough-In (DEMO-0142)			PREPARED BY: MIMETIC TECHNOLOGY	
DRAWING TITLE: AS-BUILT — PROCESS RACK — STAINLESS AND JACKETED LINES			LOCATION: Process area · utility rack	
SOURCE PHOTO: FT-08 · 2026-11-11 10:05	DRAWN: FIELD TRACE AI	CHECKED: —	SCALE: N.T.S.	REV: A
STATUS: DRAFT — FOR REVIEW IN BLUEBEAM REVU 21.11			SHEET: FT-08

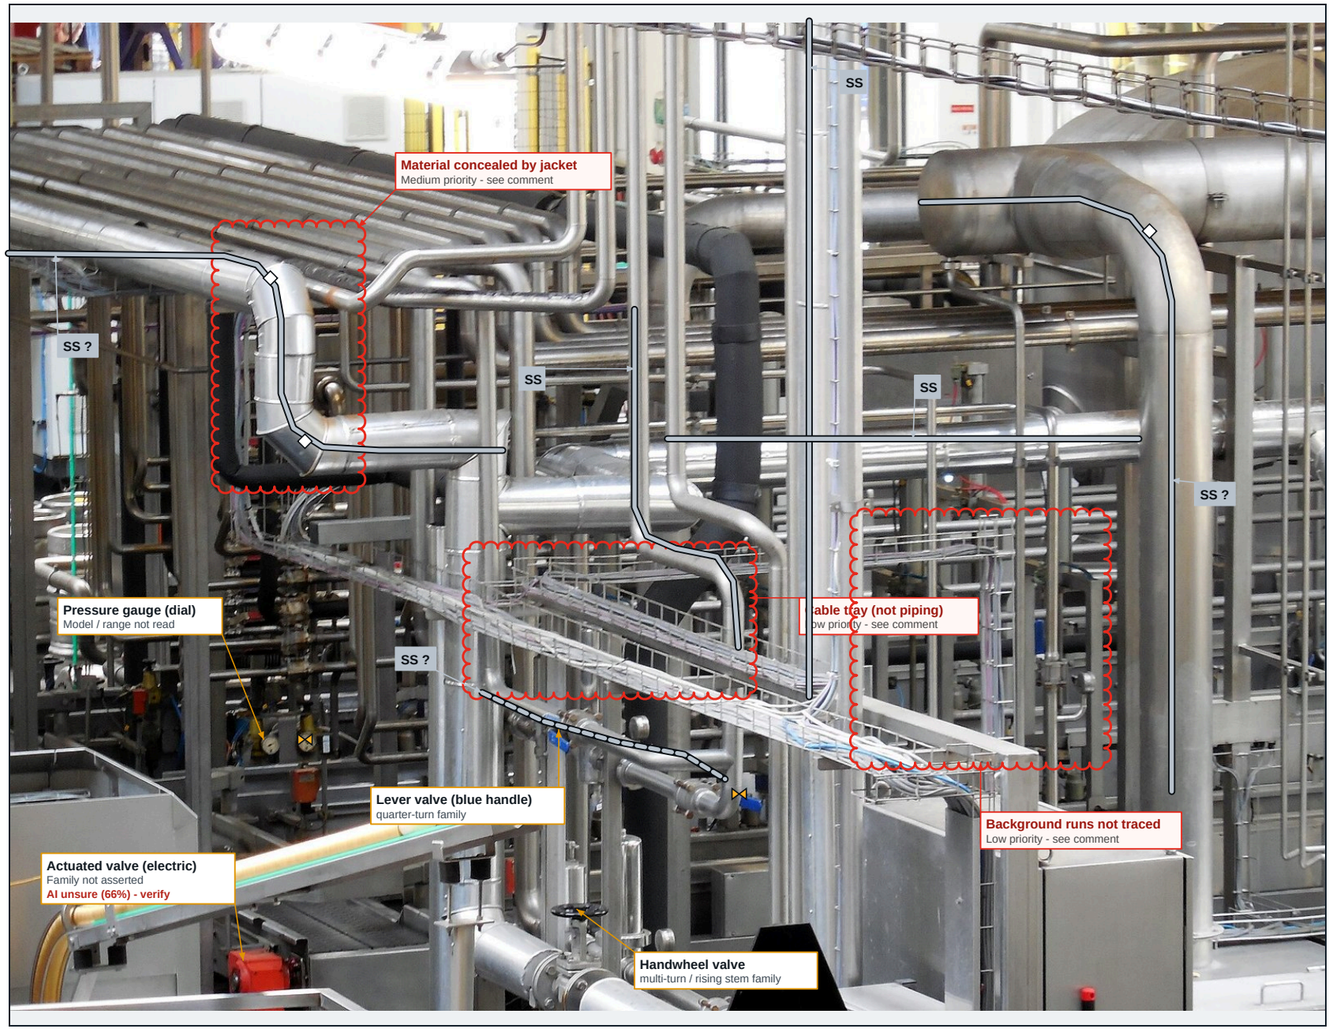
Not drafted: dense rack, no scale reference. Confirm one bare-pipe size in the workspace and lengths follow.

Wall thickness is not visible from a photo. Rating and corrosion allowance need verification.

△1 Material concealed by jacket (Medium)

△2 Cable tray (not piping) (Low)

△3 Background runs not traced (Low)
