FIELD PHOTO FT-11 · INSTRUMENT STAND · 2026-11-11 16:02

RUN SCHEDULE — PRESSURE TRANSMITTER ON STAINLESS IMPULSE TUBING

PROJECT: Sample Project — Mechanical Rough-In (DEMO-0142)			PREPARED BY: MIMETIC TECHNOLOGY	
DRAWING TITLE: AS-BUILT — PRESSURE TRANSMITTER ON STAINLESS IMPULSE TUBING			LOCATION: Instrument stand	
SOURCE PHOTO: FT-11 · 2026-11-11 16:02	DRAWN: FIELD TRACE AI	CHECKED: —	SCALE: N.T.S.	REV: A
STATUS: DRAFT — FOR REVIEW IN BLUEBEAM REVU 21.11			SHEET: FT-11

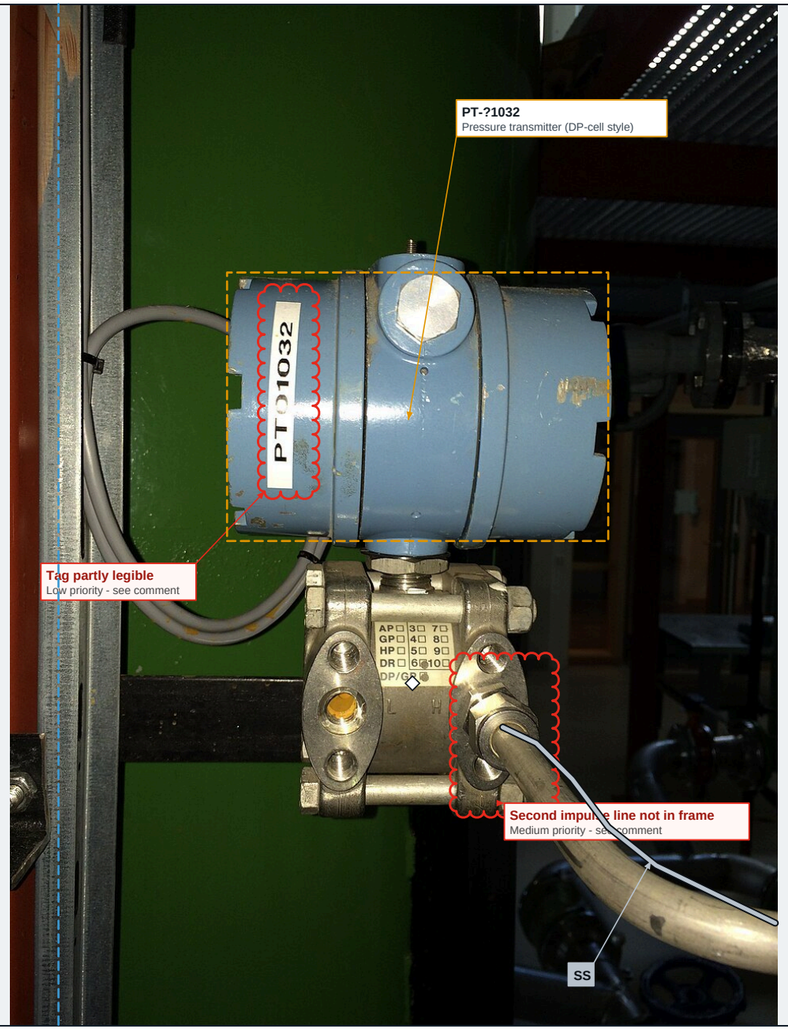
MARKUP SUMMARY — 7 MARKUPS · 2 ISSUES · 1 BELOW 70%

Wall thickness is not visible from a photo. Rating and corrosion allowance need verification.

△1 Second impulse line not in frame (Medium)

△2 Tag partly legible (Low)
