FIELD TRACE

AI markup assist for Bluebeam Revu 21 — sample output set

ANNOTATED FIELD PHOTO + AS-BUILT ISOMETRIC · FT-01

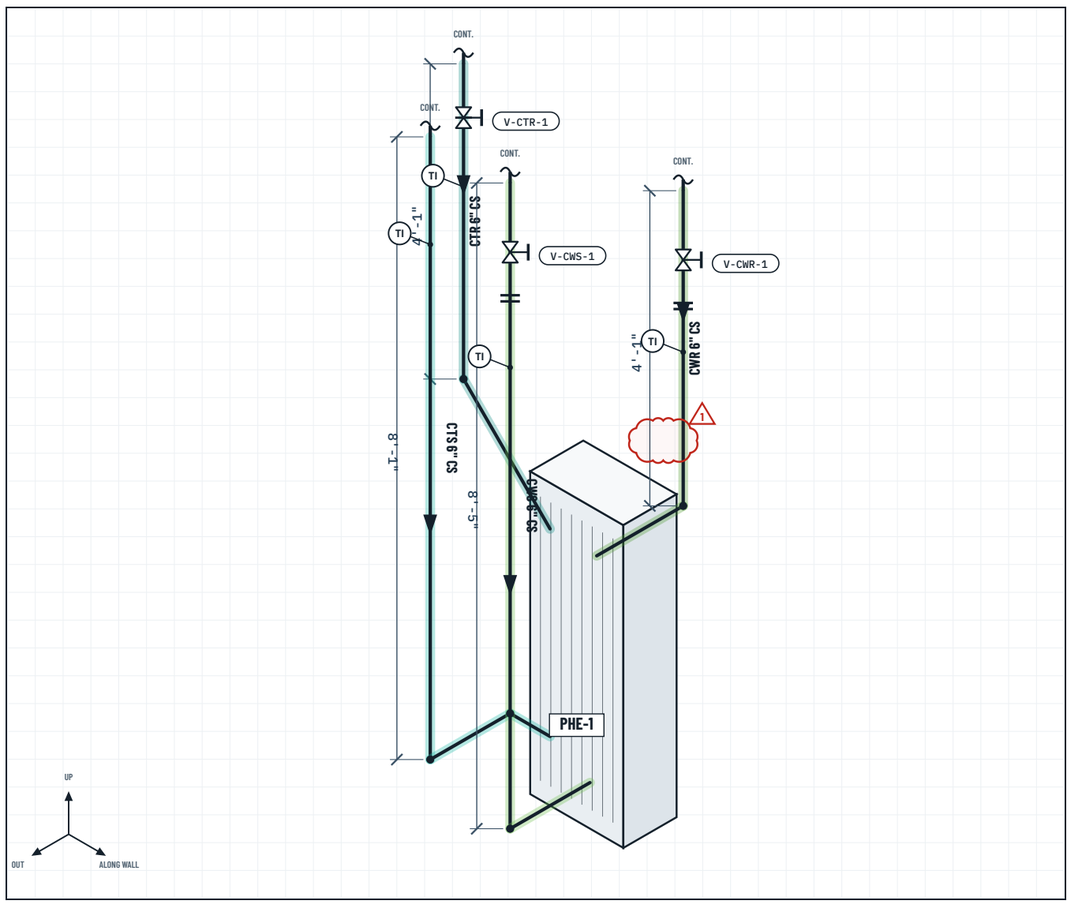
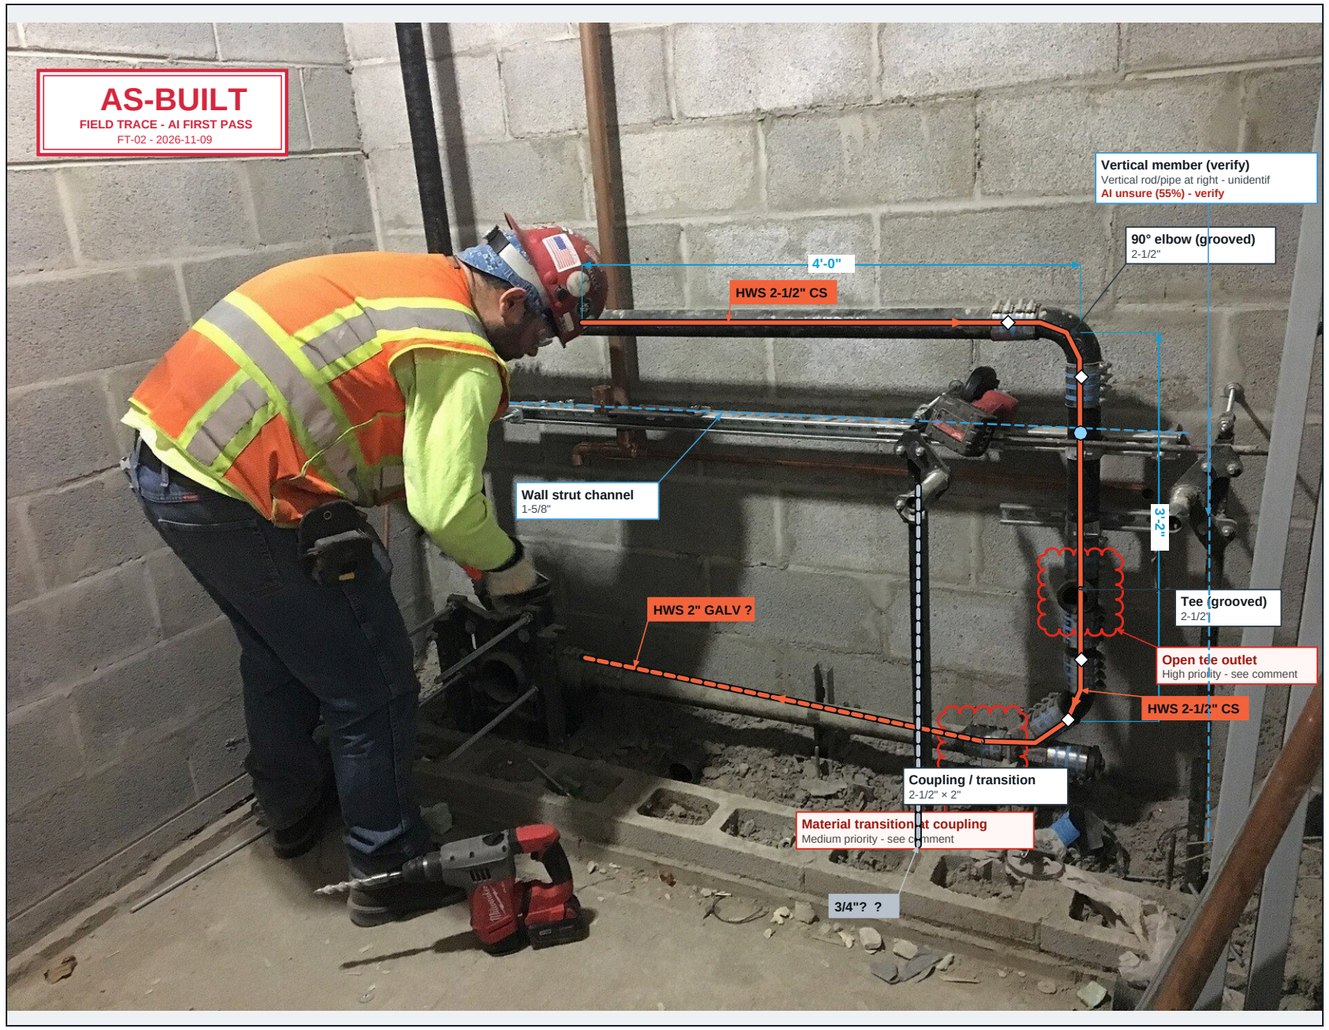
FIELD PHOTO FT-01 · MECH. RM B-104 · NORTH WALL · 2026-11-09 07:42

△1 No support visible at CWR offset (Medium)

△2 Nameplate not legible (Low)

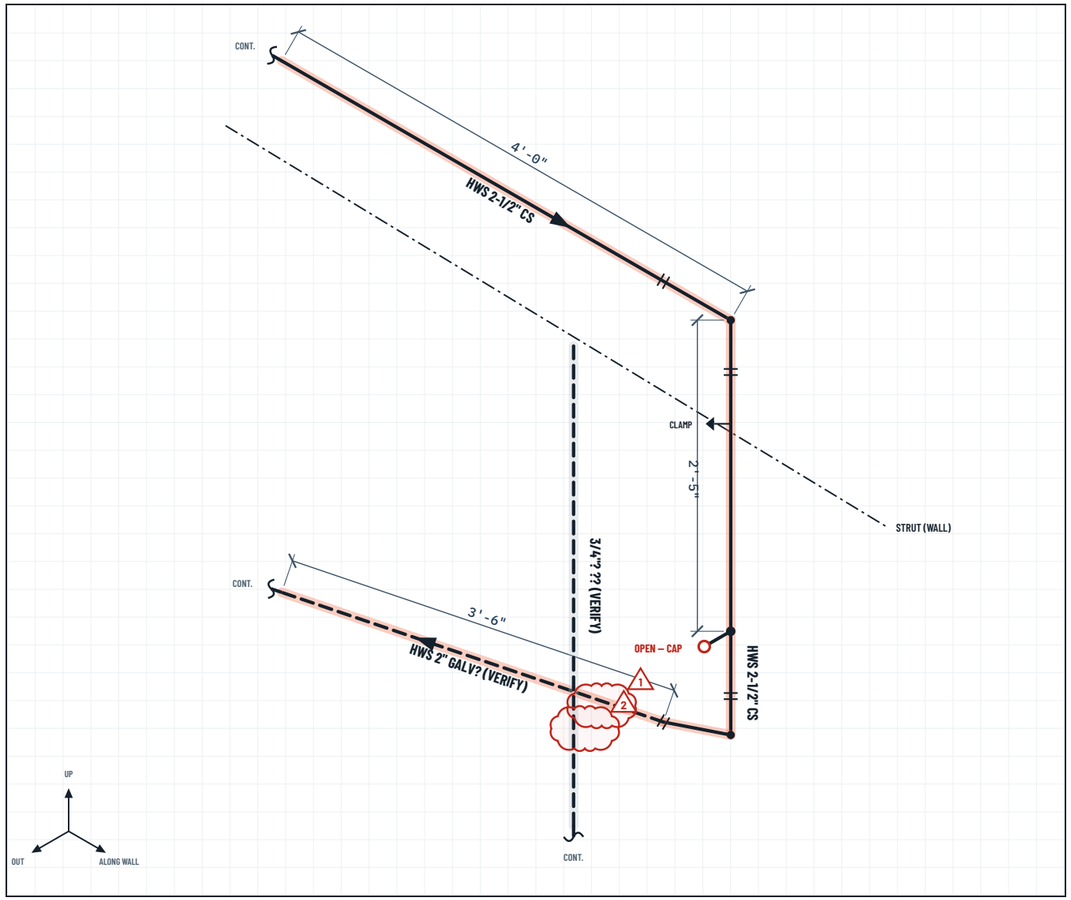
FIELD PHOTO FT-02 · LEVEL B1 · CORRIDOR C, COLUMN LINE 4 · 2026-11-09 09:15

△1 Open tee outlet (High)
△2 Material transition at coupling (Medium)

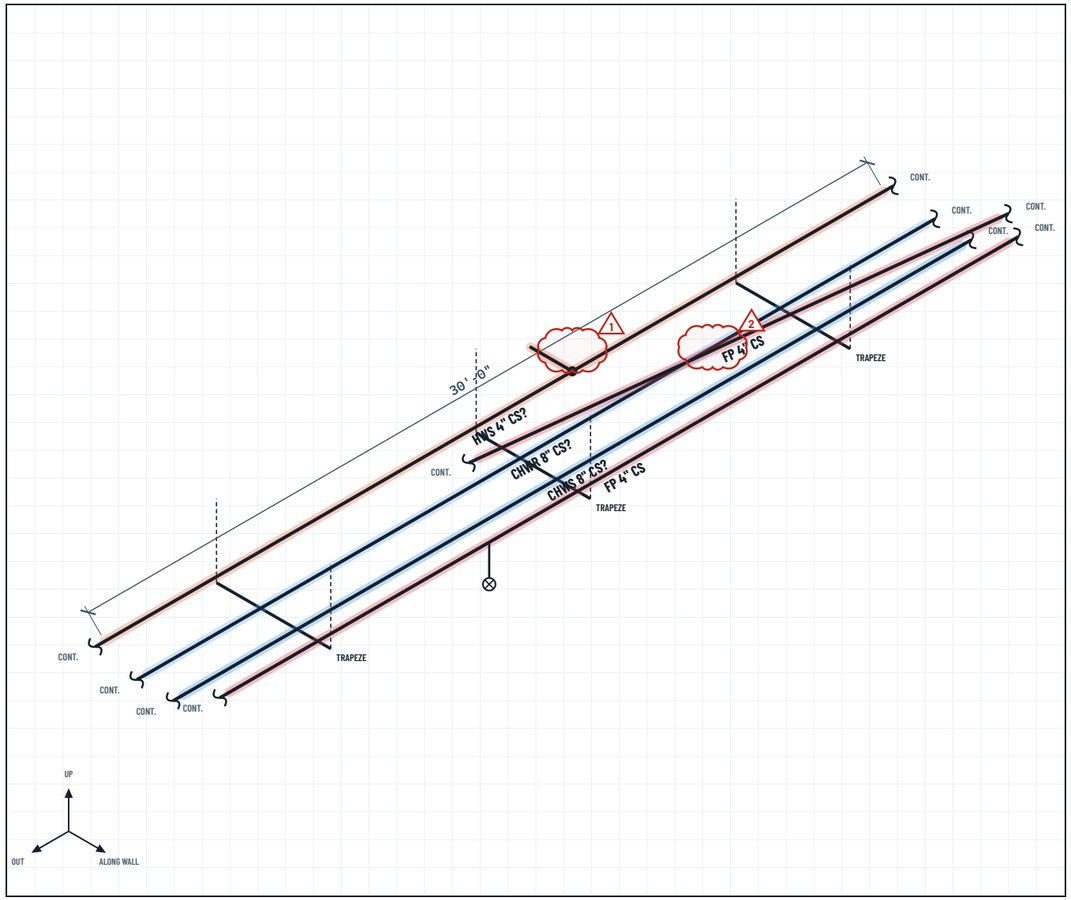
FIELD PHOTO FT-03 · LEVEL B1 · EAST SERVICE CORRIDOR · 2026-11-10 13:05

△1 Fitting insulation incomplete (Medium)
△2 Clearance at FP crossing (Low)

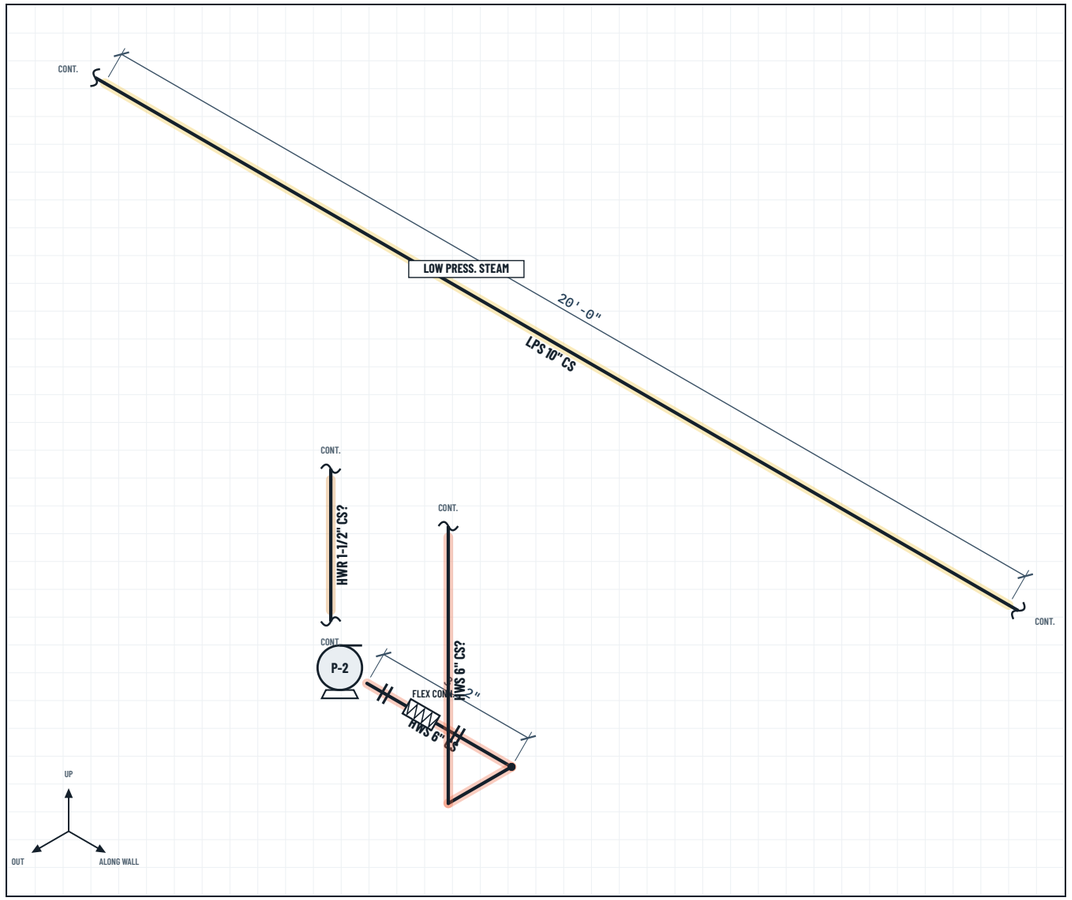
FIELD PHOTO FT-05 · CENTRAL PLANT · PUMP ROOM · 2026-11-06 10:20

△1 Steam flow direction not asserted (Low)

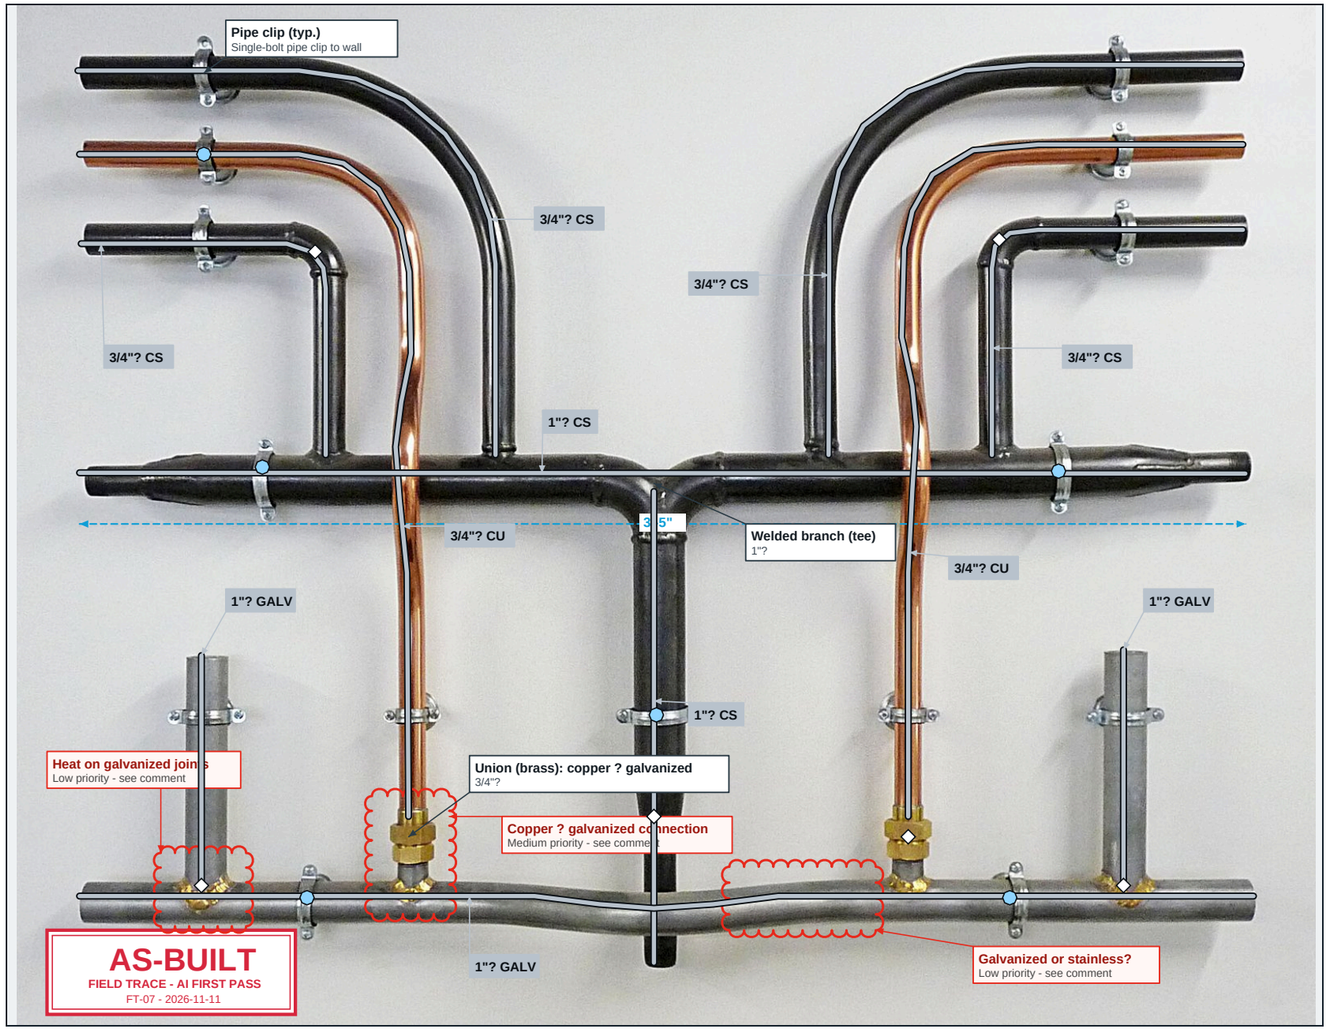
FIELD PHOTO FT-06 · LEVEL B1 · CORRIDOR D CEILING · 2026-11-11 16:48

△1 Low confidence — re-shoot or verify (High)
△2 Occluded by lift & worker (Medium)
