FIELD PHOTO FT-03 · LEVEL B1 · EAST SERVICE CORRIDOR · 2026-11-10 13:05

AS-BUILT ISOMETRIC — OVERHEAD MAINS — EAST SERVICE CORRIDOR

PROJECT: Sample Project — Mechanical Rough-In (DEMO-0142)			PREPARED FOR: Schilke Construction	
DRAWING TITLE: AS-BUILT — OVERHEAD MAINS — EAST SERVICE CORRIDOR			LOCATION: Level B1 · East service corridor	
SOURCE PHOTO: FT-03 · 2026-11-10 13:05	DRAWN: FIELD TRACE AI	CHECKED: —	SCALE: N.T.S.	REV: A
STATUS: DRAFT — FOR REVIEW IN BLUEBEAM REVU 21.11			SHEET: FT-03

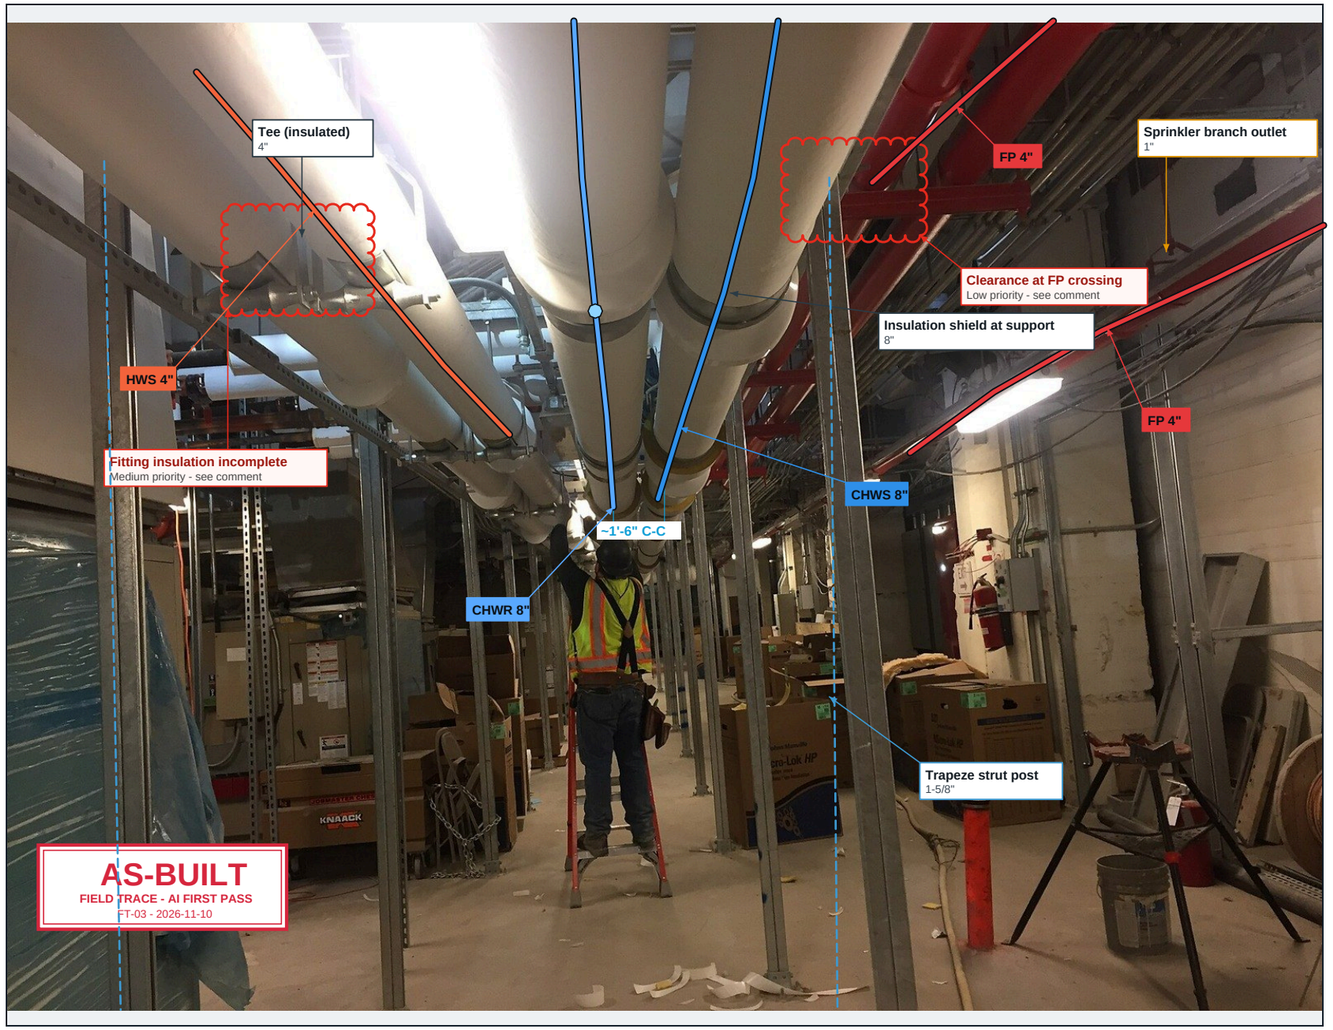
SUBJECT	LABEL	LAYER	STATUS	CONF.
Insulation shield at support	8" Insulation shield at support	Hangers & Supports	None	83%
Insulation shield at support	8" Insulation shield at support	Hangers & Supports	None	80%
Trapeze strut post	1-5/8" Trapeze strut post	Hangers & Supports	None	86%
Trapeze strut post	1-5/8" Trapeze strut post	Hangers & Supports	None	84%
Sprinkler branch outlet	1" Sprinkler branch outlet	Valves & Devices	None	74%
Tee (insulated)	4" Tee (insulated)	Fittings	None	70%
Dimension	~1'-6" C-C	Dimensions	None	62%
Stamp	AS-BUILT — Draft	Labels	None	100%
Cloud+	Fitting insulation incomplete	Issues	None	71%
Cloud+	Clearance at FP crossing	Issues	None	66%

△1 Fitting insulation incomplete (Medium)
△2 Clearance at FP crossing (Low)
