FIELD PHOTO FT-04 · LEVEL 1 · BACK-OF-HOUSE WALL W-12 · 2026-11-10 15:31

AS-BUILT ISOMETRIC — DOMESTIC WATER DROPS AT WALL PENETRATIONS

PROJECT: Sample Project — Mechanical Rough-In (DEMO-0142)			PREPARED FOR: Schilke Construction	
DRAWING TITLE: AS-BUILT — DOMESTIC WATER DROPS AT WALL PENETRATIONS			LOCATION: Level 1 · Back-of-house wall W-12	
SOURCE PHOTO: FT-04 · 2026-11-10 15:31	DRAWN: FIELD TRACE AI	CHECKED: —	SCALE: N.T.S.	REV: A
STATUS: DRAFT — FOR REVIEW IN BLUEBEAM REVU 21.11			SHEET: FT-04

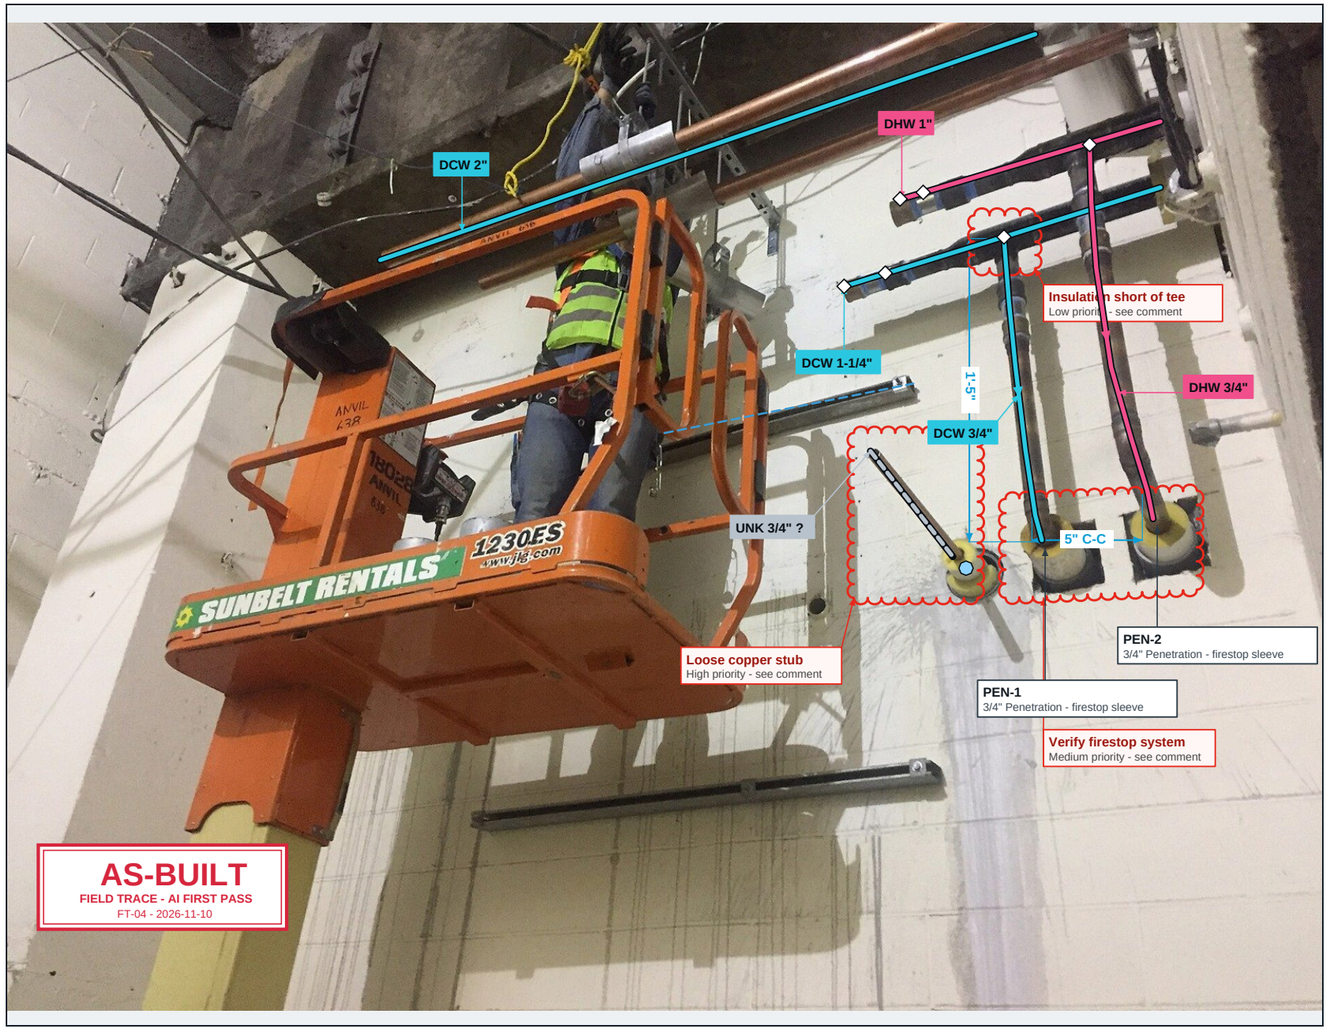
SUBJECT	LABEL	LAYER	STATUS	CONF.
Press coupling	1" Press coupling	Fittings	None	82%
Press coupling	1-1/4" Press coupling	Fittings	None	82%
Cap (stub-out)	1" Cap (stub-out)	Fittings	None	75%
Cap (stub-out)	1-1/4" Cap (stub-out)	Fittings	None	75%
Penetration — firestop sleeve	PEN-1	Hangers & Supports	None	90%
Penetration — firestop sleeve	PEN-2	Hangers & Supports	None	90%
Penetration — firestop sleeve	PEN-3	Hangers & Supports	None	86%
Wall strut channel	1-5/8" Wall strut channel	Hangers & Supports	None	85%
Dimension	5" C-C	Dimensions	None	72%
Dimension	1'-5"	Dimensions	None	70%
Stamp	AS-BUILT — Draft	Labels	None	100%
Cloud+	Verify firestop system	Issues	None	80%
Cloud+	Loose copper stub	Issues	None	74%
Cloud+	Insulation short of tee	Issues	None	69%

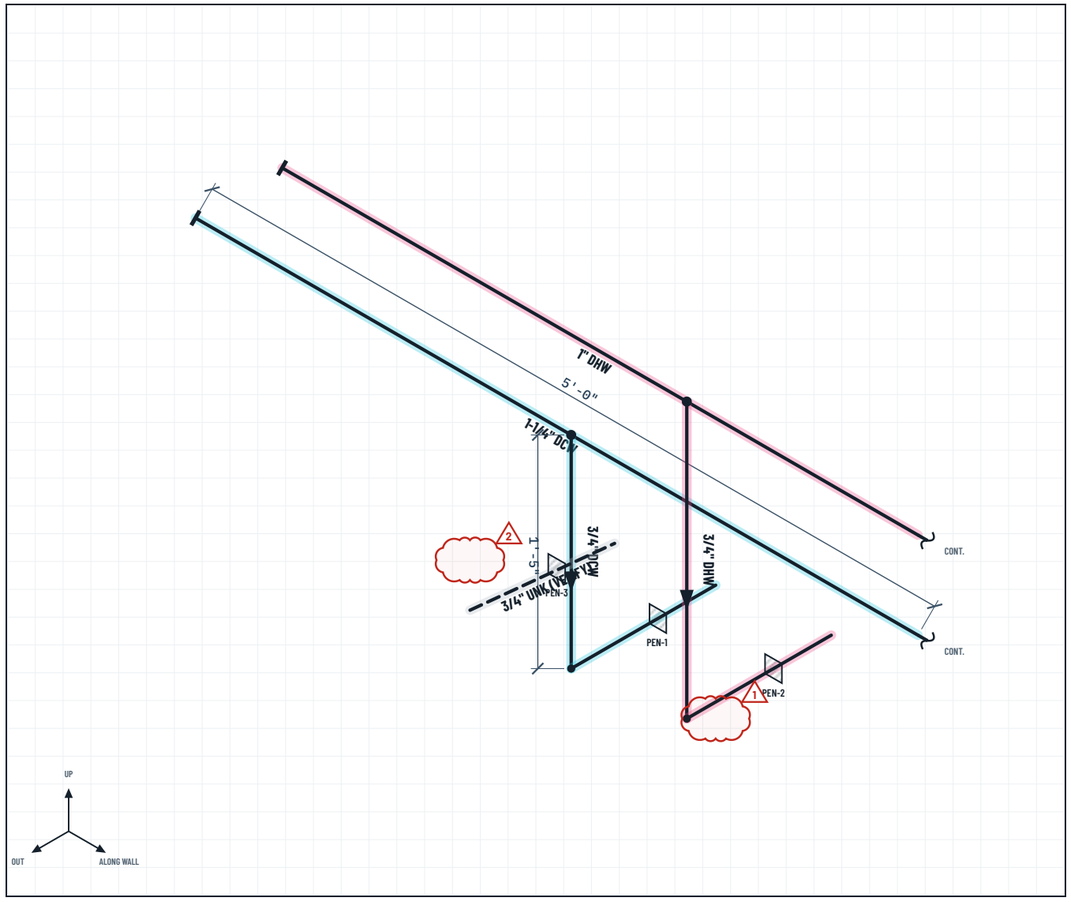
△1 Verify firestop system (Medium)
△2 Loose copper stub (High)
△3 Insulation short of tee (Low)
