Legacy Cable Routing Compliance Report

phaseboundary2

Plant: `phaseboundary2`

Baseline branch: `baseline-v1-20260429`

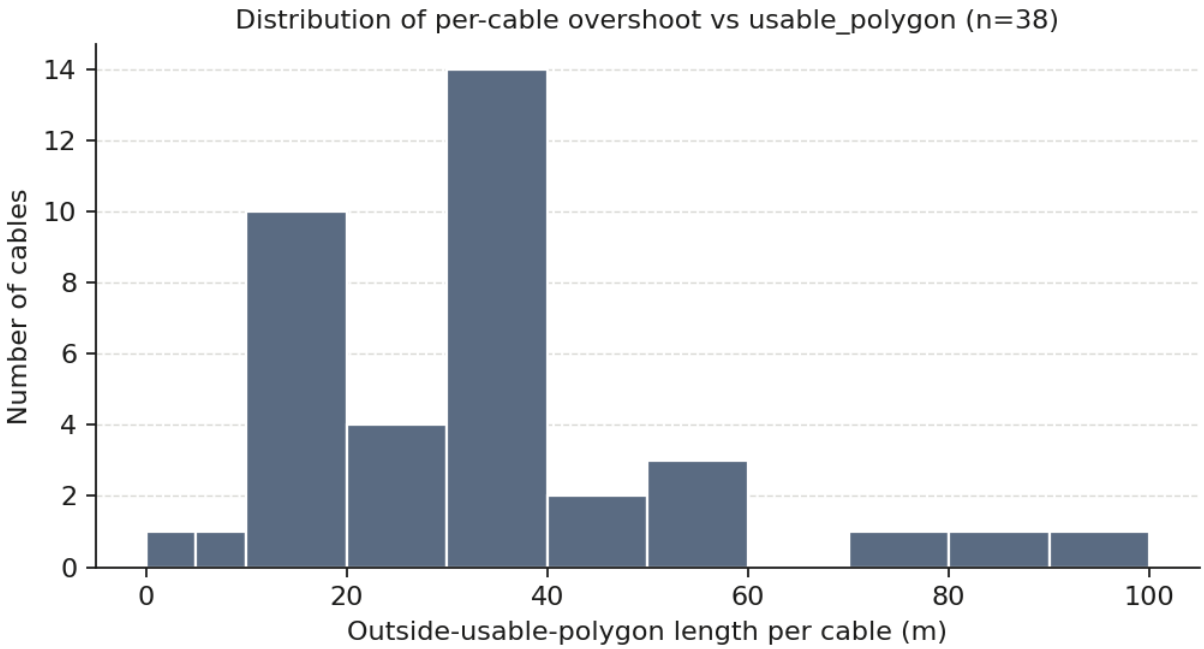
Figure 1: Per-cable overshoot length distribution. Each bar shows the count of home-run cables whose overshoot length against `usable_polygon` falls in the indicated range. The distribution is right-skewed; a small number of cables contribute disproportionately to total overshoot.

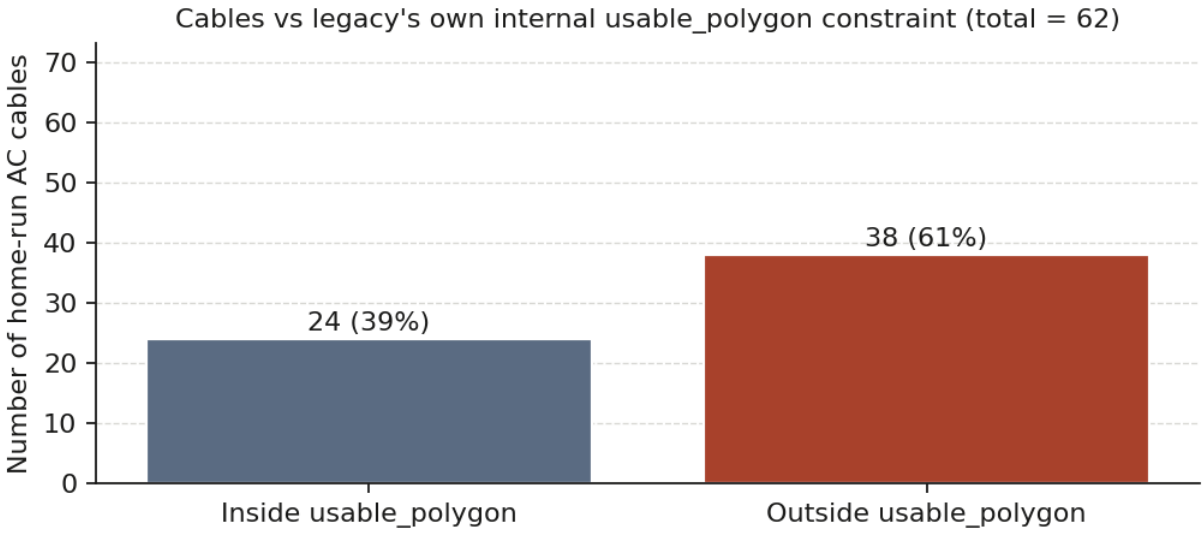
Figure 2: Compliance breakdown of all 62 home-run cables against legacy's own internal `usable_polygon` constraint. The outside-`usable_polygon` bar is the count Pattern F's `_score()` function effectively permits.

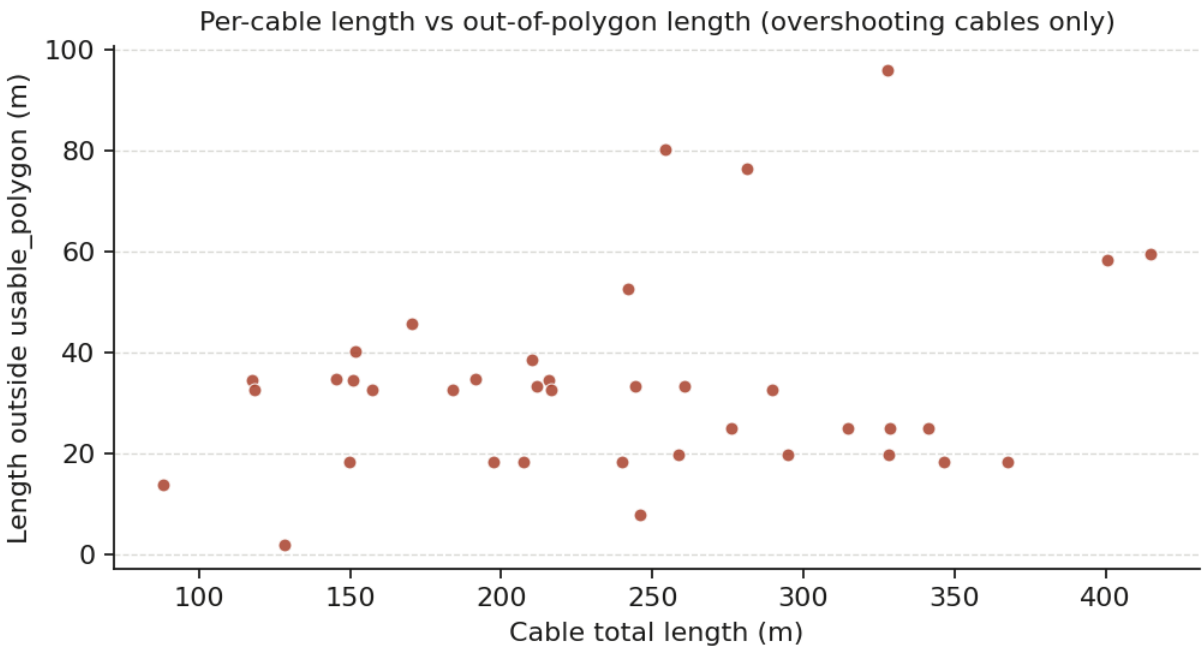
Figure 3: Per-cable length vs out-of-polygon length, for the 38 overshooting cables. Longer cables tend to incur larger absolute overshoot, but the relationship is loose — some short cables have near-100% out-of-zone fractions.
