The arc is fine above 4 kHz. Below 2 kHz the room bends it by up to 8 dB.

2026-09-08
data: laptop backup of 2 Sept
script: scripts/arc_error_map.py
full guide: docs/arc-validation-guide.html

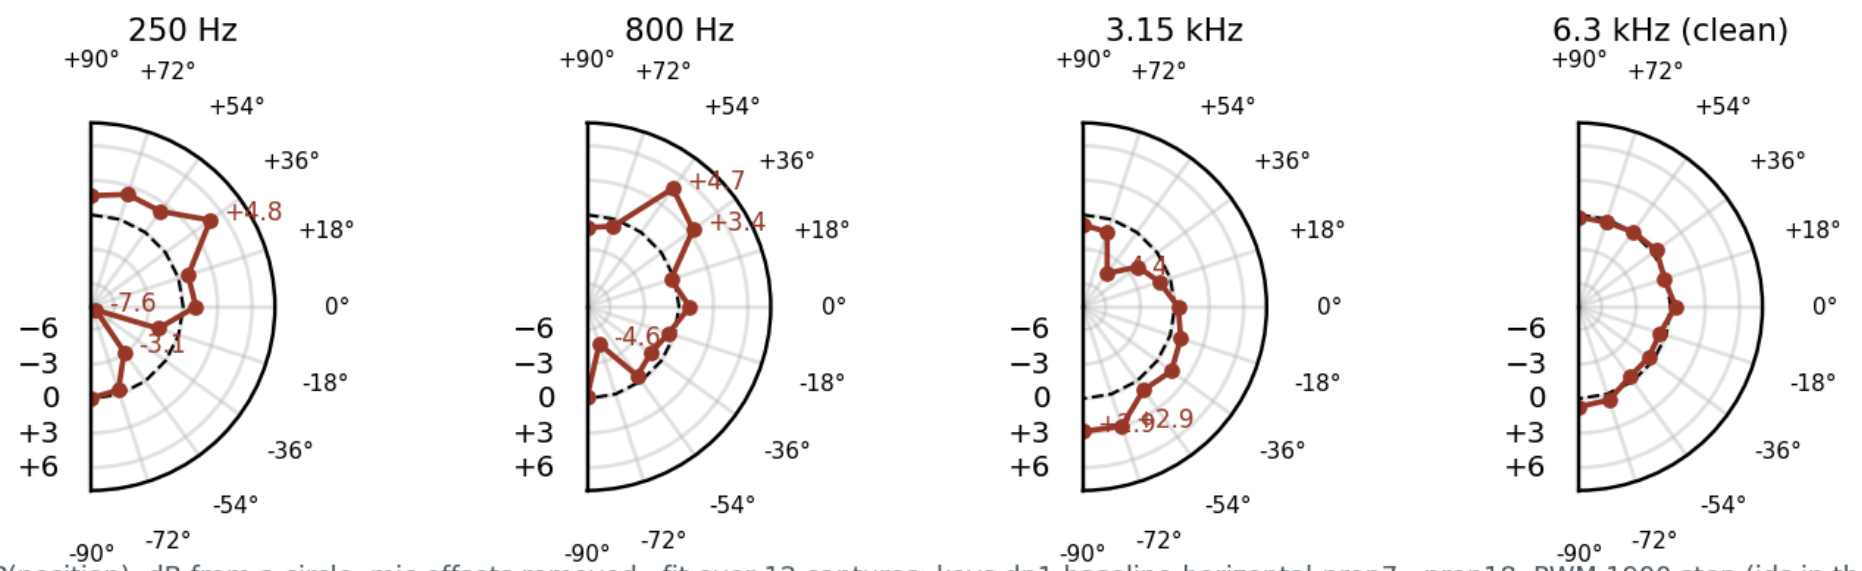
Fig. 1 · room error P(position), dB from a circle, mic offsets removed · fit over 12 captures: keys dp1-baseline-horizontal-prop7...prop18, PWM 1900 step (ids in the table below)

The level at −72° is 2.4 to 5.7 dB too low between 500 and 2000 Hz, in all twelve runs. The dip is deepest at 630 and 800 Hz (−4.5 dB). It stays when a different microphone sits there (811-1896 in eight runs, 810-8901 in the four runs with the arc turned around). This position is the one closest to the chamber corner.

The level at +36° and +54° is 3 to 7 dB too high, at 200–250 Hz and at 630–1000 Hz. Three different microphones sat at +54° over the twelve runs. The bump stayed the same.

Around the blade tone (200–250 Hz) the two halves of the arc disagree: −36° reads −7.6 dB, +36° reads +4.8 dB; −54° reads −3 dB, +54° and +72° read +2 dB. The negative-angle half of the arc (−36°, −54°) is too low, the positive-angle half (+36°, +54°, +72°) is too high. The dip also moves with motor speed (−9 dB at PWM 1900, −2 dB at 2000). A sound wave that bounces off a surface and adds to the direct wave does exactly this: it cancels at some frequencies and adds at others, and the tone slides through those frequencies as the speed changes.

Above 4 kHz the arc reads a circle within ±1 dB at every position. The positions 0°, ±18° and ±90° are within about 1 dB in every band.

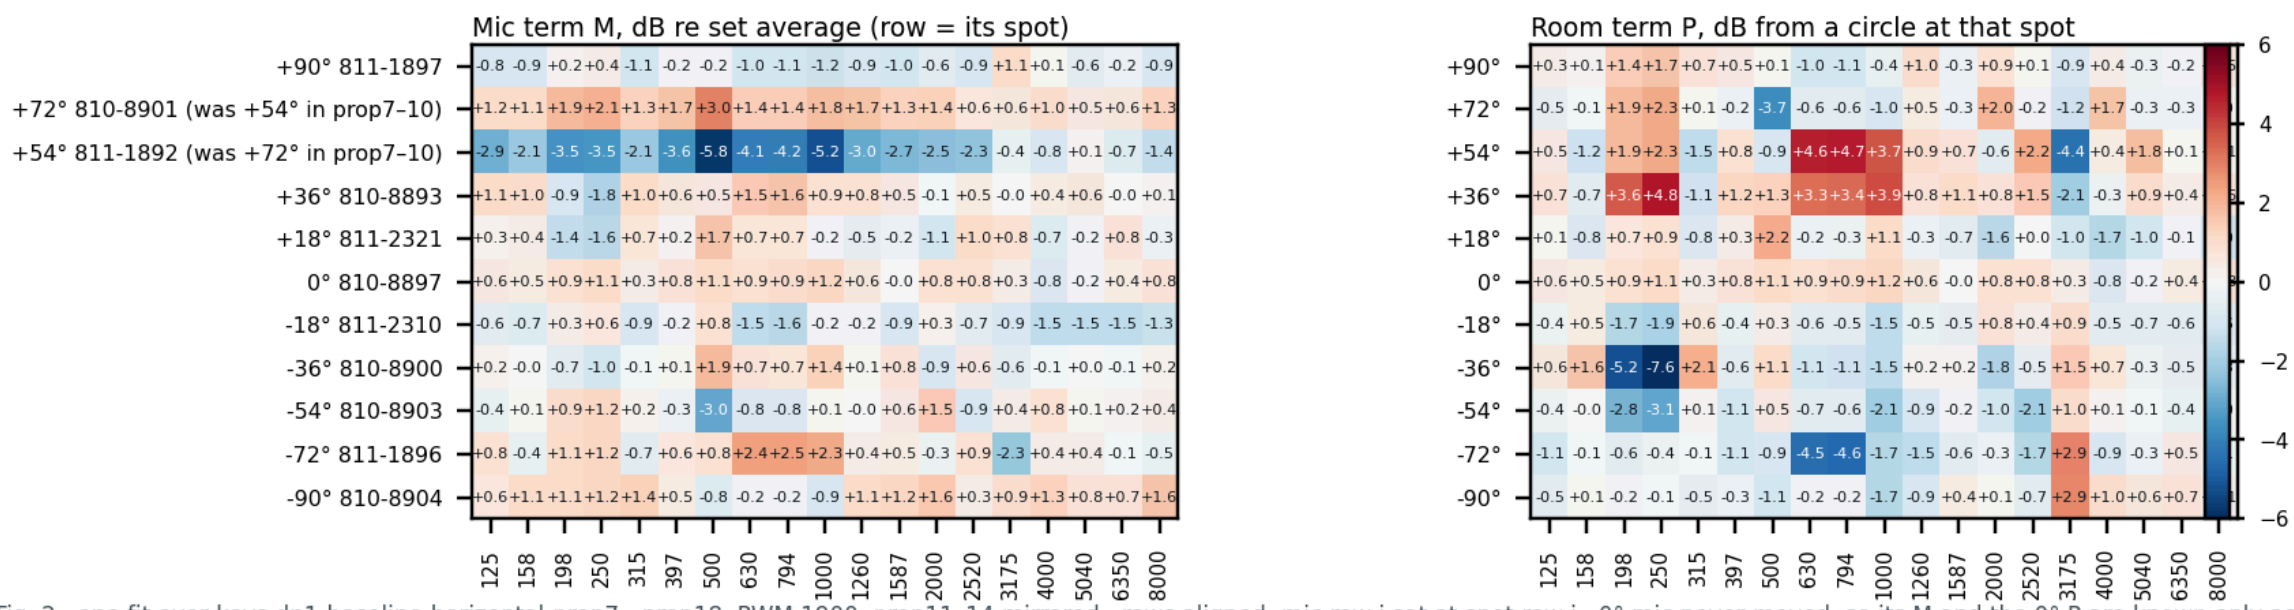
Not the microphones, with one exception. Because the microphones at +72° and +54° were swapped after prop10, and the arc was turned around for prop11–14, we can tell apart what belongs to a microphone and what belongs to a position. Ten microphones agree within ±1.8 dB in every band. **Microphone 811-1892 reads 2-6 dB too low from 125 Hz to 2.5 kHz.** Its calibration file does not match the capsule (its sensitivity value, −10.63 dB, is the least negative of the set, while the raw capsule is only about 1 dB low). When it sat at +54° it made the room error look like 7 dB. Take it off the arc or measure it again.

Not one frequency. The error sits in three separate bands, 200–250 Hz, 630–1000 Hz and 3150 Hz, and nowhere else (Fig. 2). Rajmane and Baumann (DAGA 2016) found a steel plate in a chamber only shows up once the wavelength is shorter than the plate (35 cm from 1.25 kHz, 10 cm from 3.15 kHz). So three bands point to three object sizes: about 1.5 m (floor, table or wall), about 0.4 m (stand base or a bar of the arc frame), about 0.1 m (a microphone clamp or mount).

Fig. 2 · Microphone error map (left) and room error map (right), same fit, same scale

Fig. 2 · one fit over keys dp1-baseline-horizontal-prop7...prop18, PWM 1900, prop11–14 mirrored · rows aligned: mic row i sat at spot row i · 0° mic never moved, so its M and the 0° P are known only as a sum · third-octave centre, Hz

1. Take 811-1892 off the arc.
2. Put a small loudspeaker on the stand instead of the propeller. Play short tone bursts at 250 and 800 Hz and record all microphones. The delay of the second arrival at each microphone, times 343 m/s, is the extra path length. Only one surface fits all eleven delays. With no airflow, anything left is the room.
3. Write down the geometry in docs/mic_arc.md: arc radius, propeller height, which wall or corner is at the −90° end, distances from the −72° and +72° microphones to the nearest wall.
4. Cover or move that surface, then run scripts/arc_error_map.py again. Foam only helps at 3 kHz. At 250 Hz the only fix is distance.
