An overview of our chamber problem

Two errors, not one: the blade tones are bent by up to 8 dB below 1 kHz, and under them sits a broadband error of ± 1.3 dB (3.3 dB worst) that no band is exempt from. The arc is not qualified to a standard anywhere yet. For these runs the arc was laid flat (horizontal), with the propeller axis vertical. All microphones then sit at the same height in the propeller plane, so a perfect setup reads the same level everywhere: a circle. Twelve runs (prop7–18, 1–2 Sept 2026, PWM 1900); what is left after each microphone's own offset is removed is the room.

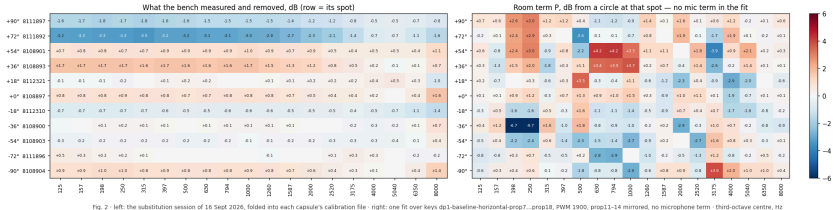
- How to read the map.** Row = spot on the arc, column = frequency band. White: the spot reads what a circle predicts. Red: too loud. Blue: too quiet. Each microphone's own error was measured on a bench and taken out before the fit (left panel), so the colour is the room.

- Deep blue at -72° and red at $+36^\circ/+54^\circ$, 500-1000 Hz.** A sound wave that bounces off a nearby surface arrives a little later than the direct wave. If the extra path is half a wavelength the two cancel and the spot goes blue; if it is a whole wavelength they add and the spot goes red. The extra path depends on the spot, so neighbours can be opposite colours and one spot can flip colour from band to band. Wavelength here is 35–70 cm, so the surface is within about a metre.

- The 200-250 Hz column is the blade tone, and it is not one nearby surface.** At BPF 216 Hz the tone polar is round to ± 2 dB; at 238 Hz -36° reads -8 dB; at 258 Hz the hole moves to -72° and the peak to $+54^\circ$, while the broadband floor beside the tone stays round to ± 1 dB. A surface within a metre cannot change the pattern that fast; narrow room modes sampled by a line spectrum can, and so can a propeller whose inflow is not axisymmetric. A loudspeaker at the hub decides which (remedies report, §03, §10).

- Blue on one side, red on the other: the surface is off-centre.** A surface symmetric around the propeller (the floor under a flat arc, say) gives every microphone the same extra path, so a whole row would be one colour. Here the colour changes around the arc, so the microphones are at different distances from the surface: it sits to one side. The colours do not say which side. Probing with the tone at three speeds: the $+36^\circ/+54^\circ$ reflection has an extra path of 1.5 m and a hard surface's amplitude, the -72° one 0.7 m (remedies report, Fig. 3); the unrecorded arc radius is what turns those into places.

- Taking the tones out removes the big errors, not all of them.** A wide band averages a reflection out, a tone does not, which is why the tones carry the big errors. With every tone notched the polar is round to ± 1.3 dB in 84 % of cells, worst 3.3 dB — but 90 of those 209 cells sit more than three standard errors from zero, so the rest is a real pattern, not scatter, and it is no smaller above 3 kHz than below (87 % of cells inside ± 1.3 dB below 3 kHz, 76 % above) (3.3 dB at $+72^\circ/2$ kHz, 3.2 at $+18^\circ/2$ kHz, 3.1 at $+54^\circ/5$ kHz). The tones need the loudspeaker check or the speed ladder; the broadband floor of ± 1 –3 dB is there in every band (report §00, §03).

Fig. 2 · What the bench measured and removed (left) and what the room leaves behind (right), same scale

- 200-250 Hz, blue at -36° .** Something about 1.5 m across, off to one side of the rig, with a bounced path 0.7 m longer than the direct one at -36° : a wall, a table top or the corner within about half a metre of that microphone.
- 630-1000 Hz, blue at -72° .** Something about 0.4 m across near the -90° end of the arc on the corner side: the stand base, a bar of the arc frame, a cable tray.
- 3150 Hz, scattered red and blue.** Something about 0.1 m across at the microphones themselves: clamps, mounts, the cable loop.
