The arc is fine above 4 kHz. Below 2 kHz the room bends it by up to 8 dB.

Twelve "horizontal prop" runs (prop7-18, 1-2 Sept 2026, PWM 1900): prop axis perpendicular to the arc, so every microphone sits in the prop plane and a perfect setup reads a circle. The deviation from that circle, with the microphones' own offsets removed, is the room.

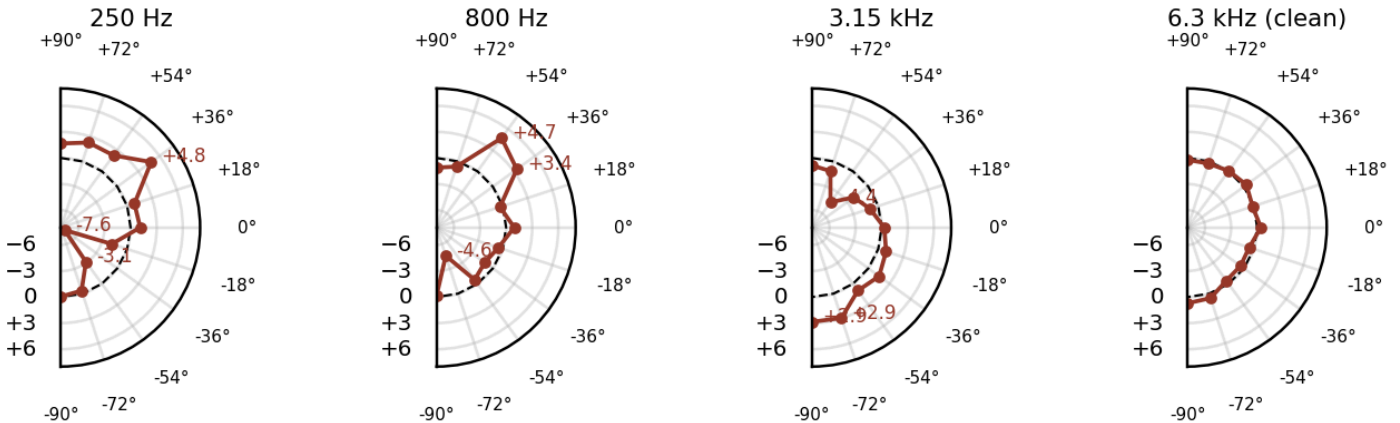
Fig. 2 · Arc error map: dB from a circle per physical position and third-octave (mic offsets removed; run-to-run noise 0.6-2.3 dB)

Mirror pattern in the BPF band (200-250 Hz): -36° reads -7.6 dB and $+36^\circ$ $+4.8$ dB; -54° -3 dB, $+54^\circ/+72^\circ$ $+2$ dB. Opposite signs above and below the prop plane, in the band the blade-passage tone sits in. The notch moves with RPM (-9 dB at 1900, -2 dB at 2000), the signature of a reflection whose comb dip sweeps through the tone.

Above 4 kHz the arc is a circle to ± 1 dB at every position; 0° , $\pm 18^\circ$ and $\pm 90^\circ$ are within ~ 1 dB in every band.

Not one frequency. The error lives in three separate bands, 200-250 Hz, 630-1000 Hz and 3150 Hz, and nowhere else (Fig. 2). Rajmane and Baumann (DAGA 2016) placed steel plates in a qualified chamber and found a reflector shows up once the wavelength is no longer than its size: 35 cm from 1.25 kHz, 10 cm only from 3.15 kHz. Three bands mean three reflector sizes: about 1.5 m (floor, table or wall), about 0.4 m (stand base, arc frame member), about 0.1 m (mic clamp or mount).

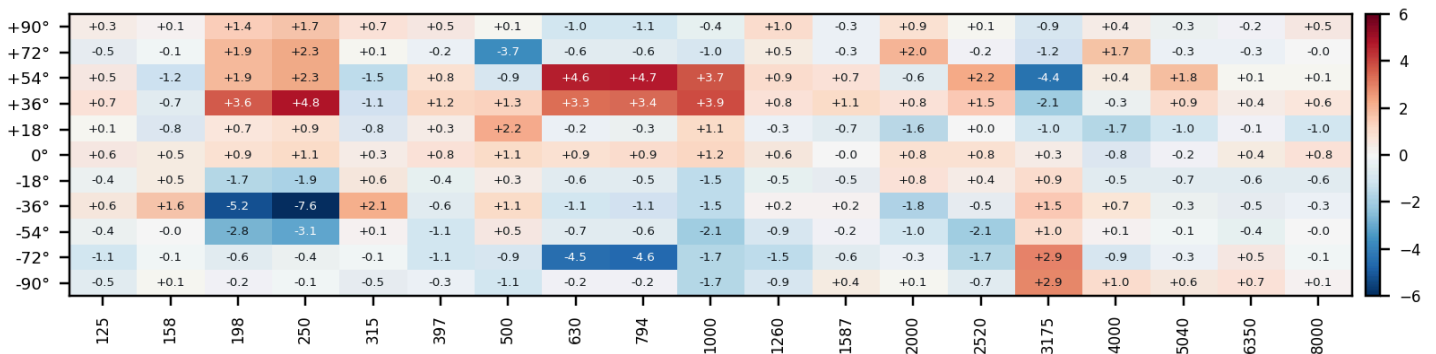
Fig. 3 · Same spots, twelve runs, three mics each

Indent at -72° : -2.4 to -5.7 dB, 500-2000 Hz, in all twelve runs. Strongest in the 630 and 800 Hz third-octaves (-4.5 dB). Present with microphone 811-1896 in that spot and, in the four runs with the arc turned 180°, with 810-8901 there. This is the position near the chamber corner.

Bump at $+36^\circ/+54^\circ$: $+3$ to $+7$ dB, 200-250 Hz and 630-1000 Hz. Three different microphones sat at $+54^\circ$ across the runs; the bump did not move.

500-2000 Hz, mic offsets removed; * = arc turned 180°. The -72° indent and the $+54^\circ$ bump keep their size whichever microphone sits there.
