The arc is fine above 4 kHz. Below 2 kHz the room bends it by up to 8 dB.

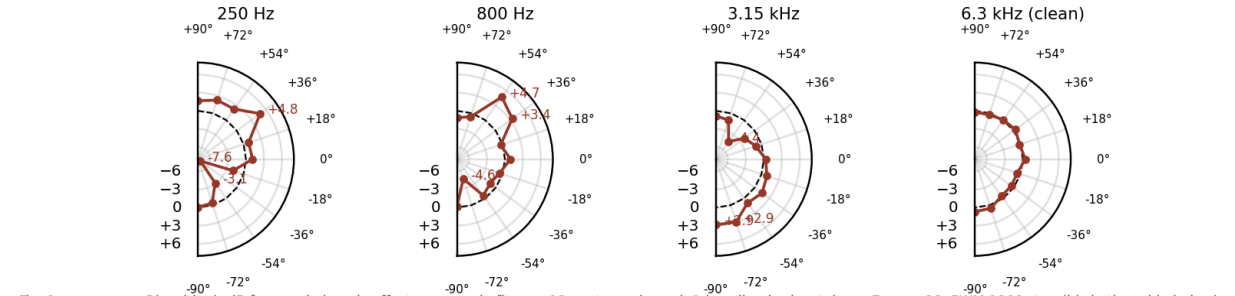
Fig. 1 · room error P(position), dB from a circle, mic offsets removed · fit over 12 captures: keys dp1-baseline-horizontal-prop7...prop18, PWM 1900 step (ids in the table below)

- The level at -72° is 2.4 to 5.7 dB too low between 500 and 2000 Hz, in all twelve runs.** The dip is deepest at 630 and 800 Hz (-4.5 dB). It stays when a different microphone sits there (811-1896 in eight runs, 810-8901 in the four runs with the arc turned around). This position is the one closest to the chamber corner.

- The level at $+36^\circ$ and $+54^\circ$ is 3 to 7 dB too high, at 200-250 Hz and at 630-1000 Hz.** Three different microphones sat at $+54^\circ$ over the twelve runs. The bump stayed the same.

- Around the blade tone (200-250 Hz) the two halves of the arc disagree:** -36° reads -7.6 dB, $+36^\circ$ reads $+4.8$ dB; -54° reads -3 dB, $+54^\circ$ and $+72^\circ$ read $+2$ dB. The negative-angle half of the arc (-36° , -54°) is too low, the positive-angle half ($+36^\circ$, $+54^\circ$, $+72^\circ$) is too high. The dip also moves with motor speed (-9 dB at PWM 1900, -2 dB at 2000). A sound wave that bounces off a surface and adds to the direct wave does exactly this: it cancels at some frequencies and adds at others, and the tone slides through those frequencies as the speed changes.

- Above 4 kHz the arc reads a circle within ± 1 dB at every position.** The positions 0° , $\pm 18^\circ$ and $\pm 90^\circ$ are within about 1 dB in every band.

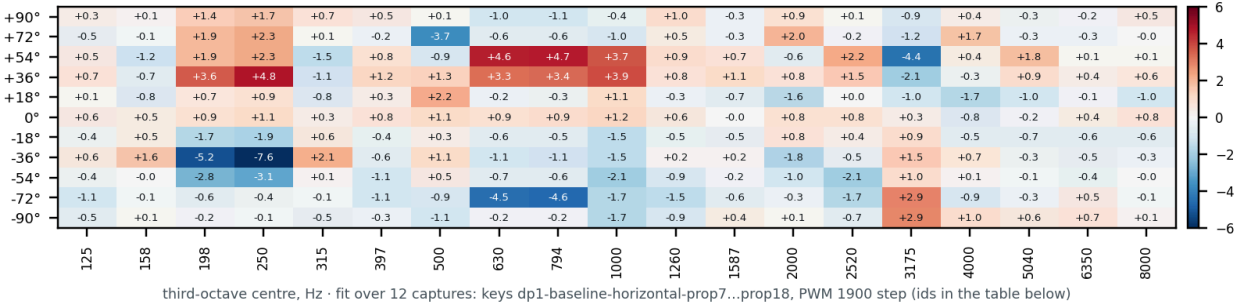
- Not one frequency.** The error sits in three separate bands, 200-250 Hz, 630-1000 Hz and 3150 Hz, and nowhere else (Fig. 2). Rajmane and Baumann (DAGA 2016) put steel plates into a good chamber and found that a plate only shows up once the wavelength is shorter than the plate: a 35 cm plate from 1.25 kHz, a 10 cm plate from 3.15 kHz. So three bands point to three objects of different size: about 1.5 m (floor, table or wall), about 0.4 m (stand base or a bar of the arc frame), about 0.1 m (a microphone clamp or mount).

Fig. 2 · Room error at each position and frequency band, in dB from a circle (microphone offsets removed; run-to-run scatter 0.6-2.3 dB)
