# Case Study – Three Mile Island

The Biggest Nuclear Accident in the US

### The Three Mile Island Disaster

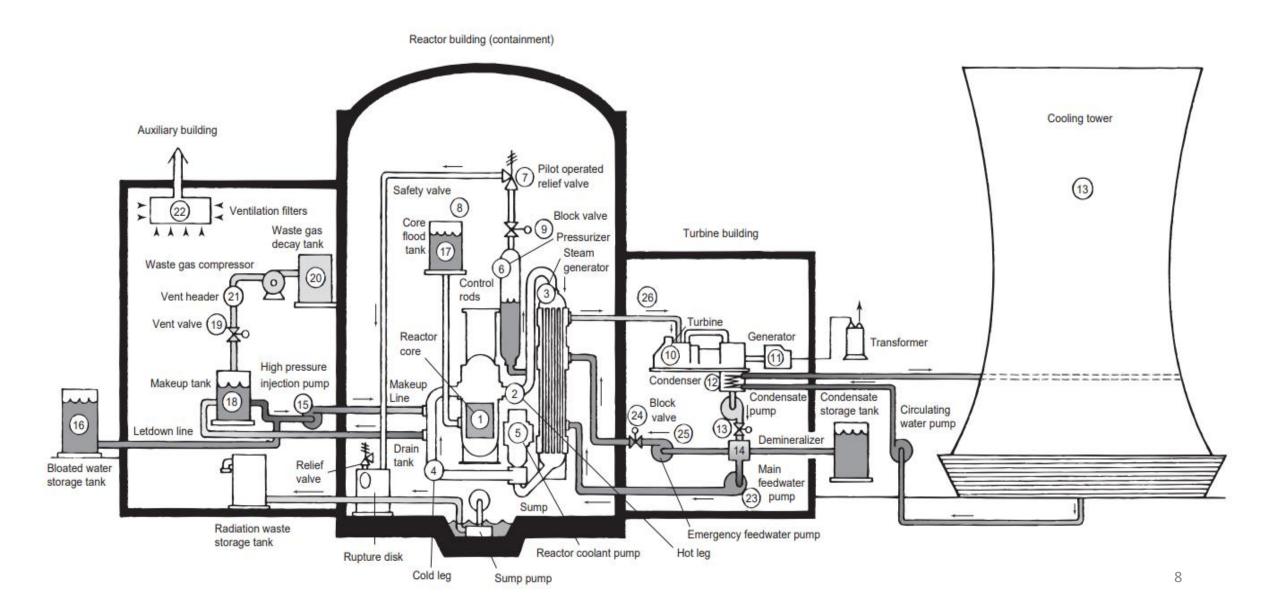
- Like any nuclear power plant, the TMI system was split into 3 sections to keep the radioactive reactor coolant contained.
- The Primary Loop, which includes the reactor and the coolant.
- The Secondary Loop, which deals with the actual power generation.
- And the Tertiary Loop, which cool the plant and contains the large cooling towers.
- For this incident we are only concerned with the Primary and Secondary loops.
- Each loop relies on the other working correctly.
