2017 - Honda Civic

8.1 / 10

Reference #
212857

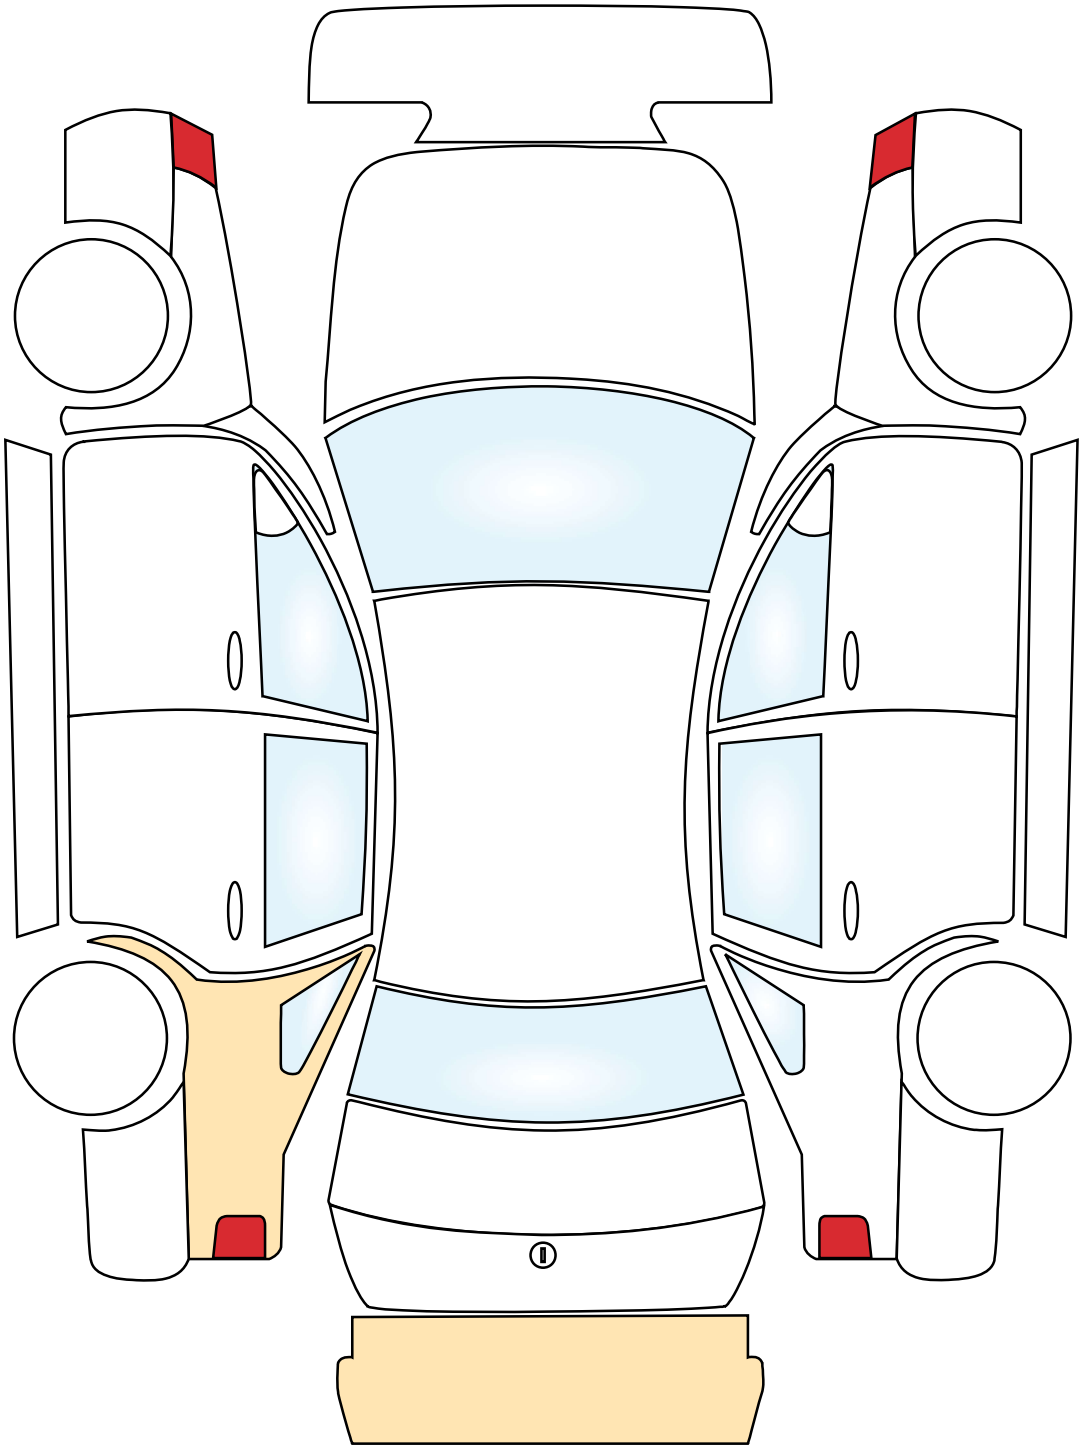
Car Details 100%	Exterior Body Damage Diagram 50.8%	Front Left Wheel & Tyre 100%
Front Right Wheel & Tyre 100%	Rear Left Wheel & Tyre 100%	Rear Right Wheel & Tyre 100%
Engine & Transmission 94.6%	Steering, Suspension & Brakes 100%	Frame Condition 70%

Front Windscreen	Chip
Bonnet	Chip +1
Front Bumper	Dent +2
Front Right Fender	Chip +3
Front Right Door	Scratch +3
Back Right Door	Dent +2
Right Running Board	Scratches
Back Right Fender	Chip +2
Car Trunk	Dent
Rear Bumper	Repair +2
Back Left Fender	Repair +2
Back Left Door	Dent +1
Front Left Door	Scratch +2
Front Left Fender	Dent +2
Left Running Board	Scratches

Door beadings & exterior Weatherstrips are deformed. Minor scratches on the door pads & interior trim panels. RR LH wheel housing repaired. Valve cover resealed. Major scratches, dents & chips on the exterior. Suspension components refitted. Oil wetness on the rear crank seal area.
