Detailed Diagnostic Report (DDR)

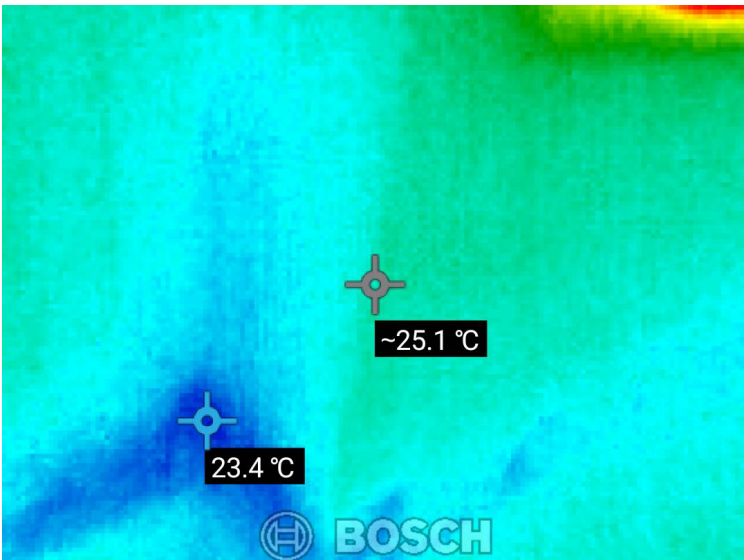
- Hall: Observed dampness at the skirting level.
- Bedroom: Observed dampness at the skirting level.
- Master Bedroom: Observed dampness at the skirting level and on the wall surface, with efflorescence.
- Kitchen: Observed dampness at the skirting level.
- Common Bathroom: Observed gaps between tile joints, hollowness, and mild dampness at the ceiling.
- Master Bedroom Bathroom: Observed gaps between tile joints and hollowness.
- Parking Area: Observed leakage at the ceiling.
- External Wall: Observed cracks and moderate algae fungus and moss growth.

The probable root cause of the issues is leakage due to concealed plumbing, damage in Nahani trap/ Brickbat coba under tile flooring, and gaps around Nahani Trap Joints. Loose plumbing joints and rust around joints and edges may also be contributing to the problems.

- Repair and replace damaged plumbing and Nahani traps.
- Seal gaps around Nahani Trap Joints and tile joints.
- Address the root cause of the leakage in the parking area and common bathroom.
- Treat the algae fungus and moss growth on the external wall.
- Conduct further inspections to ensure all issues are identified and addressed.
