Radiation Tests: SI8920 Isolation Amplifier (1)

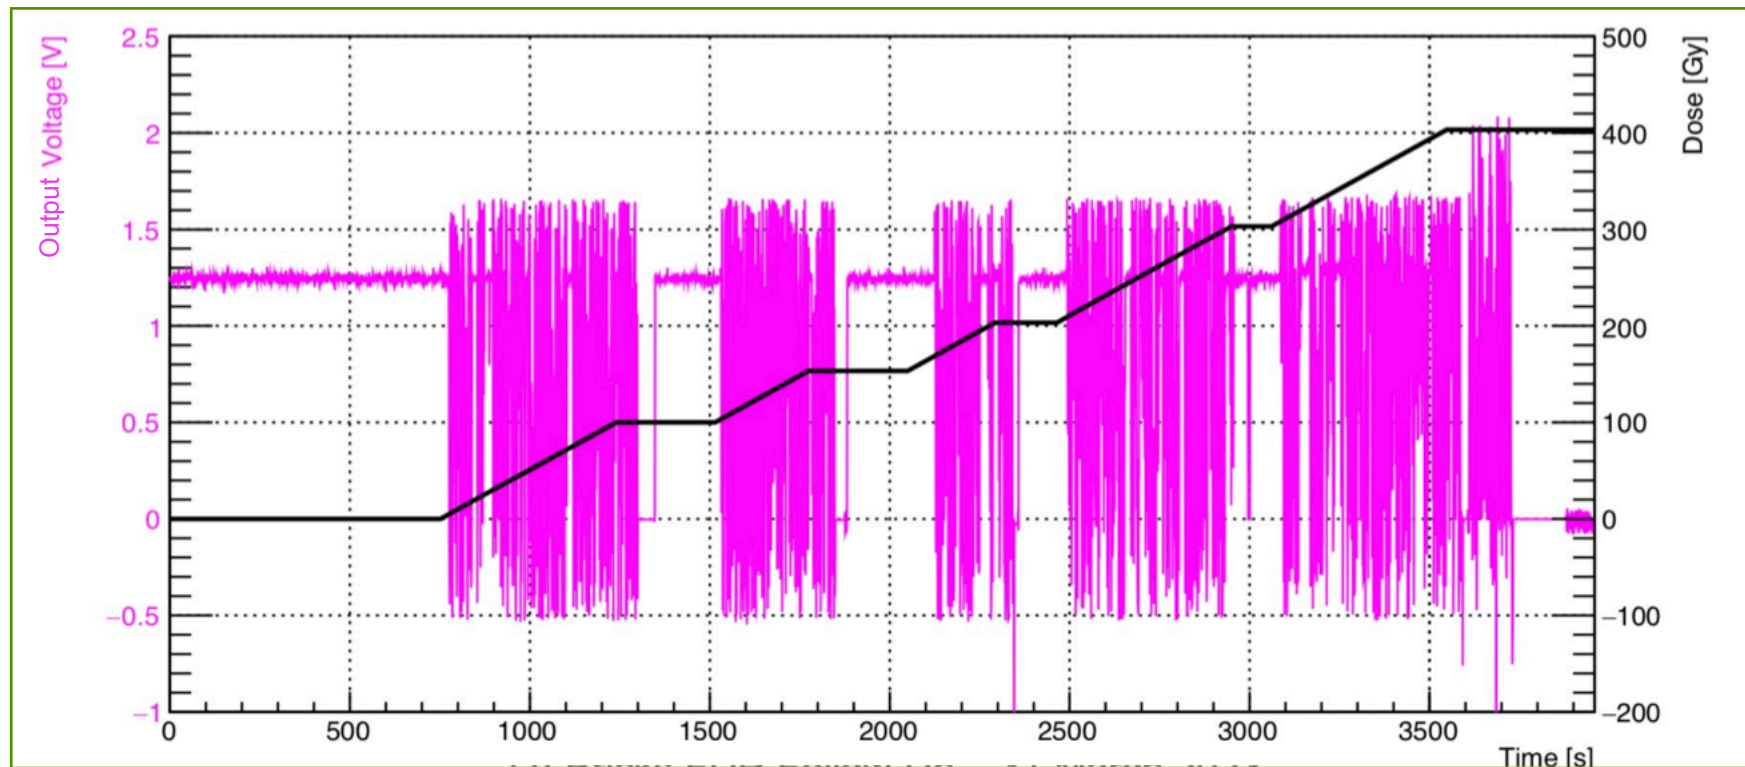
- **Chips tested for NIEL showed no issues**
- SEE/TID tests performed at a flux of 3.5×10^8 p/cm²/s
 - With an input voltage of 150 mV, test results showed fluctuations in the output voltage of some chips during the beam time
- Another set of SEE/TID tests performed at a flux of 2×10^8 p/cm²/s, but the same behavior were observed

Unstable behavior of SI8920 at input voltage of 150 mV at PIF
