Radiation Tests: HCPL7800 Isolation Amp (1)

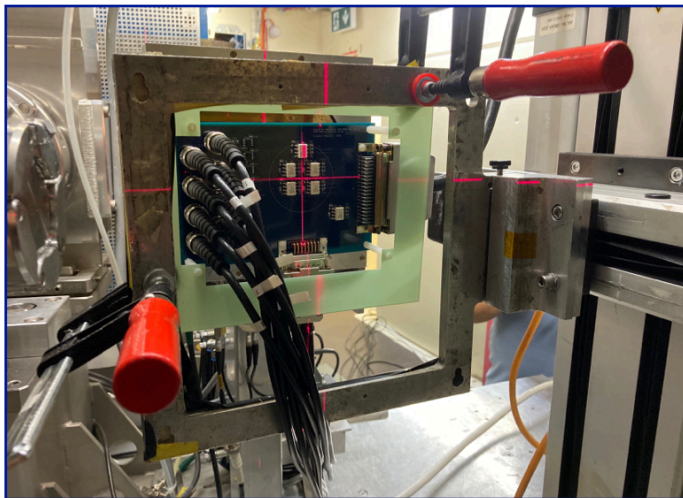
HCPL7800 test board at PIF

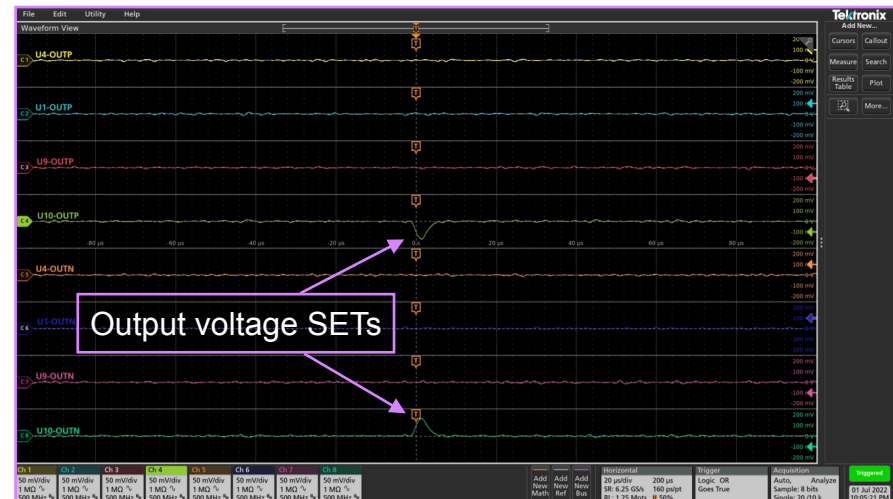
- This chip was not originally in the design, but was considered after initial failures of the original isolation amplifier
- TID and SEE tests performed together at a flux of 2.1×10^8 p/cm²/s up
 - Some SETs were observed on the output voltages, with small amplitude (~ 100 mV) and short time (~ 5 us), but as they will be filtered by low-pass filters on the brick, **the chip passed the SEE tests**
 - **There were also no changes in parameters due to TID**
- **For NIEL tests**, samples irradiated up to 8×10^{12} n/cm² at JSI showed failure, but **the ones irradiated up to 5×10^{12} n/cm² were working fine**

Couple of SETs in HCPL7800 output voltages
