Crash Pattern Summary and HSIP Warrant Analysis

NC 180/NC 226 (Post Rd) at SR 1103 (Pleasant Dr / Pleasant Hill Church Rd), Cleveland County, NCDOT Division 12

Order # 41000079736 | PH/SS # TSUINT716412 | TEAAS Intersection Analysis Report, 9/1/2016 to 8/31/2026 (10 years), Y-line 150 ft | 35.246324, -81.509409

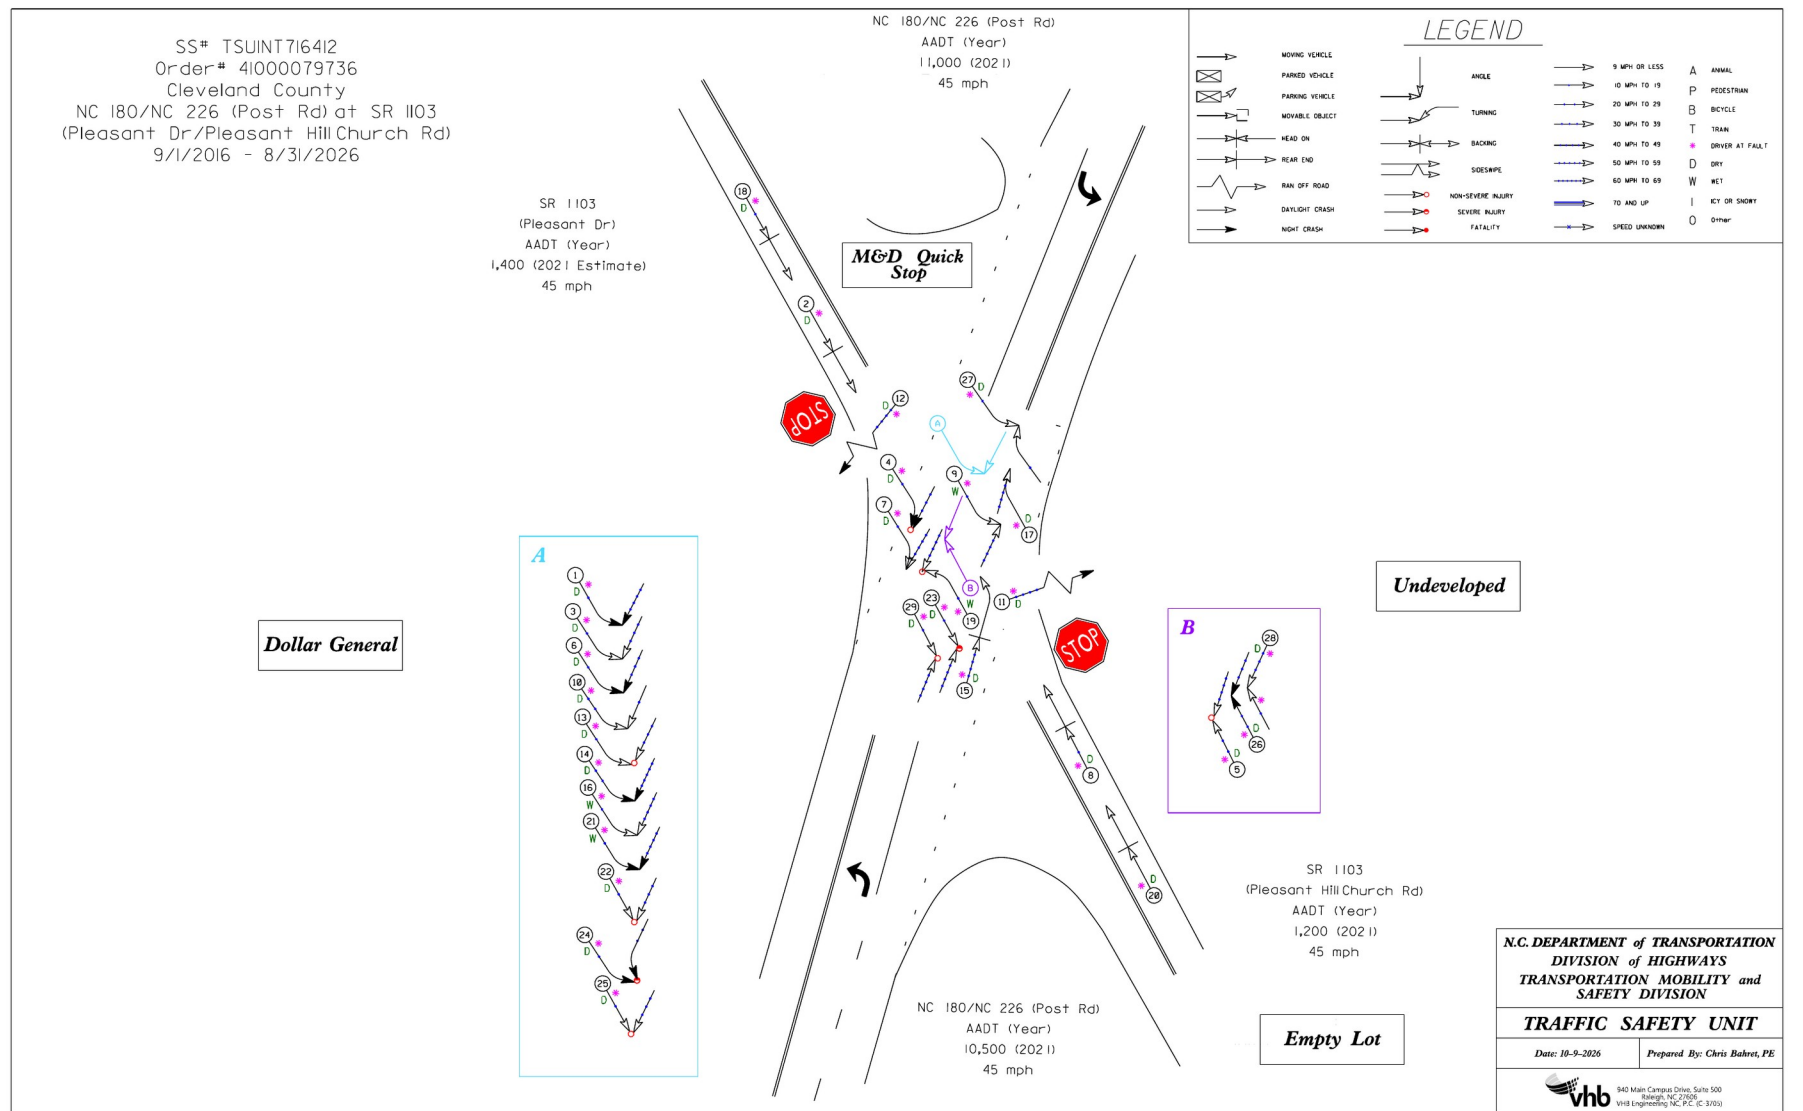
Figure 2. Collision diagram, 9/1/2016 to 8/31/2026 (MicroStation sheet, enlarged; maps/41000079736_CollisionDiagram_labeled.pdf). Numbers are the TEAAS report order of Appendix A.

- **c. Pleasant Dr left turns in front of southbound traffic are the pattern: inset A.** Nine crashes (1, 3, 6, 10, 13, 14, 16, 21, 24) show a Pleasant Dr driver turning left toward northbound NC 180 and being struck by a southbound through vehicle (in 24 the southbound vehicle was itself turning left onto Pleasant Hill Church Rd). Two angle crashes (22, 25) put a Pleasant Dr driver crossing straight into the same southbound lane. The diagram stacks these 11 crashes at one point, the southbound lane just beyond the Pleasant Dr stop line: 38 percent of all crashes and four injuries (13 Class B, 24 Class A, 22 and 25 Class C) at a single conflict point. Four of the nine left-turn crashes were at night (1, 6, 14, 21) and two on a wet road (16, 21).

- **e. Pleasant Hill Church Rd: five frontal crashes, four of them with southbound traffic.** Three angle crashes stacked in inset B where a Pleasant Hill Church Rd driver crossing straight was struck by a southbound vehicle (5 Class B at dusk, 26 at night, 28 with both drivers at fault), one left turn onto

Result. The location meets Warrant I-1r, Frontal Impact Rural: 22 frontal impact crashes, 76 percent of all crashes, with 45 percent of the crashes in the last three years. The identified pattern is minor-street vehicles from SR 1103, chiefly Pleasant Dr drivers turning left or crossing in front of southbound NC 180 traffic (inset A on the diagram), failing to yield to through traffic.

2. The dominant conflict is a Pleasant Dr driver turning left (9 crashes) or crossing (2) in front of southbound NC 180 traffic, stacked at one point just beyond the Pleasant Dr stop line (inset A: 11 of 29 crashes, four with injuries). With the six other Pleasant Dr entries, 17 of the 22 frontal crashes and 7 of the 9 injury crashes start on that one approach, and in 13 of the 17 the vehicle struck was southbound. The 49 degree skew places southbound traffic far behind the stopped driver's left shoulder and the M&D Quick Stop sits in that sight triangle; sight distance, the skew and the driveways are the field questions that decide the countermeasure.

- Stop-approach conspicuity on SR 1103, Pleasant Dr first: oversize STOP signs with retroreflective post strips or flashing LED borders, STOP AHEAD signs, CROSS TRAFFIC DOES NOT STOP plaques, refreshed stop bars, and transverse rumble strips on the Pleasant Dr approach.

- Sight-line clearing in the northwest quadrant (M&D Quick Stop frontage) and driveway management on Pleasant Dr.
- Advance intersection warning on NC 180 in both directions with street-name plaques, and an intersection conflict warning system (VEHICLE ENTERING WHEN FLASHING beacons on the southbound approach, actuated from the SR 1103 approaches) if the sight-distance review supports it.

- Intersection lighting, given 7 frontal crashes in the dark at an unlit location.
- Geometric correction of the skew: realigning the Pleasant Dr approach to meet NC 180 near 90 degrees, which turns the look-back for southbound traffic into a normal left look, or offsetting the two SR 1103 legs.

- Restricting the Pleasant Dr left turn and the through movement: a reduced-conflict (J-turn) configuration on NC 180 removes the 9 left-turn and 2 crossing crashes of inset A and the inset B
