PCB Inspection Report

Timestamp	2026-04-05 15:25:53
PCB Name	test3
Source	upload
Status	DEFECTIVE
Risk Level	HIGH
Failure Probability	70.06%

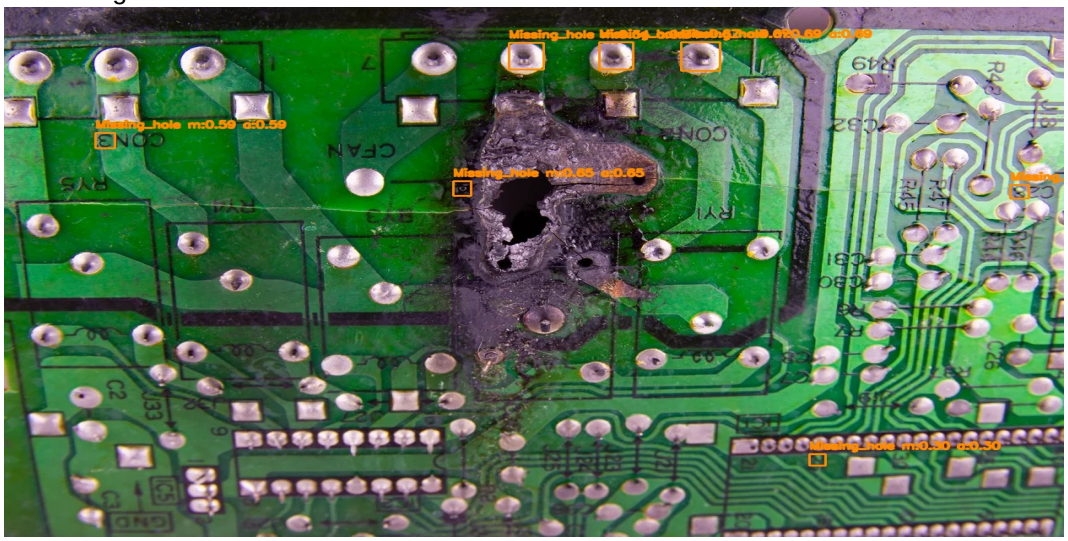
Detection Image

#	Label	Confidence	Severity	Impact	BBox
1	Missing_hole	0.7954	High	Function incomplete	[1192, 280, 1214, 301]
2	Missing_hole	0.6899	High	Function incomplete	[802, 55, 848, 100]
3	Missing_hole	0.6693	High	Function incomplete	[705, 55, 745, 98]
4	Missing_hole	0.649	High	Function incomplete	[532, 274, 553, 297]
5	Missing_hole	0.5945	High	Function incomplete	[108, 198, 131, 222]
6	Missing_hole	0.3384	High	Function incomplete	[598, 56, 639, 98]
7	Missing_hole	0.3038	High	Function incomplete	[954, 704, 973, 722]

1) Inspection Status
- Overall status: DEFECTIVE
- Risk level: HIGH
- Predicted failure probability: 70.06%
2) Defect Assessment
- Defect 1: Missing_hole | model_conf=0.80 | fused_conf=0.80 | bbox=[1192, 280, 1214, 301]

- Defect 2: Missing_hole | model_conf=0.69 | fused_conf=0.69 | bbox=[802, 55, 848, 100]
- Defect 3: Missing_hole | model_conf=0.67 | fused_conf=0.67 | bbox=[705, 55, 745, 98]

- Defect 4: Missing_hole | model_conf=0.65 | fused_conf=0.65 | bbox=[532, 274, 553, 297]
- Defect 5: Missing_hole | model_conf=0.59 | fused_conf=0.59 | bbox=[108, 198, 131, 222]

- Defect 6: Missing_hole | model_conf=0.34 | fused_conf=0.34 | bbox=[598, 56, 639, 98]
- Defect 7: Missing_hole | model_conf=0.30 | fused_conf=0.30 | bbox=[954, 704, 973, 722]

3) Operational Risk Impact
- High probability of field failure if unreworked defects remain.
4) Recommended Actions
- Rework defects by label priority (short/open/missing first).

- Reinspect repaired regions under magnification and AOI.
- Perform continuity + isolation checks on affected paths.
5) Release Decision Guidance
- Hold production release until full rework and electrical validation are complete.

- Missing_hole: Replace missing component and verify BOM compliance. Check for tombstoning or skew during reflow. Perform ICT test post-repair.
