AHU screening (single-system, 2026-06)

AHU_1

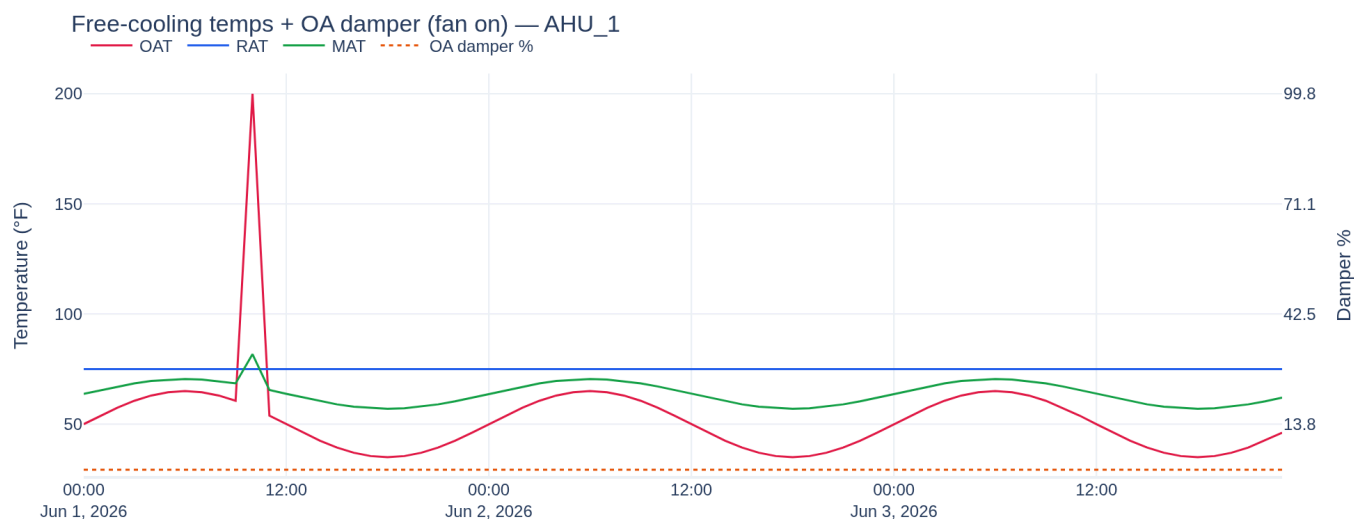
Executive summary

AHU_1 in June 2026 (72 samples, 72.0 h). Sensor checks found issues. Fail. Outdoor air temperature: reading out of physical range (low 35.0, high 200.0). Fail. Return air temperature: sensor stuck flat; Supply air temperature: sensor stuck flat. Fail. Outdoor air temperature: reading jumped suddenly. Fail. Outdoor air temperature: reading changed faster than expected. Anomaly screening: screened trends look normal. These screening notes are not equipment faults. Confirmed operating findings: Duct static below SP at full fan (GL36 A) 72.0 h; Economizer stuck closed 26.0 h; Always-on fan or pump runtime 72.0 h. The fan was on for 100.0 percent of the samples.

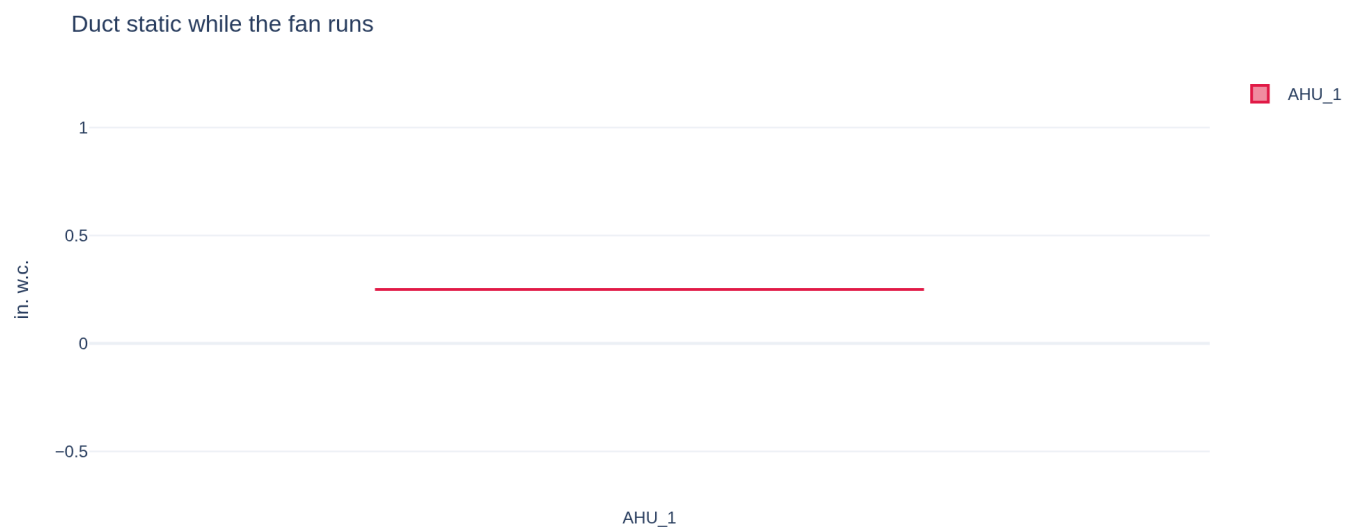
Duct static while the fan runs

Duct static pressure with the fan running.

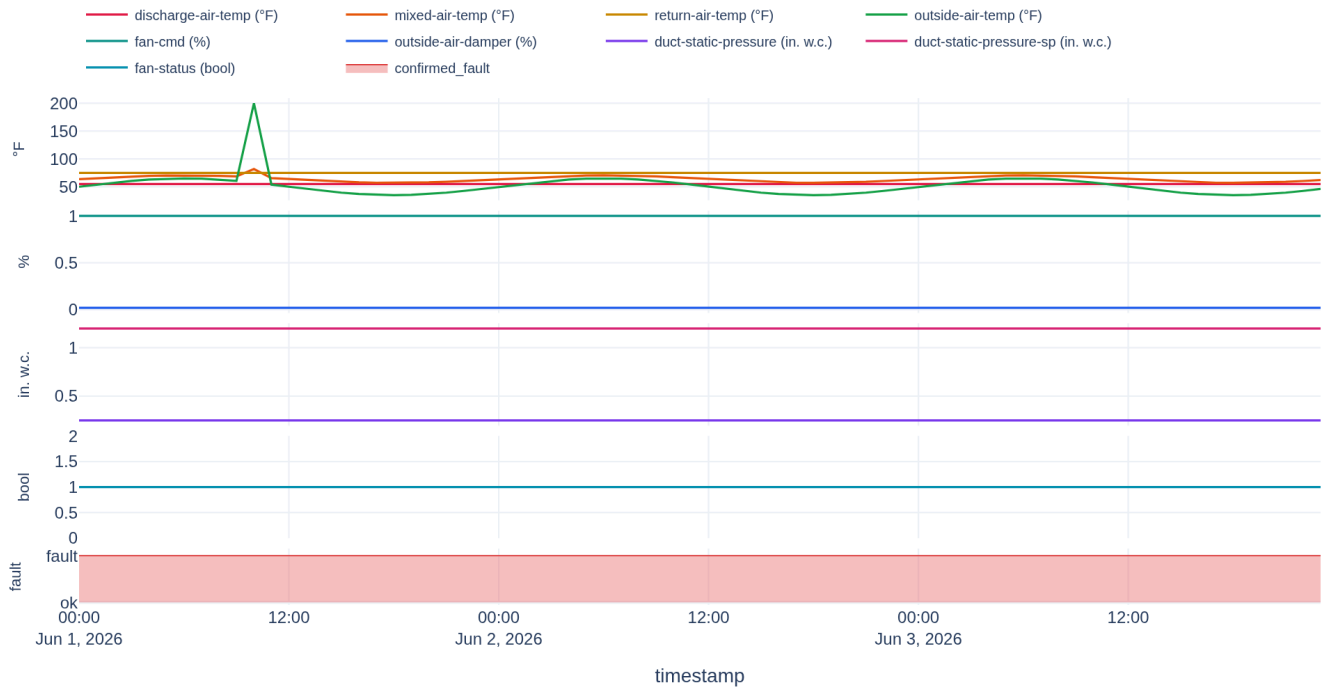
FC1 – Duct static below SP at full fan (GL36 A)

Troubleshoot: Flags duct static too low while the supply fan is near full speed. Check: $DSP < DSPSP - \epsilon DSP$ AND $VFDSPD \geq 100\% - \epsilon VFDSPD$.

In the data: In June 2026 this holds for 72.0 hours, 2026-06-01 00:00 UTC through 2026-06-03 23:00 UTC. duct static pressure was on for 0.0 percent of those samples; duct static setpoint was on for 100.0 percent of those samples; fan speed command was on for 100.0 percent of those samples.

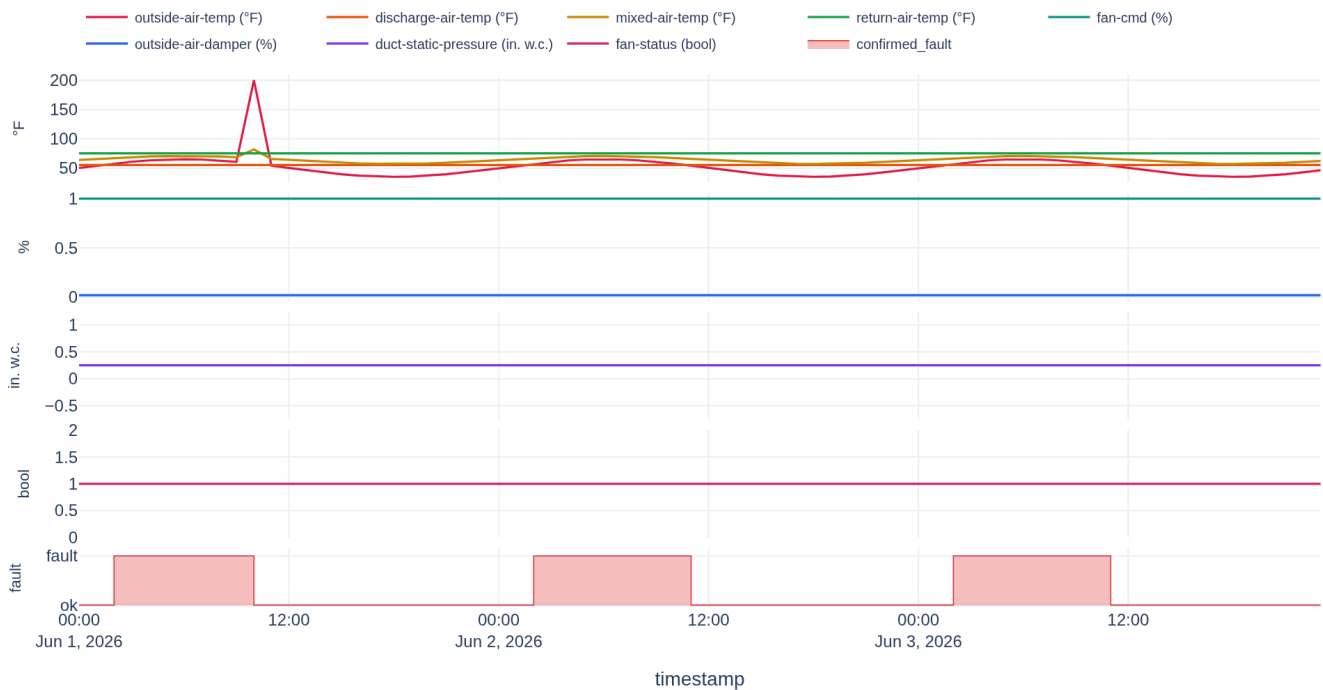
ECON-1 – Economizer stuck closed

Troubleshoot: Fan on, OA damper < 5%, OAT > 55°F (should be economizing). Check: Fan on, OA damper < 5%, OAT > 55°F (should be economizing).

In the data: In June 2026 this holds for 26.0 hours, 2026-06-01 02:00 UTC through 2026-06-03 10:00 UTC. fan speed command was on for 100.0 percent of those samples; outdoor air damper was on for 0.0 percent of those samples; outdoor air temperature was about 63.0.

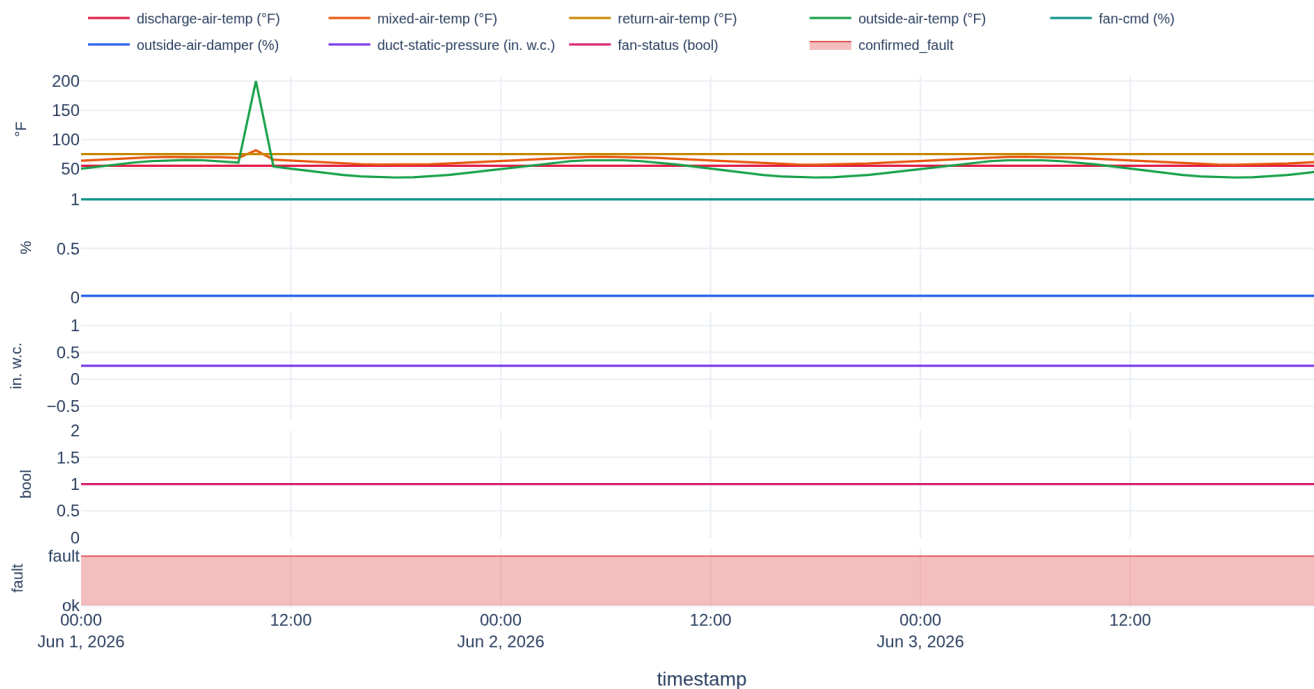
SCHED-247 – Always-on fan or pump runtime

Troubleshoot: Flags fans or pumps that stay on for nearly the entire analysis window (24/7 runtime). Check: Ranked proof (status/current > command) is on for $\geq$ always_on_pct of the window. Pressure is inferred runtime only and does not trip this rule ID.

In the data: In June 2026 this holds for 72.0 hours, 2026-06-01 00:00 UTC through 2026-06-03 23:00 UTC. fan status was on for 100.0 percent of those samples; fan speed command was on for 100.0 percent of those samples; duct static pressure was on for 0.0 percent of those samples.

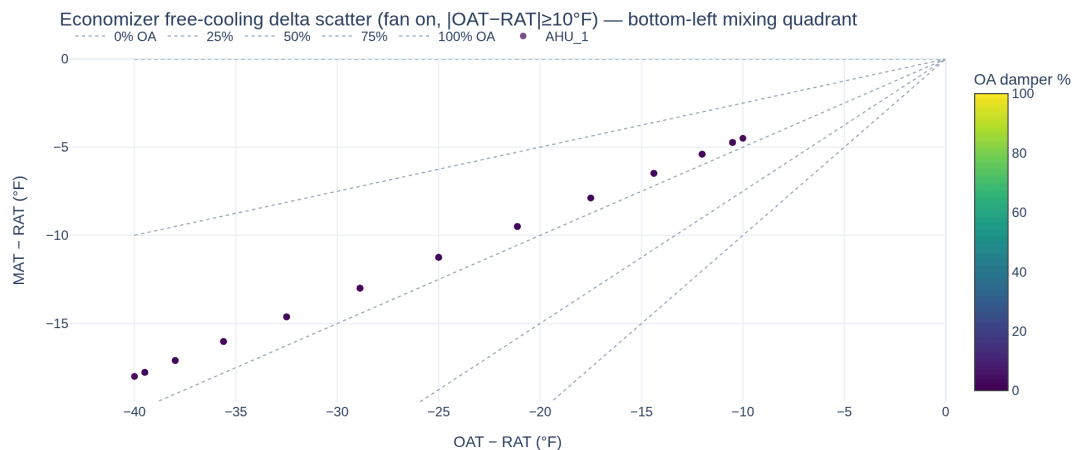
Economizer delta scatter

Outdoor-air mixing with the supply fan on. The horizontal axis is outdoor-air temperature minus return-air temperature (OAT - RAT). The vertical axis is mixed-air temperature minus return-air temperature (MAT - RAT). The view is the bottom-left diagnostic quadrant only, where outdoor air is at or below return air and mixed air is at or below return air. A sample is plotted only when the fan is on and the absolute difference between outdoor air and return air is at least 10°F, so the outdoor-air fraction is identifiable.
