TECHNICAL NOTEEdition Anglaise

77 11 188 300 APRIL 1996

TWINGO

RE-PROOFING THE LOWER WING PANEL ROUNDED SECTION TO ACCOMMODATE SNOW CHAINS

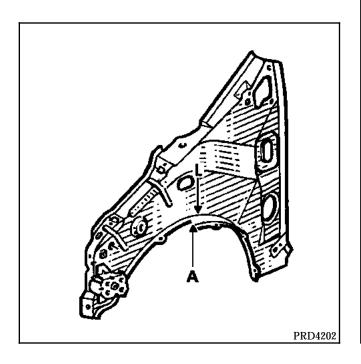
The radius of the wing panel rounded section (pillar lining) has been increased to allow the fitting of snow chains. Therefore, on an older vehicle, for partial replacement of this component when cutting the middle of the rounded section, it will be necessary to adjust the shape of the edging of the part supplied by the Parts Department (see method described in the technical note).

Shape the edge of the original along the line (L) in such a way as to adjust the rounded section of both parts of the component, then cut off any excess metal at (A).
