Site walk notes — Example Foods - Smithfield

Infeed to packing · Site walk · 29 October 2026

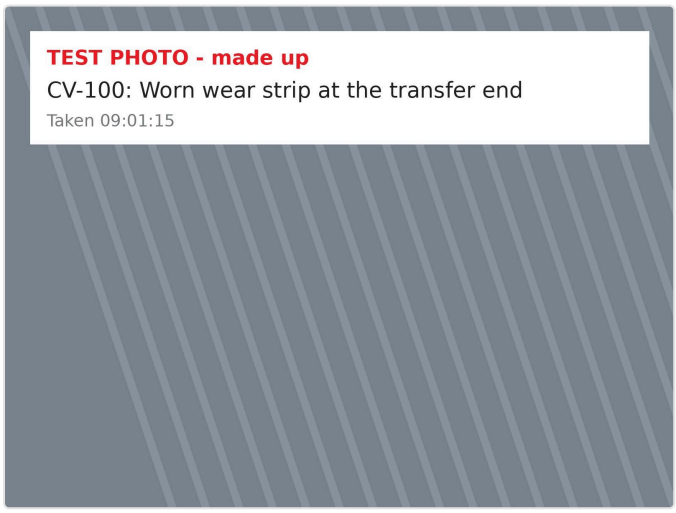
- Walked three conveyors with Jo Bloggs, from the infeed (CV-100) to packing (CV-300).
- CV-100 infeed: carryway wear strips worn at the transfer end, about half their height left. Example Foods maintenance will replace them at the next shutdown. Belt, tracking, sprockets, shafts and return way are fine.

09:01 CV-100: carryway wear strips worn down at the transfer end.

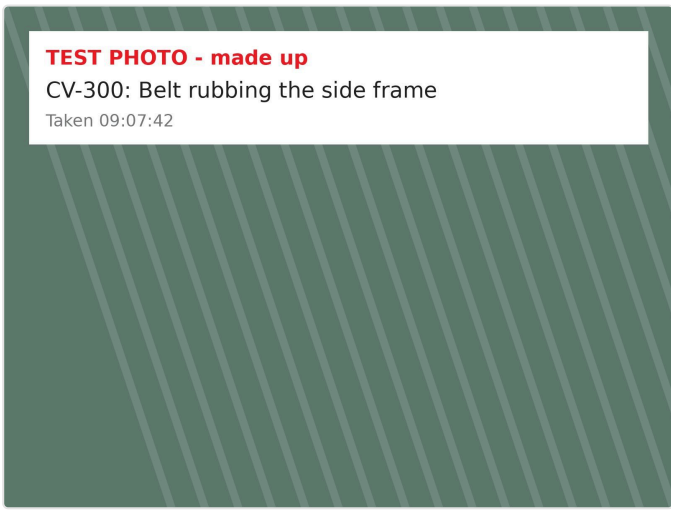
- CV-300 packing: belt tracking to the right and rubbing the side frame near the outfeed. Not urgent; check the take-up adjustment at the next service. Hygiene is good.

09:07 CV-300: belt rubbing the side frame near the outfeed.

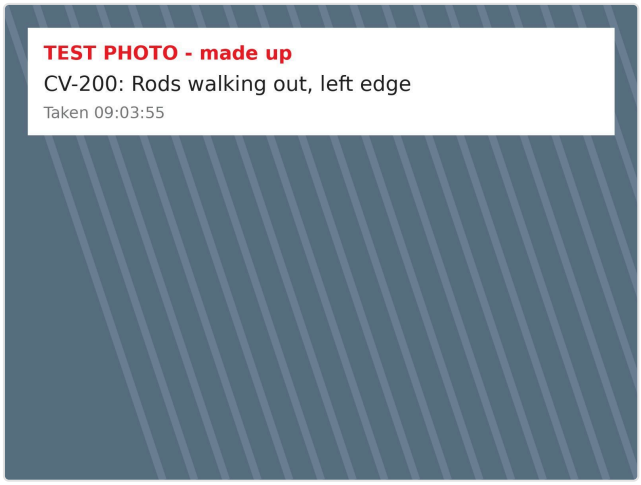
- CV-200 spiral exit: rods walking out on the left side about every third row, with worn hinges, since the wash-down change about six weeks ago. Drive sprocket teeth are hooked. A new belt and sprockets are recommended (Belts to quote, below).

09:03 CV-200: rods walking out on the left edge.

Replacing a belt with rods walking out and worn hinges; the drive sprockets are hooked and are replaced with it. Quote requested by Friday 30 October.

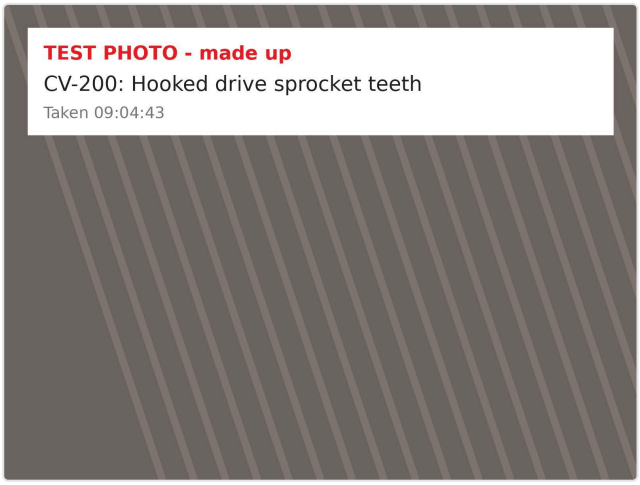
09:04 CV-200: drive sprocket teeth hooked.
