Site walk report — Example Foods - Smithfield

Infeed to packing · Site call · 29 October 2026

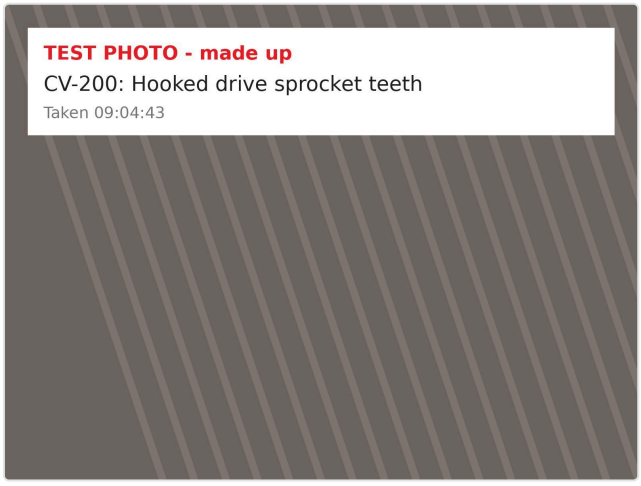
- CV-200 spiral exit: rods walking out on the left side about every third row, with worn hinges, since the wash-down change about six weeks ago. Drive sprocket teeth are hooked. A new belt and sprockets are recommended (Belts to quote, below).

09:03 CV-200: rods walking out on the left edge.

09:04 CV-200: drive sprocket teeth hooked.

Replacing a belt with rods walking out and worn hinges; the drive sprockets are hooked and are replaced with it. Quote requested by Friday 30 October.
