## 3D PRINTING DEFECT DETECTION REPORT

Name: wrong\_z\_offset\_honeycomb\_box.jpg

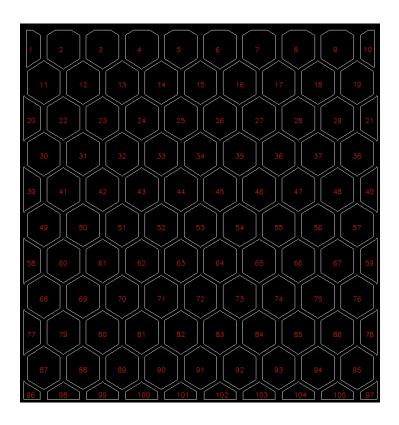
- Prediction probability: 7.500E-1 %

- Type of defect: Low Z-offset

- The print platform is not level.
- The Z-offset between the print platform and the extruder has not been correctly adjusted and it's too low.
- The diameter of the extruder may be affecting the Z-offset:
   Extruders with larger diameters may require a larger Z-offset

due to the greater extrusion of material, while smaller ones may require a smaller value.

- Different types of materials influence the Z-offset calibration: Variable diameters of materials can affect the volume of extrusion of the molten material.

- Hardware problems:

It may have mechanical problems that affect the accuracy of the Z-offset. Check for loose, misaligned or aged components that may affect to the printing precision of the printer.
