Post Clean Verification

Client Birtley House

Project Grease extract ventilation system clean

Clean Date 31/05/2017

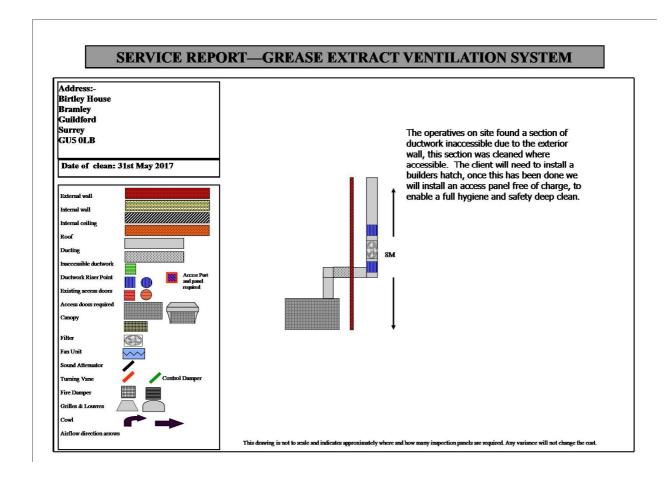
The ductwork exits the back of the canopy then passes out through the exterior wall of building. At this point the ductwork turns 90 degrees and rises up the outside wall of the building for approximately six metres before venting to atmosphere. The extract fan can be located within the riser section of ductwork.
