Detailed Diagnostic Report

Property DDR Report

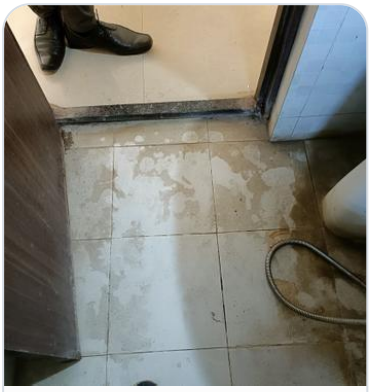
Bedroom Skirting level Dampness Common Bathroom tile hollowness

Probable Root Cause: Moisture ingress likely linked to wet-area tile joint failure, plumbing leakage, or poor sealing.

Severity Reasoning: Severity is based on visible moisture-related distress is present.

- Inspect bathroom and plumbing fixtures, then repair leaking joints, traps, or concealed lines.
- Re-grout or reseal failed tile joints and replace hollow or loose tiles where needed.
- Trace the moisture source before cosmetic repairs, then remove damaged plaster and repaint after drying.

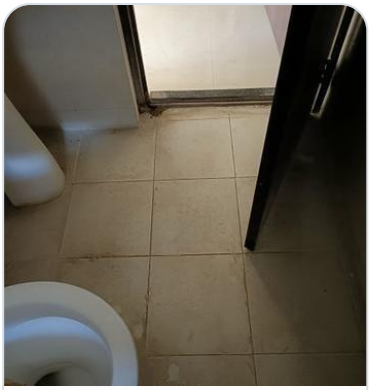
Master bedroom Skirting level Dampness MB Bathroom tile hollowness

Probable Root Cause: Moisture ingress likely linked to wet-area tile joint failure, plumbing leakage, or poor sealing.

Severity Reasoning: Severity is based on visible moisture-related distress is present.

- Inspect bathroom and plumbing fixtures, then repair leaking joints, traps, or concealed lines.
- Re-grout or reseal failed tile joints and replace hollow or loose tiles where needed.
- Trace the moisture source before cosmetic repairs, then remove damaged plaster and repaint after drying.
