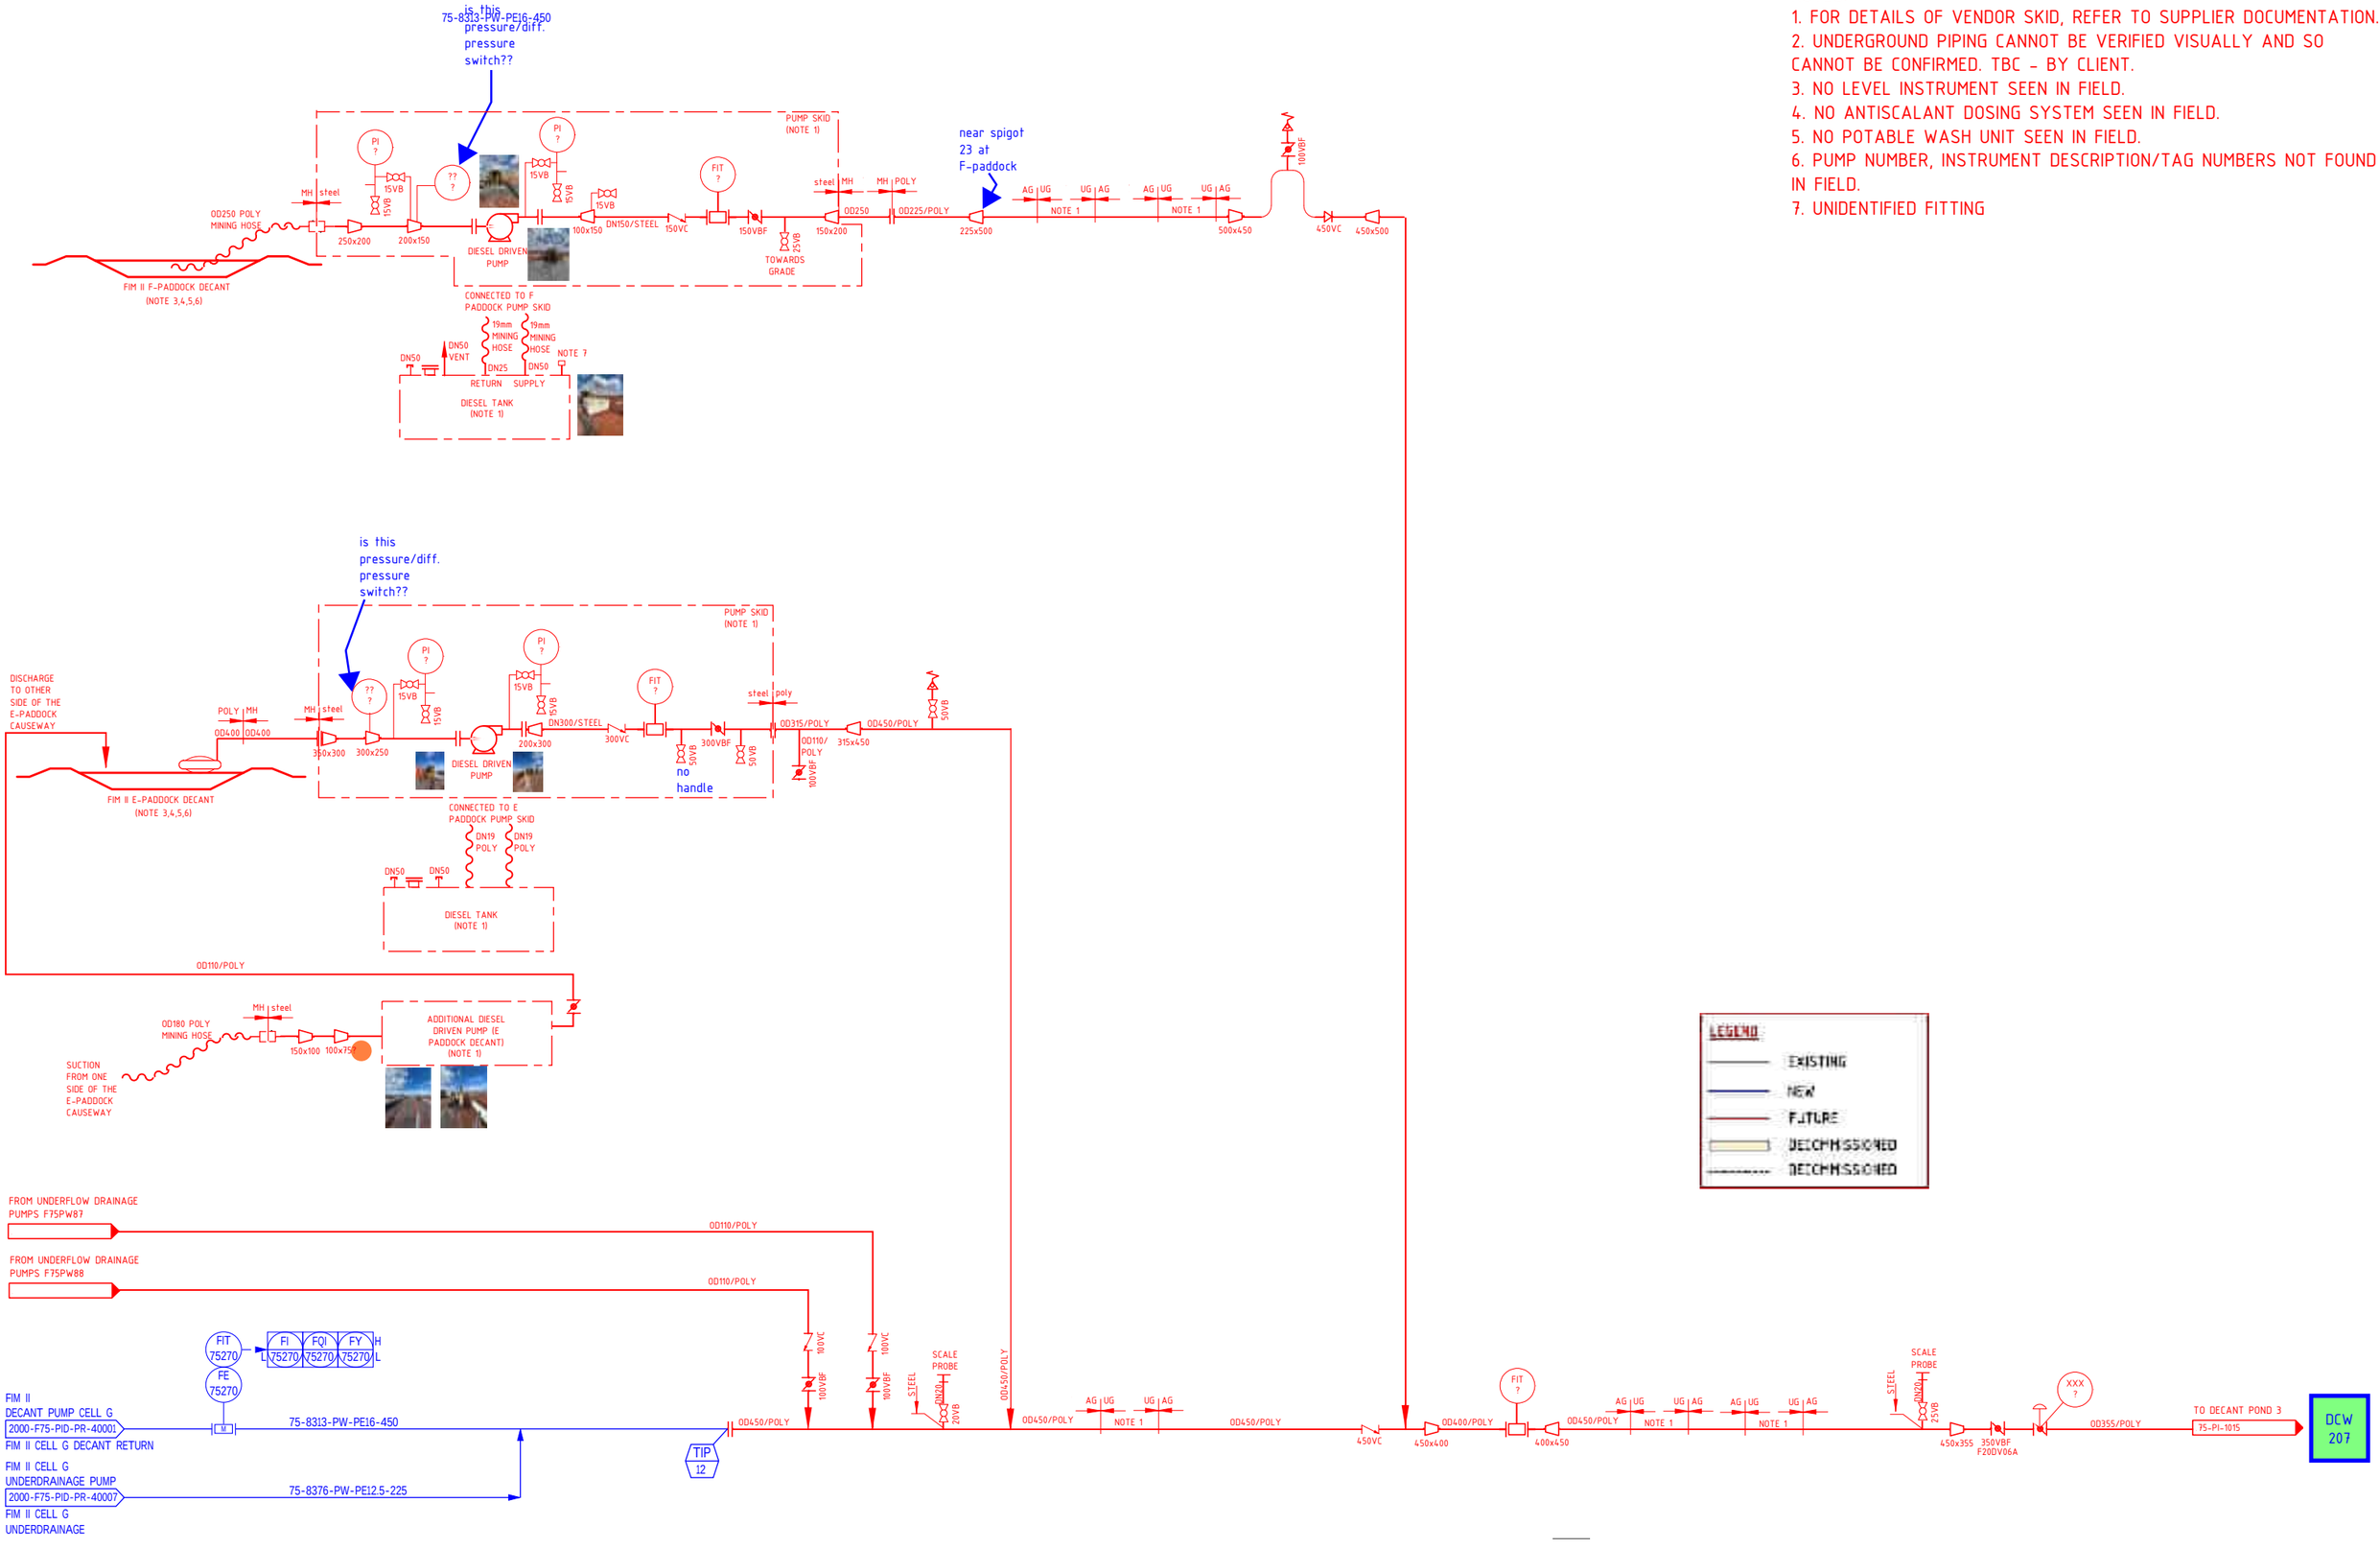
1. FOR DETAILS OF VENDOR SKID, REFER TO SUPPLIER DOCUMENTATION.
2. UNDERGROUND PIPING CANNOT BE VERIFIED VISUALLY AND SO CANNOT BE CONFIRMED. TBC - BY CLIENT.
3. NO LEVEL INSTRUMENT SEEN IN FIELD.
4. NO ANTISCALANT DOSING SYSTEM SEEN IN FIELD.
5. NO POTABLE WASH UNIT SEEN IN FIELD.
6. PUMP NUMBER, INSTRUMENT DESCRIPTION/TAG NUMBERS NOT FOUND IN FIELD.
7. UNIDENTIFIED FITTING
