Model : SM-G928W8

Revision : REV0.8

# Setup(2015-05-20)\_HHP

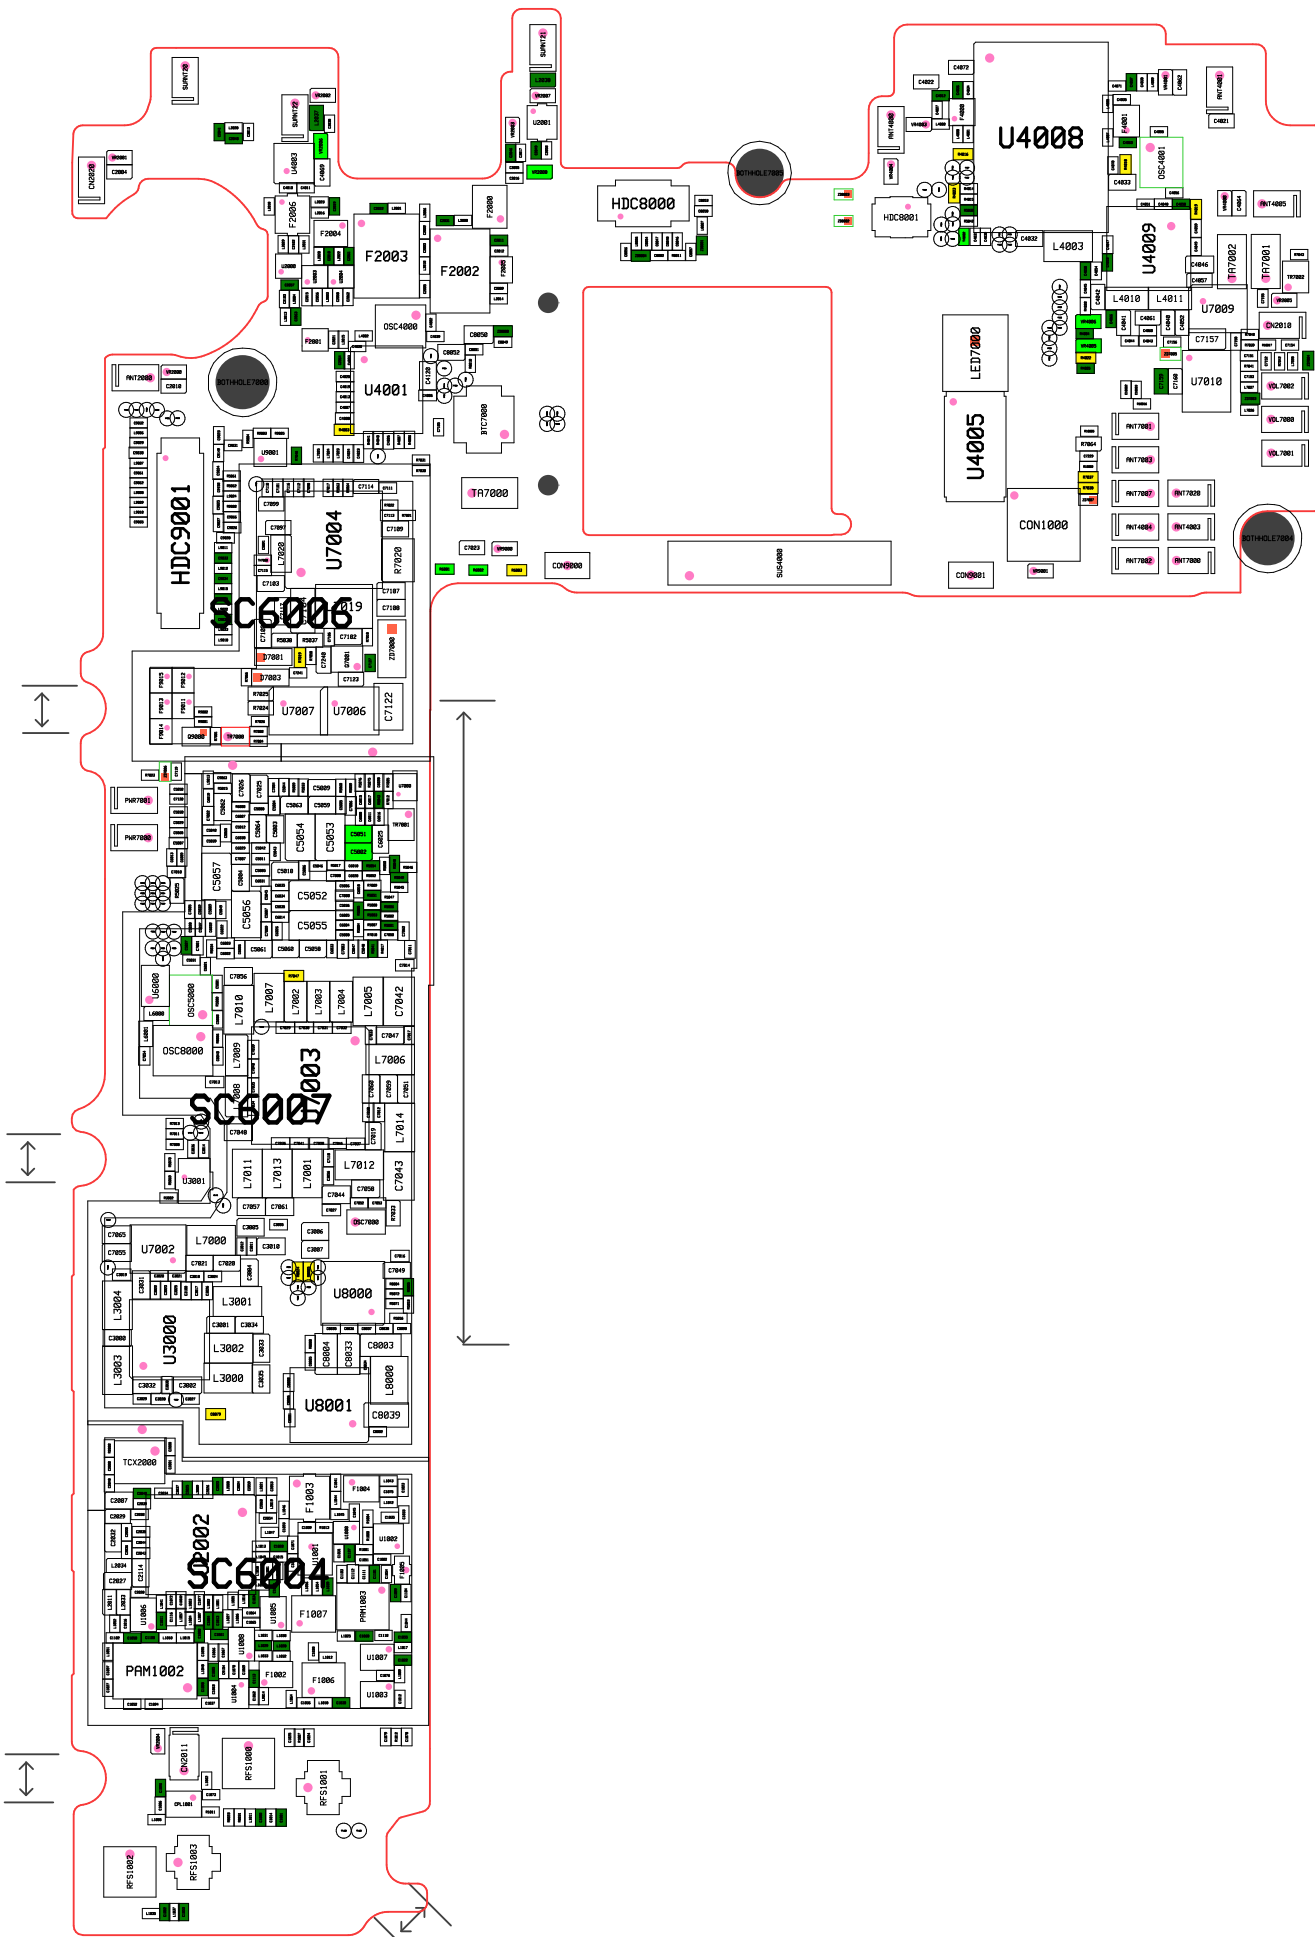
AON1605(TR7000) : IT'S Wrong Polarity possibility. Check the Pin1  
2007-010848(R10004) : Check! Bottom Surface of Component

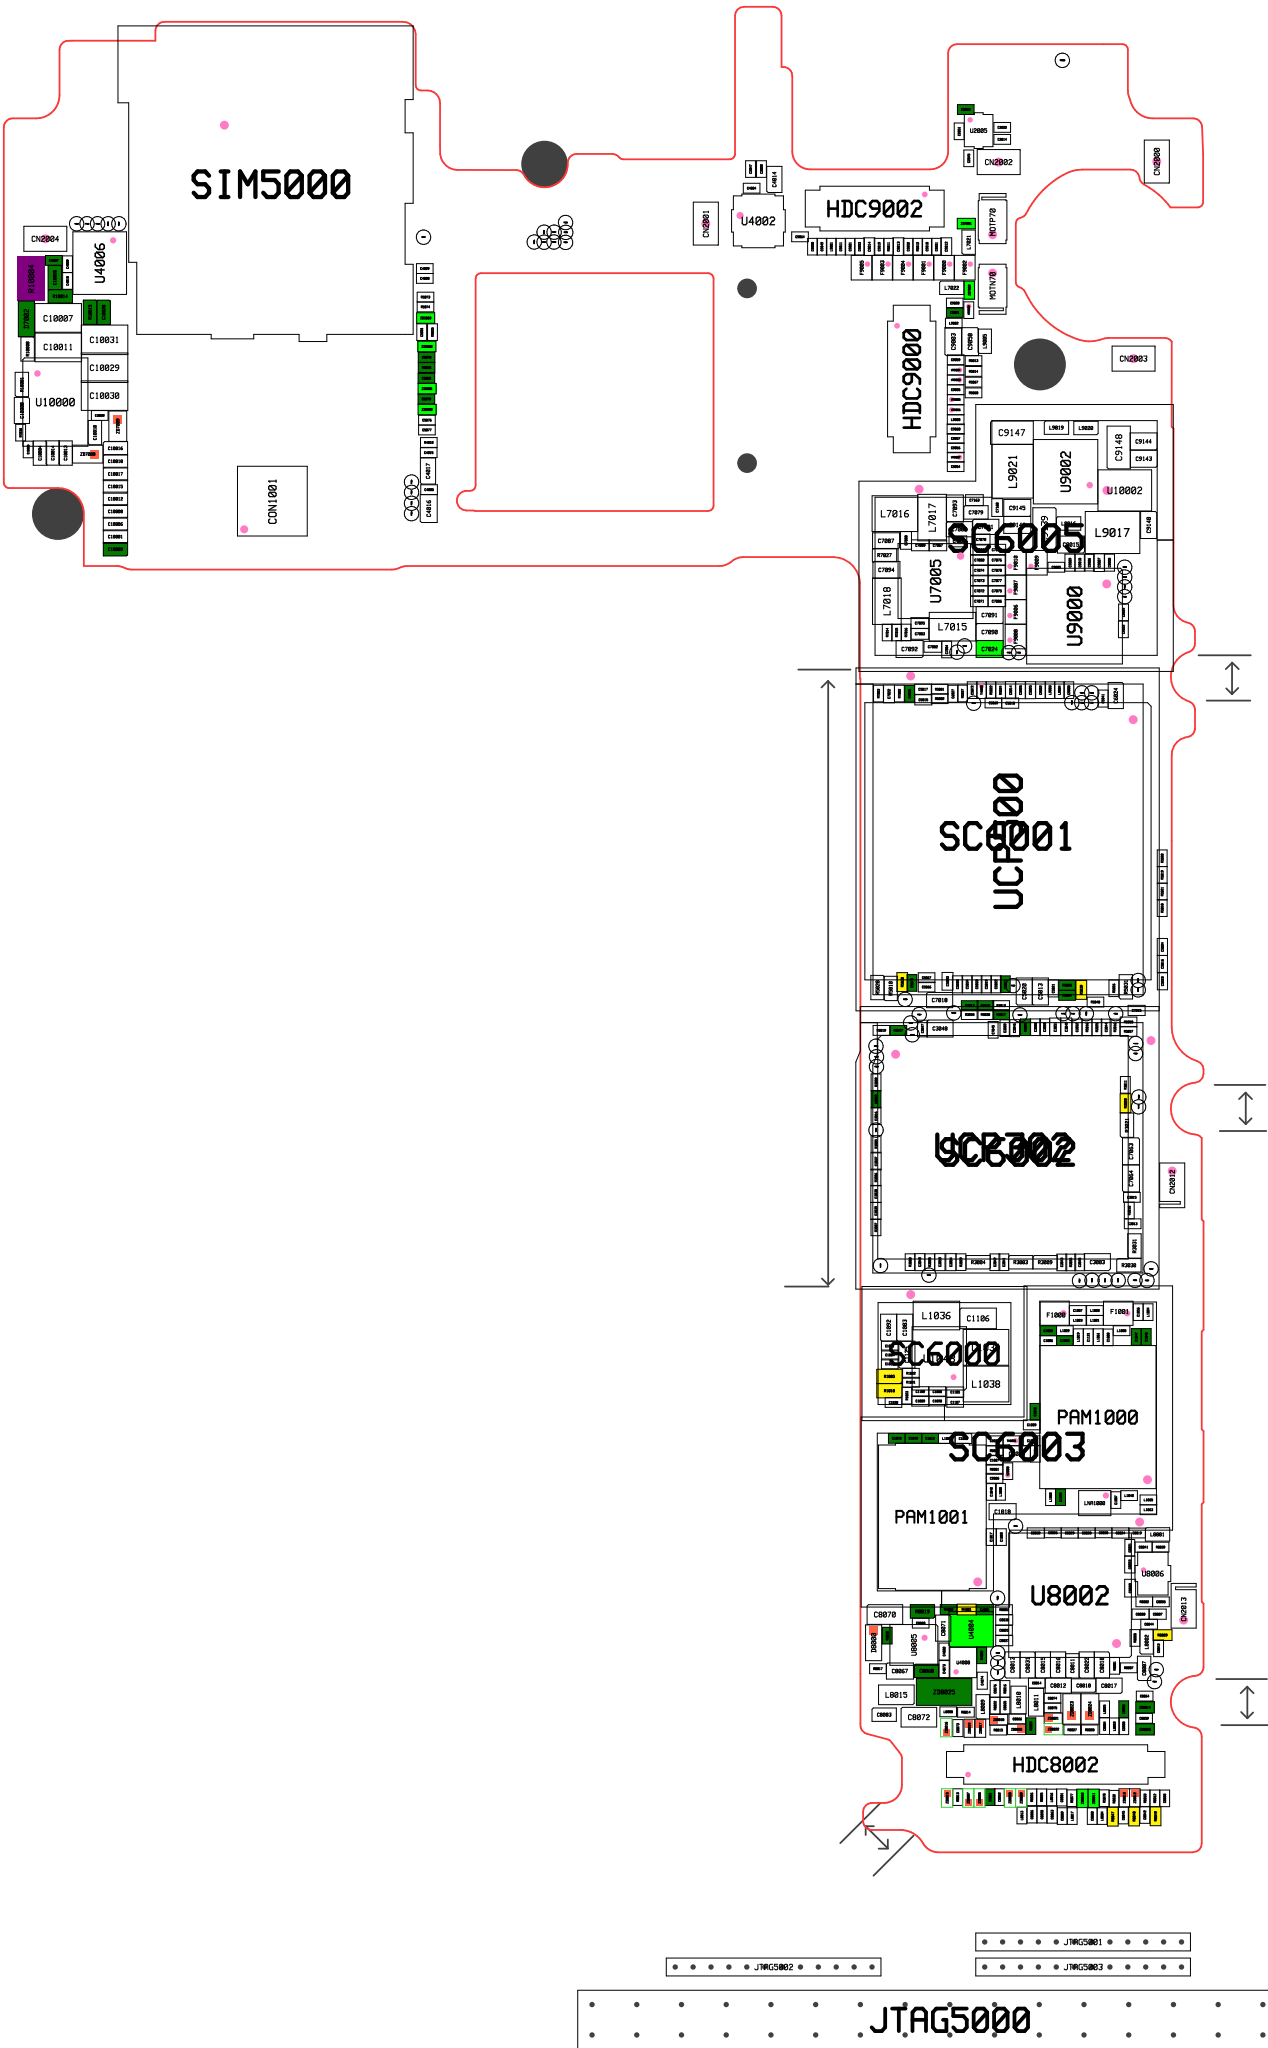
AON1605(TR7000) : IT'S Wrong Polarity possibility. Check the Pin1  
2007-010848(R10004) : Check! Bottom Surface of Component
