Paper Jam in Rear Door

HP CP2025, CM1312MFP, CM2320MFP, M375MFP, M475MFP, M476MFP, M351, M451

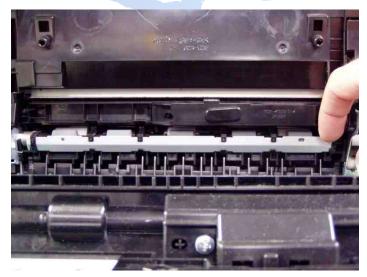
This problem is caused by the guide on top of the registration assembly in the back of the printer being out of position. Physical damage to that specific part because of a paper jam causes the printer to show a **false** paper jam in the back door. This problem can be seen from the back of the machine. Check the registration roller and make sure it is in the right position as shown in the picture below.

If there is a problem with the registration, you will see the guide is not all the way up and it does not go back to the original position right away, see picture below.

If the issue is confirmed, carefully move the guide to left or right to see if it will go to its home position. If not, a close look will be needed to determine the cause of the problem and may need to contact LPI tech support for further diagnosis.
