## Grinding from the fuser or back of the printer HP LaserJet P4014, P4015 and P4515 HP LaserJet M601, M602 and M603 HP LaserJet M604, M605, and M606

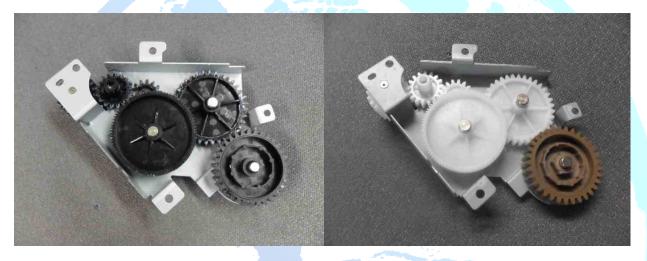
There have been cases of a grinding noise in the fuser area or back of the printer. This symptom is similar to the swing plate assembly grinding on the LJ 4250/4350 series, but these are not swing plates as they do not have the ability to dis-engage the fuser, but classified simply as fuser drive assembly.

Most instances the fuser is replaced only to find the printer still having the same sound or even a louder grinding sound with the new fuser gears not completely meshing with the printers worn drive gears.

M600-FDA (M601/602/603)

P4015-FDA

The P4000 series (P4014, P4015, and P4515) service manual does not list an actual part number for this assembly but it can be purchased through Laser Pros International via part number: P4015-FDA.

The M600 series (M601, M602, and M603) service manual does not list an actual part number for this assembly but it can be purchased through Laser Pros International via part number: M600-FDA.

The M600 series (M604, M605, M606) service manual lists part # RM2-6321. This assembly is cross compatible to M601, M602, and M603 also.

The repair procedure is very similar to replacing the swing plate on the LJ4250/4350 series where all covers and power supply must be removed (see service manual) however the P4014-FDA and M600-FDA have the

addition of a 4<sup>th</sup> screw on the front end of the assembly. The procedure also requires removal of a metal guide from the bottom of the laser scanner cross member (2 screws from each front and back side) as shown below:
