13.A2.D2 input paper jam

HP M601/M602/M603/M604/M605/M606

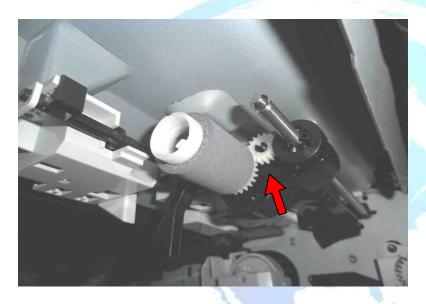
There are a few causes for the M600 series printers to display the 13.A2.D2 input jam i.e. worn rollers, defective pick up drive assembly (as the most common) but the least obvious is a broken/missing gear that transfers drive to the pick up roller, shown with paper feed roller removed.

This gear is not available alone however is included on the paper feed shaft assembly RM1-8424 as shown.
