## Lines caused by faulty ITB

## HP CM3530MFP, CP3525, CP4025, CP4525, M551, M575MFP, M552, M553, M577MFP, CP5225, CP5525, M775MFP, CM4540MFP, M651, M652, M653, M680MFP, M681MFP, M682MFP, CP6015, CM6040MFP, M855, M880MFP

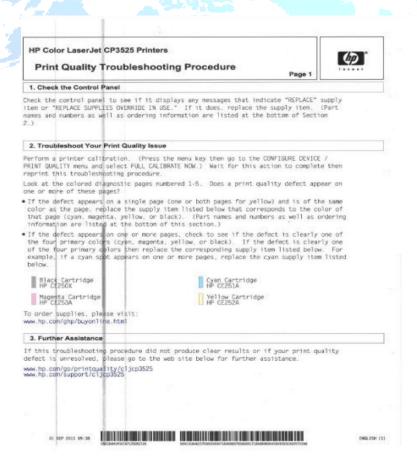
This problem is seen with lines or streaks that show on the page in paper feed direction. They are usually dark gray lines but other colors can be present as well. This issue occurs when the cleaning mechanism on ITB is faulty.

- 1. Perform a disable cartridge check to isolate the problem from any of the toner cartridges
- 2. Replace Transfer Kit
