## Damaged Tray 2 Guides HP CLJ 3000/3600/3800/CP3505 Printers

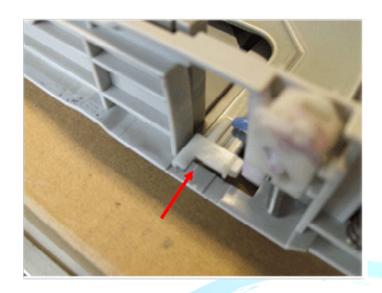
Figure 4: Unbroken Tray Lift Plate Guide

At the same time the guides are inspected, the paper tray for Tray 2 should also be inspected for damage, especially the plastic guides on the lift plate. Pictured below are the location of these guides and examples of unbroken and broken parts. If these guides are broken, it is necessary to replace the paper tray along with the guides. Failure to replace the tray if these guides are broken will likely result in breaking the tray guides inside the printer again when the tray is installed.

The Tray 2 part number is: 250-sheet paper tray assembly RM1-2705-070CN
