OFFICIAL NORTH CAROLINA WOOD-DESTROYING INSECT INFORMATION REPORT

1.	
Seller's Name(s) <u>Heon & Sooja Lee</u>	
Buyer's Name(s) <u>Mahlian & Steve Carmichael</u>	
Address of Property <u>38 Forest Knoll Drive, Weaverville, NC, 28787</u>	
Structure(s) Inspected: A. Main Residence Only <u>---X---</u> B. Other _____

FIRM: Biggs Pest ControlPCO Lic No. 1547PW Date 06/25/26Address: PO Box 6443, Hendersonville, NC 28793Telephone: () (828) 275-1014

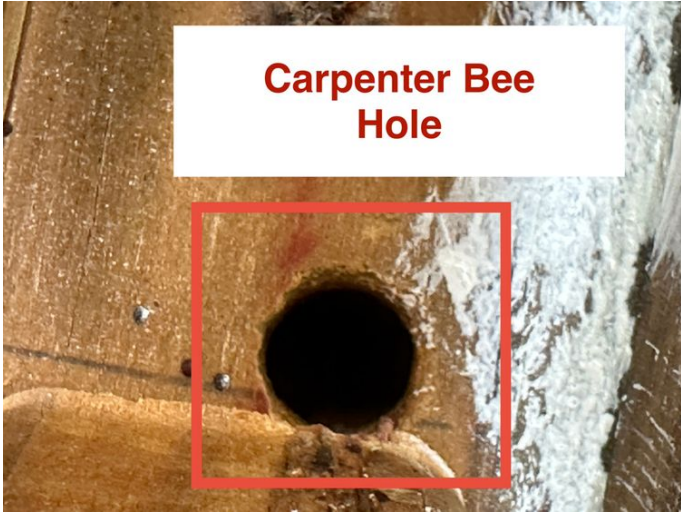
****Carpenter Bees: See Attachments**

**Carpenter Bee
Hole**

Treatment Instructions: Liquid treatment by broadcast and/or injection treatment where active carpenter bee are noted on the front deck handrails to eliminate
