# KTM SUPER DUKE R motorcycle Repair Manual

### Basic information:

Due to deviations in the assembly process, damage to the cable bundle at the lower rear section cannot be ruled out. Therefore, it must be checked that the cable harness has no damage in three different areas. Due to this, the lower rear part must be dismantled and finished.

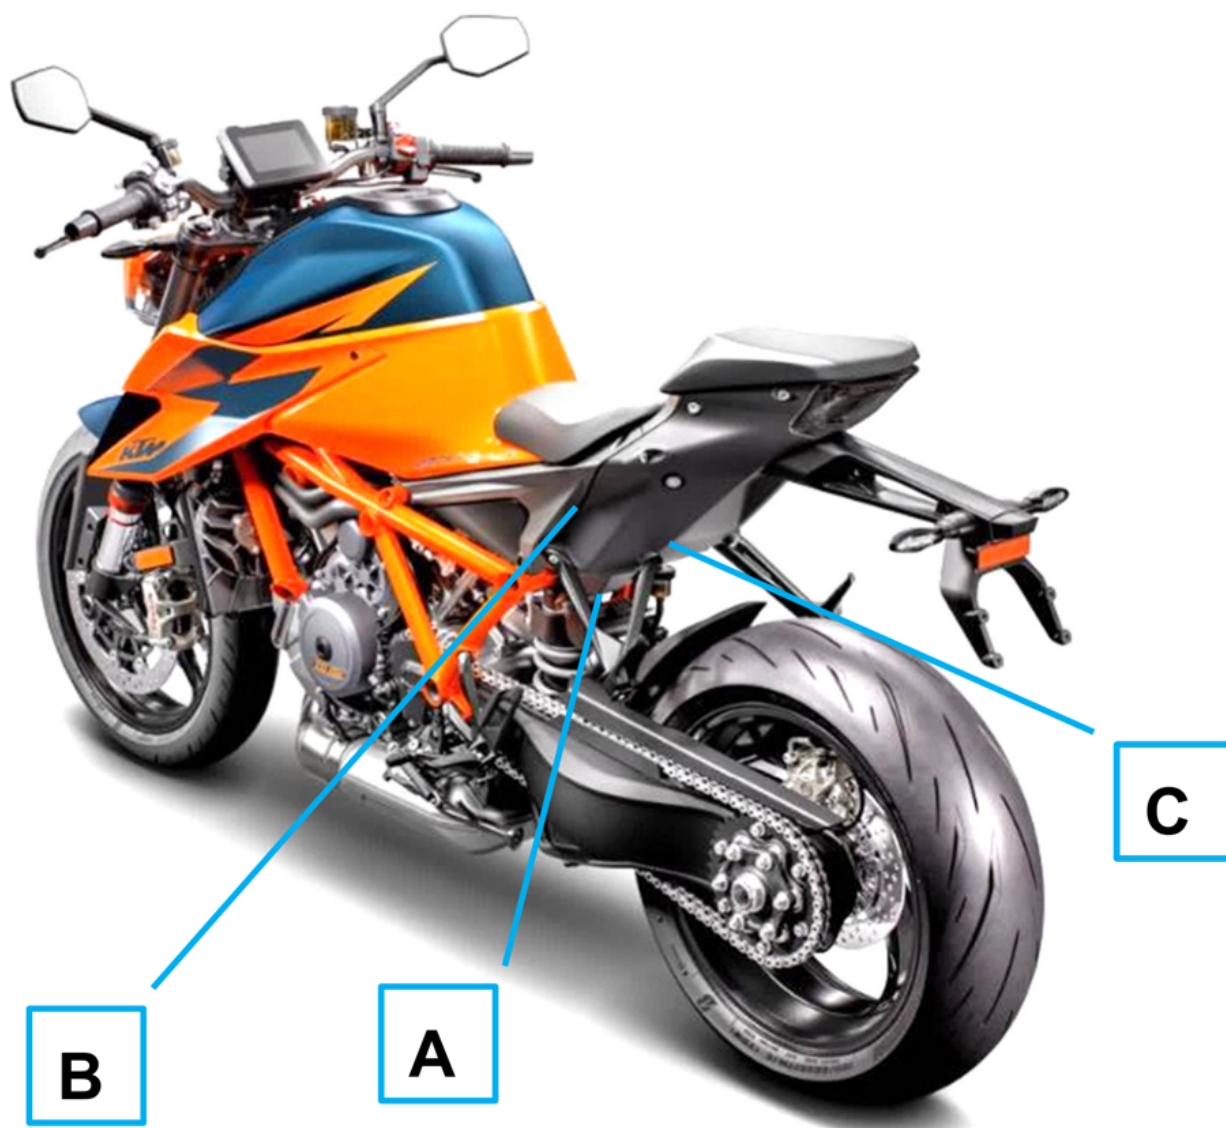
Figure 1 - Overview

- Remove the lower rear section according to the repair instructions / appendix 1.
- Check the cable harness in the areas below to see if there are any abrasion marks, damage or if cables have melted. See Figures 1 to 3 and Table 1 for more details.
- Photos must always be taken for documentation in the warranty application.

O In case of damage in area A for the voltage regulator, the cable can be repaired - see action code 01.

O If the cables on the cable harness have been damaged in the area B and C, must cable harness replaced - see action code 02.

| Area | Description | Possible action codes | |
|---|---|---|---|
| <b>A</b> | Cable bundle from cable trunk to voltage regulator | 00 | 01/02 |
| <b>B</b> | Cable harness at the diagnostic connector | 00 | 02 |
| <b>C</b> | Cable stem at the seat lock | 00 | 02 |

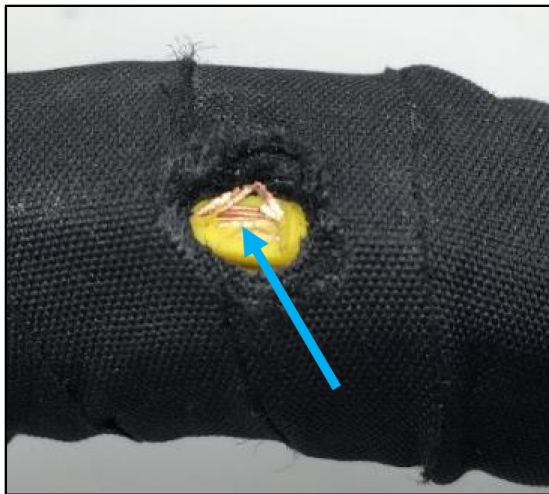
| Action code | Extent of damage |
|---|---|
| 00 | <ul style="list-style-type: none"> <li>- Wear on the black electrical tape (Fig. 4).</li> <li>- No damage to the cable.</li> </ul> |
| 01 | <ul style="list-style-type: none"> <li>- The voltage regulator has worn on the cable insulation • copper is visible (Fig. 5).</li> <li>- Damages less than 1 cm.</li> </ul> |

Figure 4 - Slight damage (00)

Picture 5 - Copper visible (01)

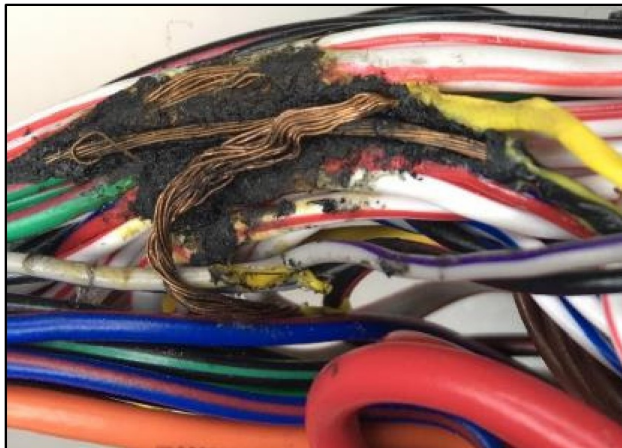
| Action code | Extent of damage |
|---|---|
| 02 | <p>Melted, broken or cracked cable insulation in an area larger than 1 cm (Fig. 6).</p> <ul style="list-style-type: none"> <li>- The damage extends into the cable trunk.</li> <li>- More than three cables are damaged.</li> </ul> <p><b>Repairs via promotion code 02 must be approved by KTM's current customer service country.</b></p> |

Figure 6 - Severe damage (02)

### Action code 02 - Finishing lower rear part + replacement of cable trunk

8. Disconnect the cables from the 12 V battery.
  9. Replace the cable harness.
  10. Attach the voltage regulator cable bundle to the battery holder with 2 cable ties as shown in Figure 11.
- Note! The cable bundle must not protrude from the contact housing and the wiring to the main frame must be checked to see if there are contact surfaces (Fig. 12).
11. Fit the lower rear section according to the repair instructions.
  12. Connect the cables to the 12 V battery and set the time and date.
- Install the lower rear section according to the repair instructions / appendix 1 and tighten the screws according to table 3.
14. Connect the cables to the battery and correct the time and date in the instrument cluster.
  15. Read the error memory with XC\_2 and delete if necessary.
  16. Visually check that the assembly was done correctly and perform a test run.

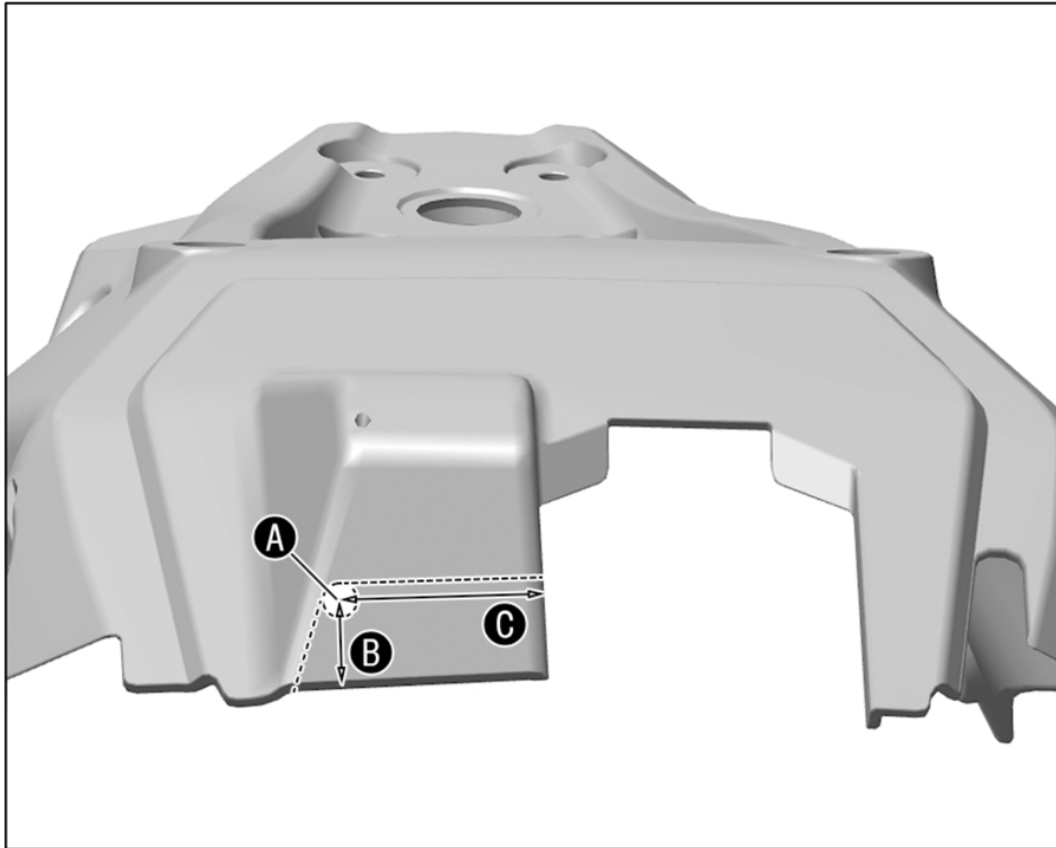
Fig. 7 - Position for holes on the lower rear part B = 15 mm C = 45 mm

Fig. 8 - Remove the lower rear part clearly

1. Lay the lower rear part on a suitable surface. Mark holes and cut lines according to the presentation in Figure 7-B
2. = 15 mm C = 45 mm. Cover the surrounding area with tape to avoid scratches.

- 3.
  4. Drill the marked hole with a step drill · A = 10 mm (Fig.7).
  5. Saw in from the side with the hand saw and complete the marked recess (pictures 7 and 8). Burr and round off the

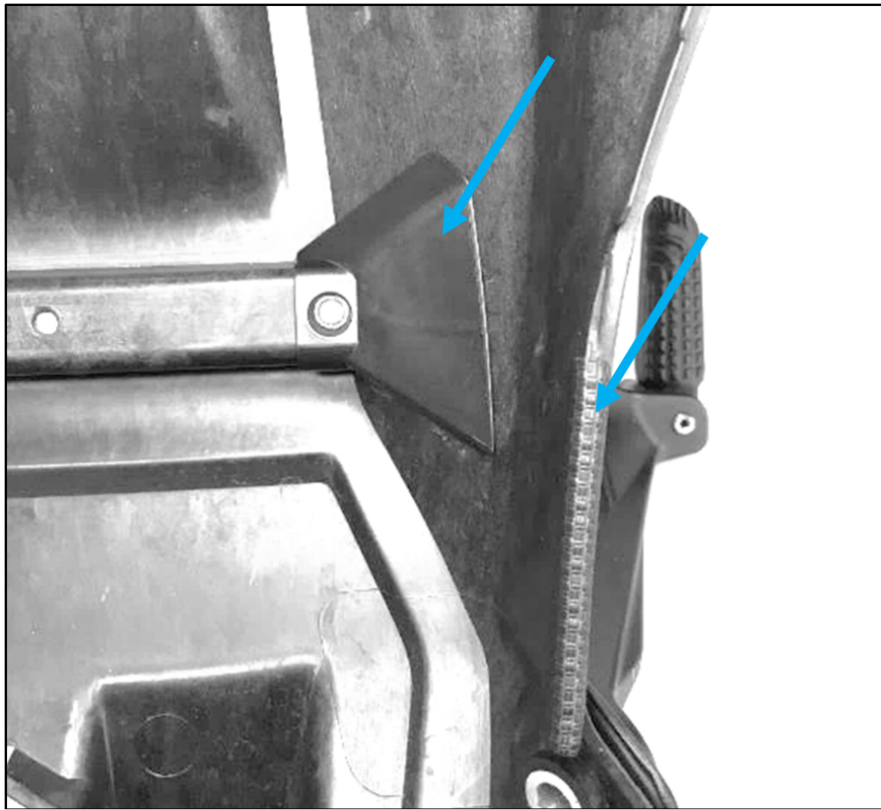
Fig. 9 - Install cable and edge protection inside

6. cutting edges, remove the tape.
  7. Place the plastic part (61708019025) on the rail on the inside of the lower rear section and fit the edge guard (76003095074) as shown in the picture (picture 9).

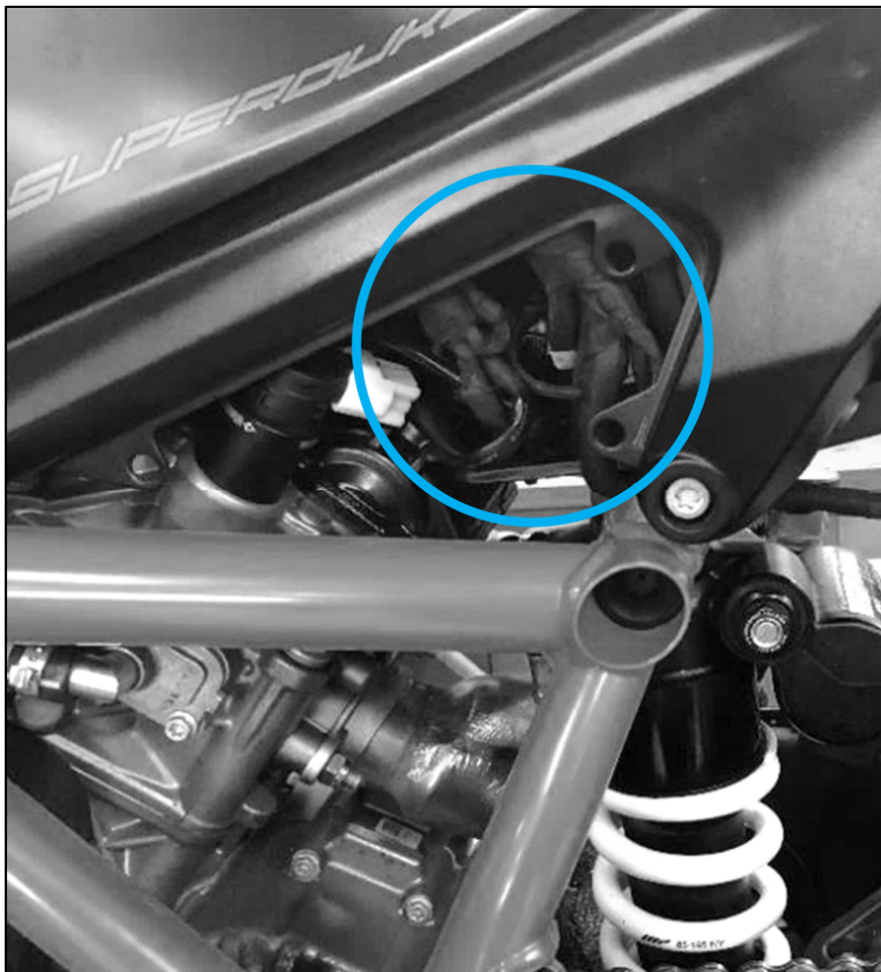
Figure 10 - Area for checking the cable trunk

8. If necessary, repair slightly worn insulation on the cable trunk.
  9. Also check the cable harness behind the side cover (Fig. 10) to see if there are contact points and, if necessary, reattach with cable ties.

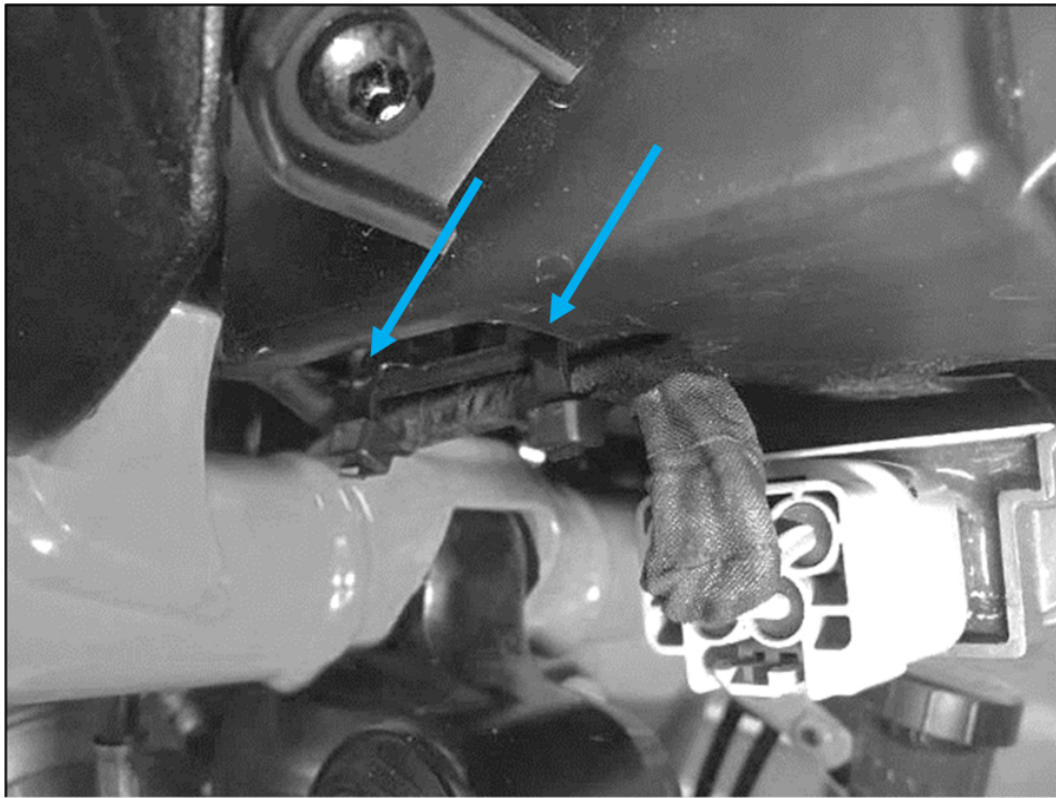
Fig. 11 - Attach the cable bundle with 2 cable ties

10. Attach the voltage regulator cable bundle to the battery holder with 2 cable ties as shown picture 11.
- Note! The voltage regulator cable bundle must not protrude from the contact housing and the wiring to the main frame must be checked to see if there are contact surfaces (picture 12).

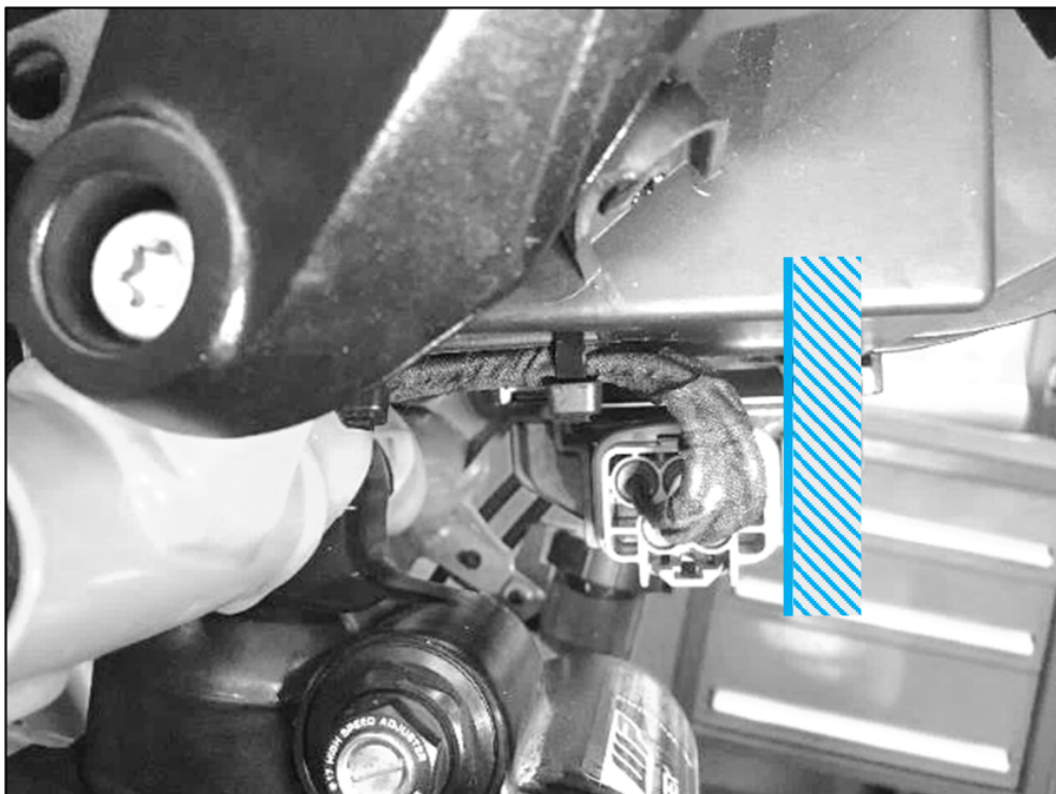
Figure 12 - Align the cable bundle correctly
