## **USED VEHICLE INSPECTION REPORT**

**ADESA Wisconsin** W 10415 S.R. 33 Portage, WI 53901 Phone: (608) 742-8245 Fax: (608) 742-4415

Ttoma.		2.00.100 01410	•	
VIN	Year	Make	Model	Series Or	Doors	Lift
	E	Body Style	Trim	Truck Dsc	#P	Gate
J T J B T 2 0 X 0 5 0 0 8 1 9 8	3 05 LEXUS		GX470		4	N
	UTILITY				5	
Mileage Odo Type Fuel DT	Transmission	Engine	Exterior Col		el Base	Mats
7 0 0 8 5 Digital 6 1/8 N	Automatic	4.7L V8 DOHC Gas		Grey / Leather		N
			Code:	Code:		
Sound Roo AM/FM/Cass/CD Power S				Equipment: Air Type:Air		
Alvi/Fivi/Cass/CD Fower's	ouii			Conditioning,Airbag Front Lo Right,Brake Type:ABS,CD I		
				Control,Drive Train:4x4,Eng		
				Cylinder Gas,Engine Type:(		5.0
				Lights,Heated Seats:Driver		enger I
No.	111/	<i>(</i>		Running Board, Memory Sea		inger,L
		—, <i>9</i> /-		Locks, Power Mirrors, Power		Power
		\ ( )		Windows,R Running Board,		••
				Equip:AM/FM/Cass/CD,Rea		Remote
	1 ( 5PE)	$\rightarrow$		Entry,Roof Luggage Rack,R		
				Sun, Seat Covering Type:Le		
Michelin 7/32"	7/32" Miche	elin		Options:Bucket,Seat:Power

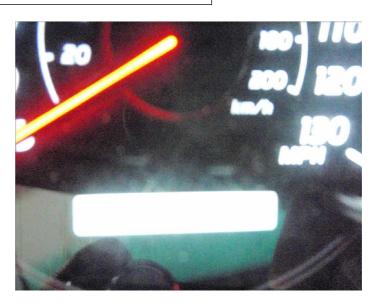
Total Chargeable Damage: \$150.00					То	tal Non-	-Charge	able Dama	ge:	\$0.00		
Damage Desc.	Damage Action	Y D	T D	S A	Airbrush Amount	Body Hours	Ref Hours	Labor Amount	Parts	PDR Amount	Total Charges	C/ NC
FRONT Bumper Cover												
Pitted	Repair				100.00						100.00	С
REAR Bumper Cover												
Chipped less than 1 inch	Repair				50.00						50.00	С
RF DR Panel												
Previous Repair	Report											NC
Totals					150.00	0.00	0.00	0.00	0.00	0.00	150.00

Comments: Possible GOLD. F Bumper full, full touch up. Maint. Req. light is on

Recondition Instructions: Complete Detail
