RFI-002 - Manhole Provision Excessive - Stormwater

Excessive manhole
usage on road radii

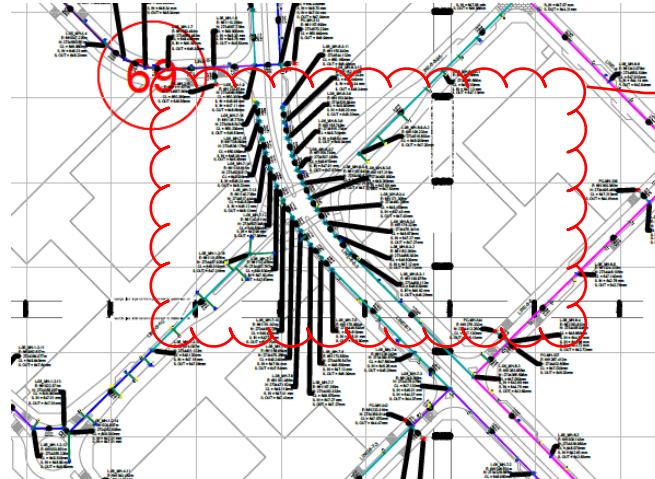
Review an alternative constructable solution to this arrangement.
there are 24 manholes installed within one bend in the road - totally excessive.
An alternative solution can be proposed with a formed GRP radiused section for
the respective pipework.
The principle of installing a manhole in this location appears to be the radius of
the pipework and not for access.

Recommendation - Revise to ensure

- Time and Cost saving
- Aesthetic Improvement of the streetscape which will foul future public realm
and landscape design, potentially streetlighting and security impact.
- utilise closed concrete channel - customised radius section and/or pipework
