Week 2: Daily Journals

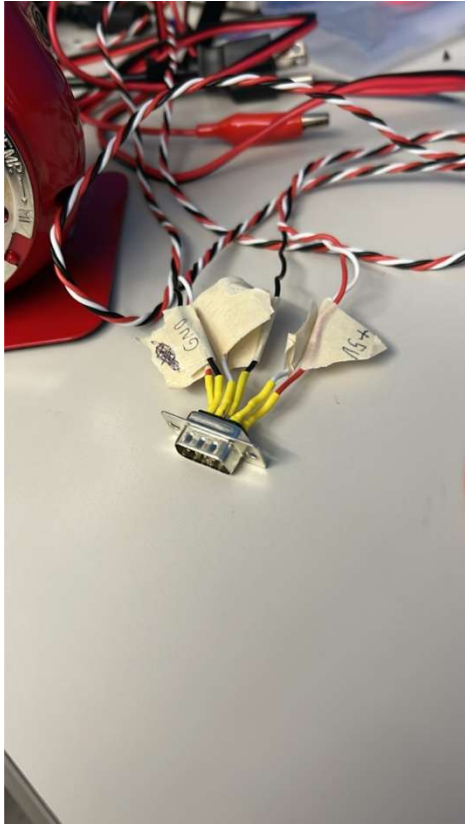
Figure 1: Power Cable
