Boat theft footage review

Findings and events, with screenshots · Grady-White (blue hull) on DOCK 1
System: DW Spectrum, LACGAR-DW-SVR · Footage available Jul 23, 2026 onward · Reviewed Nov 7–8, 2026
All times EDT (the timeline clock). Nobody is identified by face; only what is visible is described.

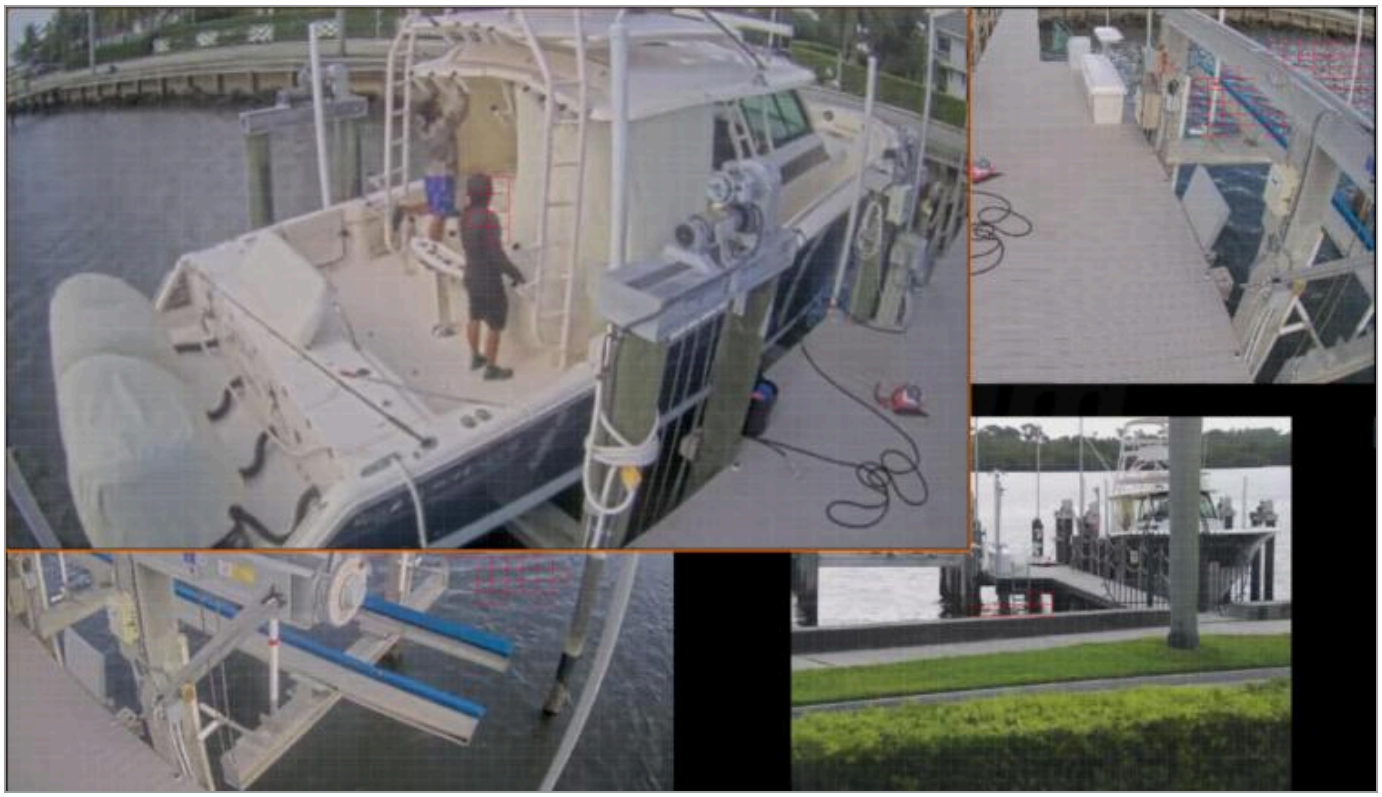
- About 9:10 AM: the boat has been lowered and the cockpit canvas is off. One person stands up at the console/T-top. Cushions, a bucket and small items are on the deck.

Jul 24, ~9:10 AM · DOCK 1 (large), DOCK 3 (top right), DOCK 2 and DOCK PTZ (bottom). Boat lowered, canvas off, person at the console.

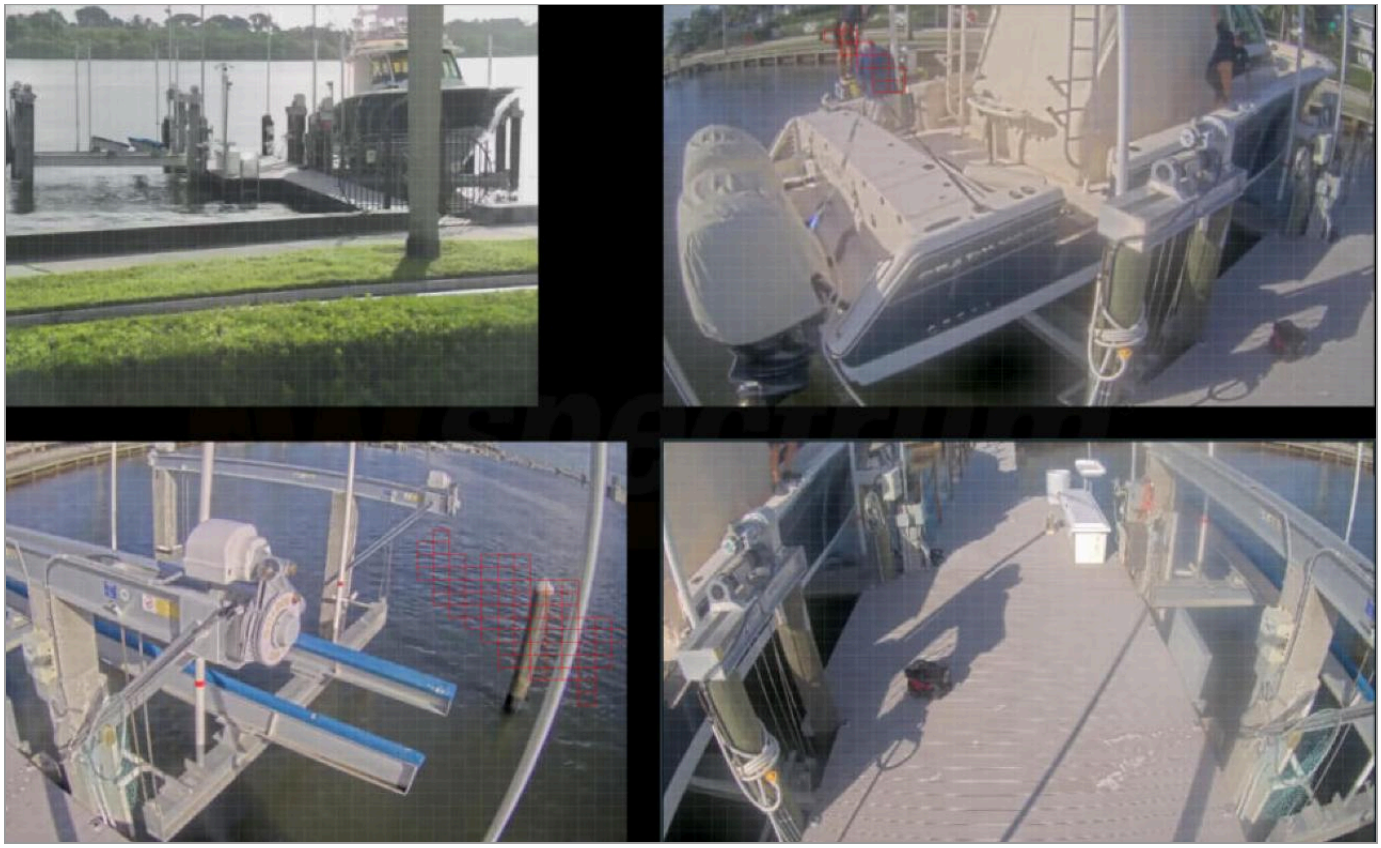
- Two or three people, one in a yellow/hi-vis top, with a yellow item and red items near the Grady-White lift.
- Later, a person with a long yellow line or hose and a red item. One person appears low beside the dock, possibly in the water (a hull-cleaning diver?).

Oct 22, ~10:05 AM · Four cameras. Crew with a yellow line; a person low by the dock.

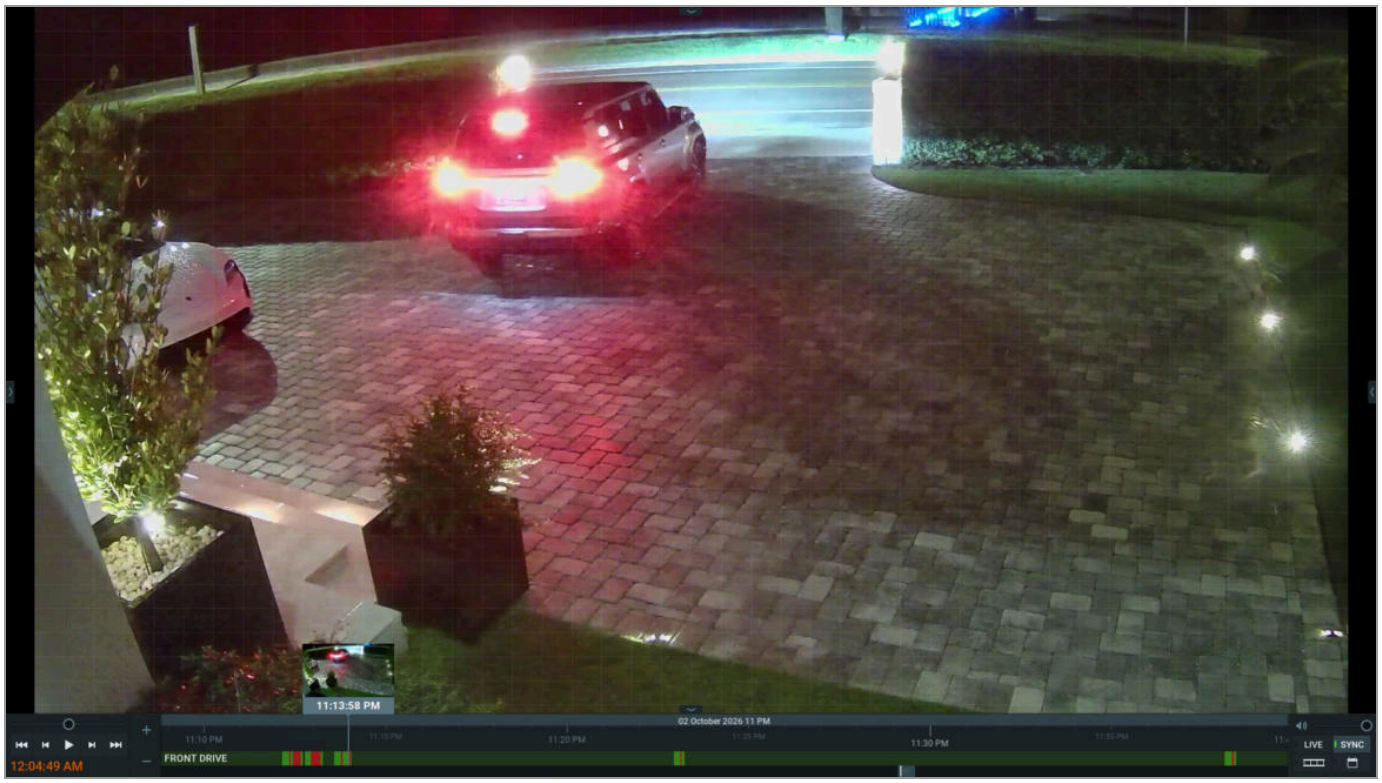
Oct 2, 11:13:58 PM · FRONT DRIVE. The SUV stopped at the top of the drive, brake lights on.

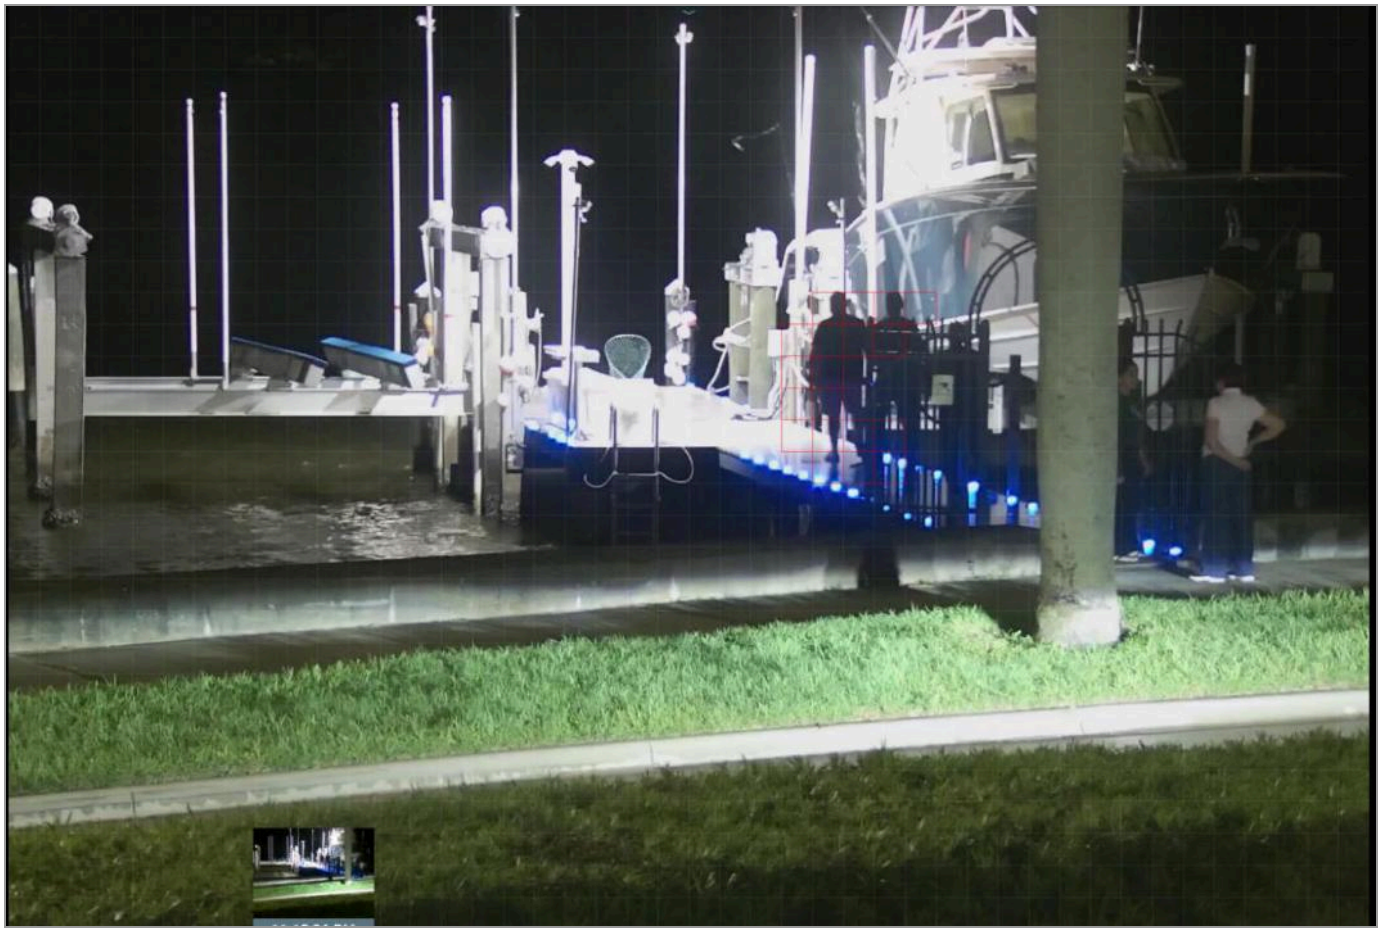
Oct 2, 11:15:36 PM · DOCK PTZ. The group goes through the dock gate; one person in white waits outside.

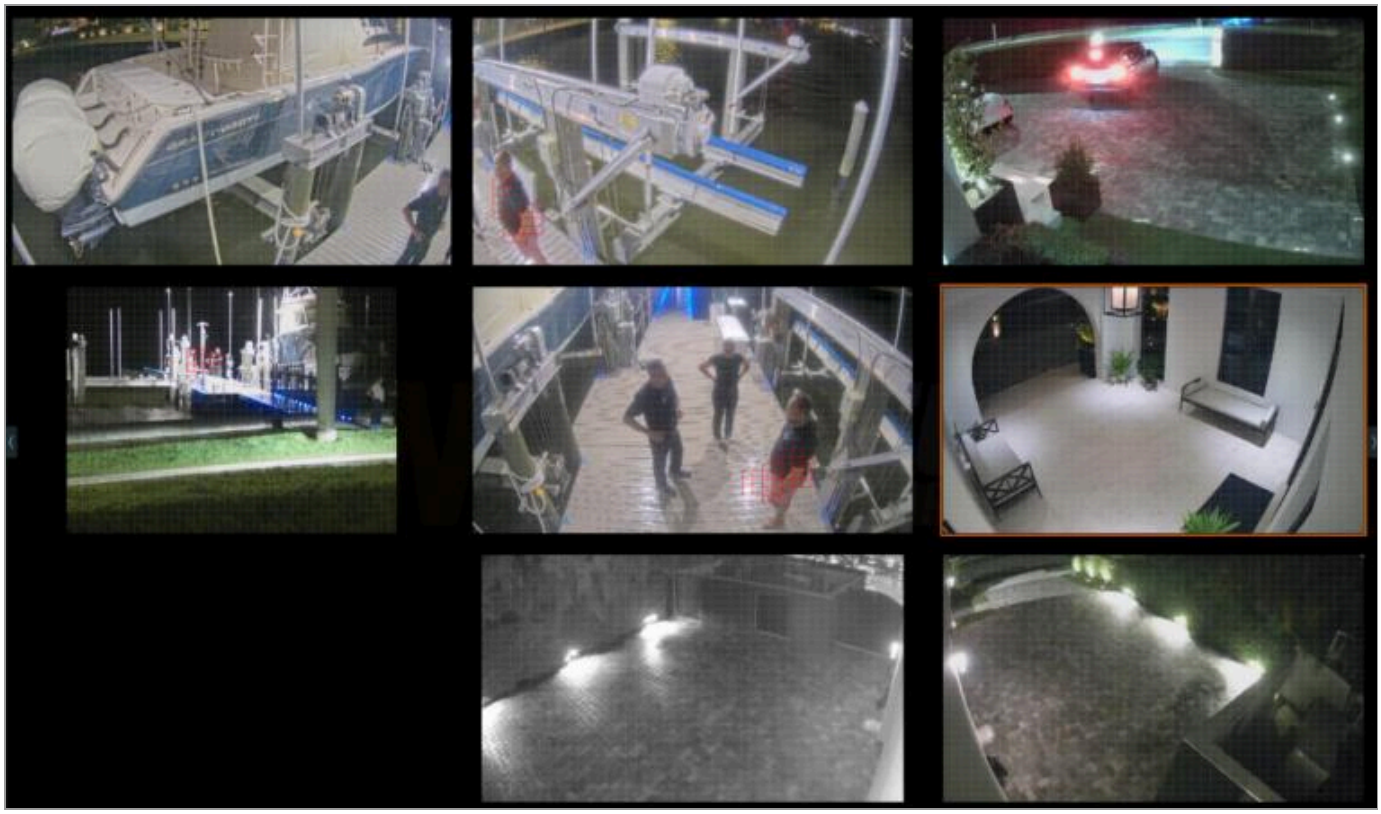
Oct 2, ~11:16 PM · Four cameras (infrared). Person walking down the dock.

Oct 2, ~11:18 PM · Dock cameras. Three people on the dock, one at the Grady-White's lift.

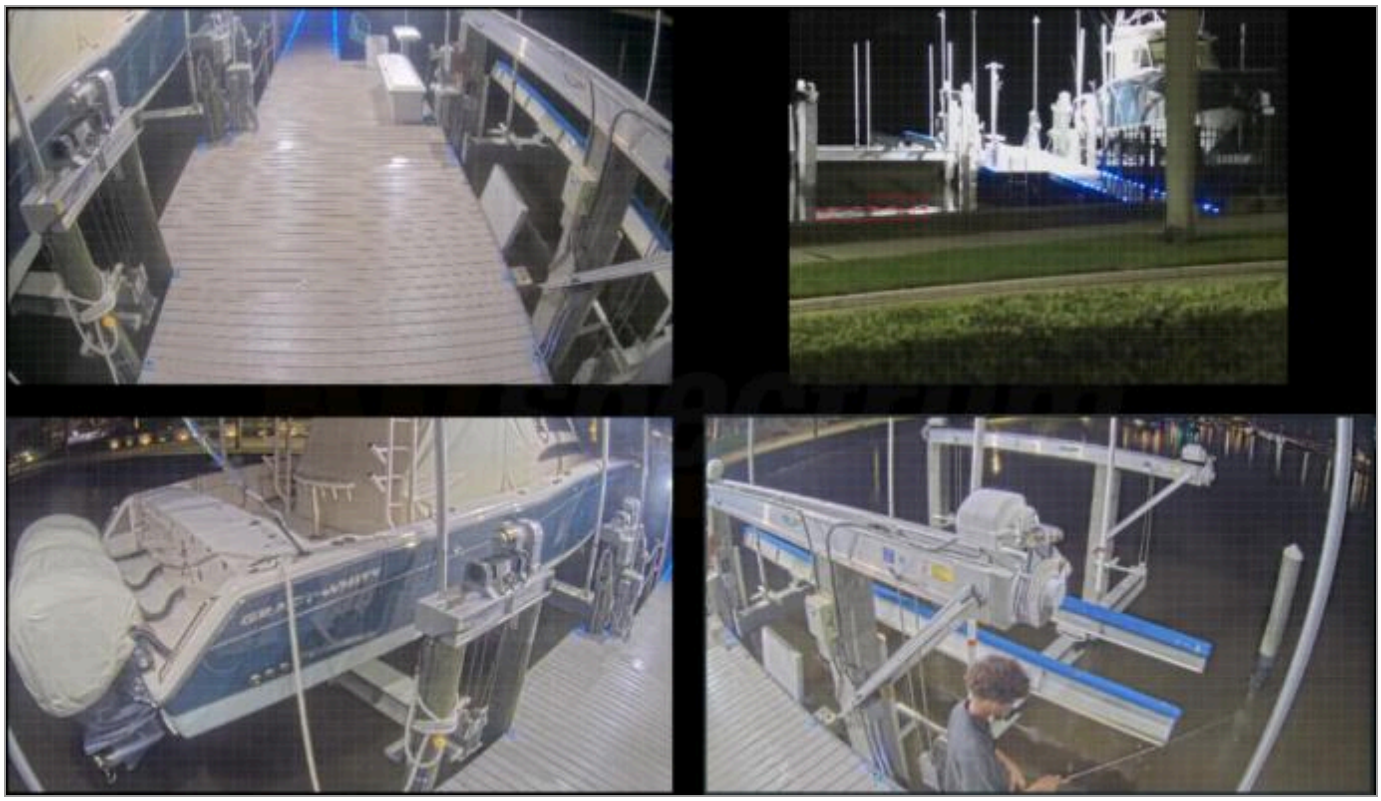
Sep 23, ~10:16 PM · Four dock cameras. The kid on the DOCK 3 walkway with the fishing pole; motion cells at the DOCK 2 lift.

Sep 23, ~10:17 PM · Four dock cameras. DOCK 2 (bottom right): the kid fishing from the empty lift.

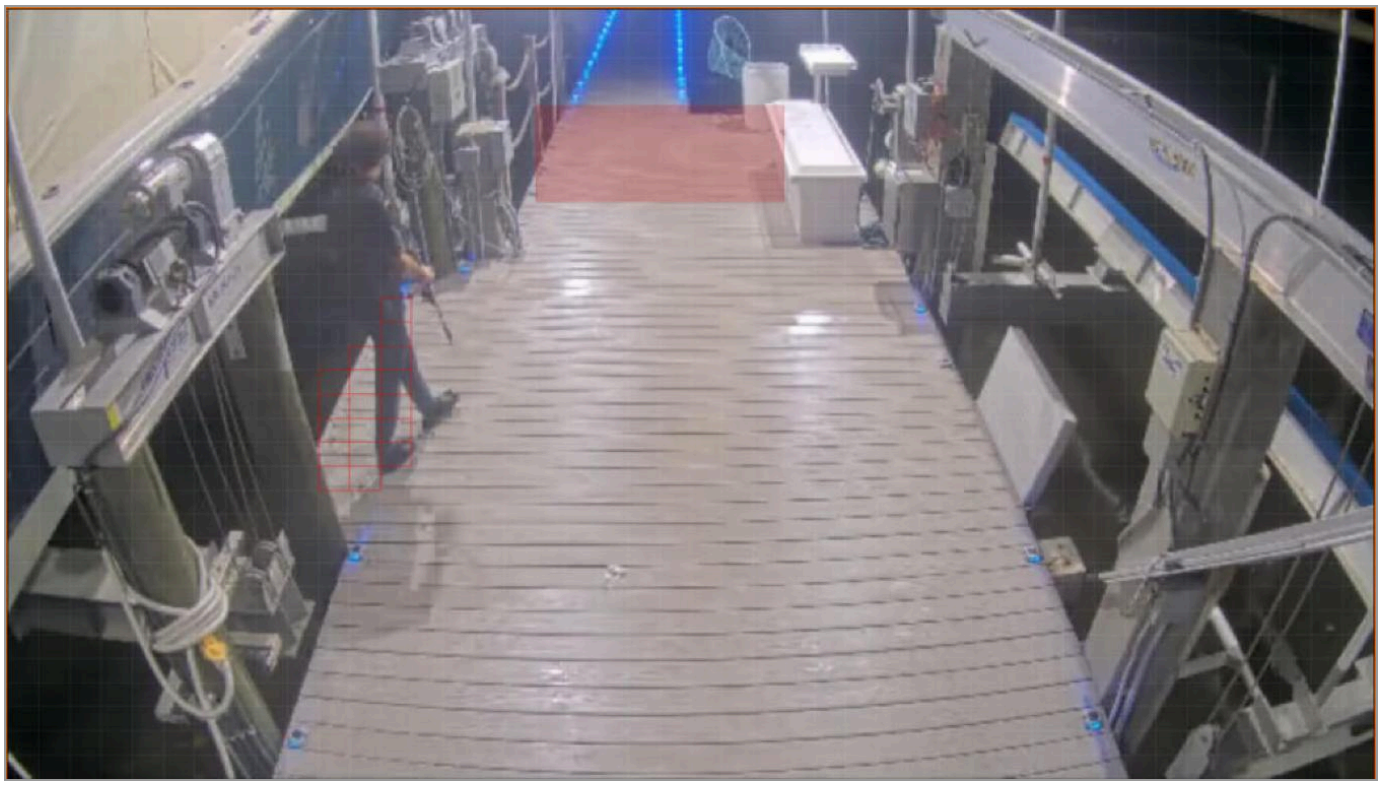
Sep 23, ~10:18:40 PM · Four dock cameras. DOCK 1 (bottom left): the kid on the dock beside the Grady-White's lift controls. He did not board.

Sep 23, ~10:18:50 PM · DOCK 3. Walking back toward shore with the same fishing pole. The red area at the far end is the motion box used for the search.
