Maintenance_checks_report

Checklist_name	Year
Preventive Maintenance Year 7 (new)	7

Site	Turbine_serial_number	Order_Number
Wikinger	WK01 - 1121441	61160781
Language	Revision_date_checklist	Approval_Date
en-US	8/21/2025	9/20/2025

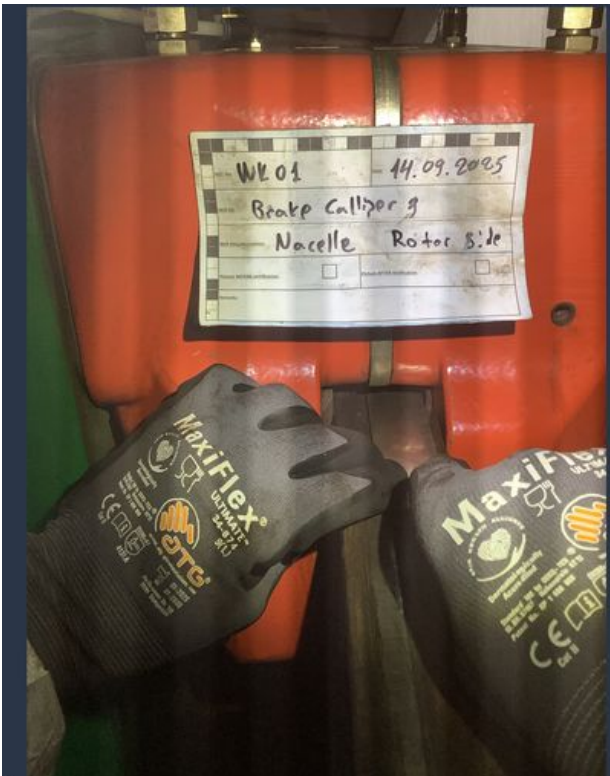
7 Figure_from Checklist 'AD 5-135_1_1_5_Preventive_year_null', Task 77 - Measuring_points

77		ATD000297.9: Rotor brake - Brake disc, bolted connection area segments 2 & 3 (rotor and generator side) - Measure and picture Rotor side - Flatness +0 mm Generator side - Flatness +0 mm Lateral side - Picture <u>See annex 'Taken_photos': 7</u> Rotor side - Picture <u>See annex 'Taken_photos': 8</u> Generator side - Picture <u>See annex 'Taken_photos': 9</u>			✓
78		ATD000302.0: Yaw system - Lubricant collector bottles - Inspection and replace if level >75% Amount of replaced bottles +5			✓
