Maintenance_checks_report

Checklist_name	Year
Preventive Maintenance Year 7 (by days)	7

Site	Turbine_serial_number	Order_Number
	WK04 - 1121444	61160786
Language	Revision_date_checklist	Approval_Date
en-US	6/29/2025	8/15/2025

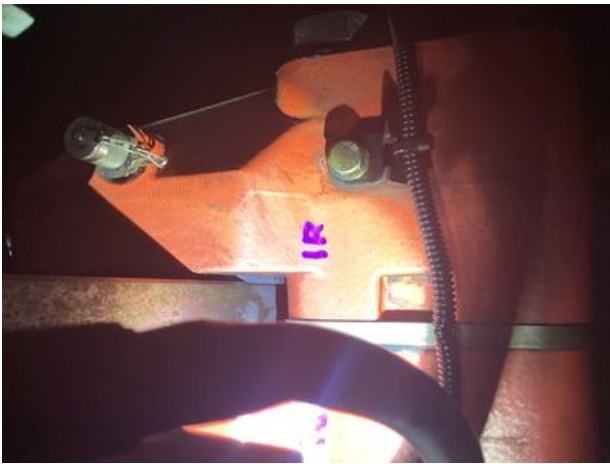
15 Figure_from Checklist 'AD 5-135_1_1_5 Preventive_year_null', Task 266 - Measuring_points

AD 5-135_1_1_5_Preventive_year_null					
#	Chapter	Measuring_points	Remarks	Tools	Status
Location:					
265		ATD000614.23: Rotor brake - Thickness of rotor brake pad calliper 5 (rotor side) - Measure Wear of rotor brake pad calliper 5 (rotor side) +0 mm Wear of rotor brake pad calliper 5 (rotor side) picture See_annex 'Taken_photos': 14			✓
266		ATD000614.24: Rotor brake - Thickness of rotor brake pad calliper 5 (generator side) - Measure Wear of rotor brake pad calliper 5 (generator side) +0 mm Wear of rotor brake pad calliper 5 (generator side) picture See_annex 'Taken_photos': 15			✓
267		ATD000614.25: Rotor brake - Calliper 6 - Clean			✓
268		ATD000614.28: Rotor brake - Thickness of rotor brake pad calliper 6 (rotor side) - Measure Wear of rotor brake pad calliper 6 (rotor side) +0 mm Wear of rotor brake pad calliper 6 (rotor side) picture See_annex 'Taken_photos': 16			✓
269		ATD000614.29: Rotor brake - Thickness of rotor brake pad calliper 6 (generator side) - Measure Wear of rotor brake pad calliper 6 (generator side) +0 mm Wear of rotor brake pad calliper 6 (generator side) picture See_annex 'Taken_photos': 17			✓

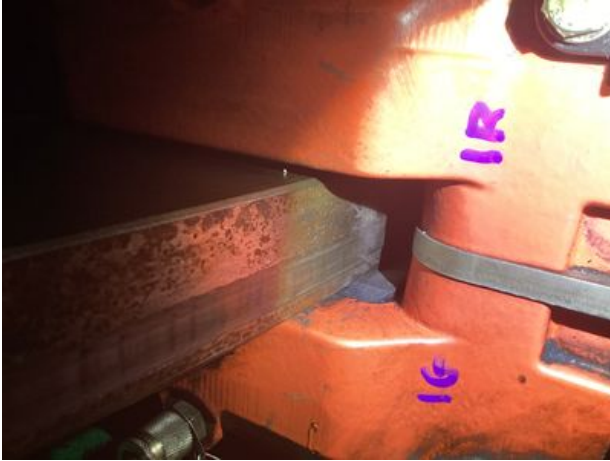
18 Figure_from Checklist 'AD 5-135_1_1_5 Preventive_year_null', Task 270 - Remarks

270		ATD000614.30: Rotor brake - Rotor brake, sensors fixations to the Beckhoff module - Inspection Module of the right side picture Ok Module of the left side picture Ok Module of the upper side picture Ok	Remark 1 See_annex 'Taken_photos': 18		✓
271		ATD000614.31: Rotor brake - Rotor brake pad, resistance of the connectors - Measure			NotApplicable
272		ATD000614.3: Rotor brake - Thickness of rotor brake pad calliper 1 (rotor side) - Measure Wear of rotor brake pad calliper 1 (rotor side) +0 mm Wear of rotor brake pad calliper 1 (rotor side) picture See_annex 'Taken_photos': 19			✓
