Maintenance_checks_report

Checklist_name	Year
Preventive Maintenance Year 7 (new)	7

Site	Turbine_serial_number	Order_Number
Wikingen	WK09 - 1121449	61160798
Language	Revision_date_checklist	Approval_Date
en-US	3/16/2025	9/28/2025

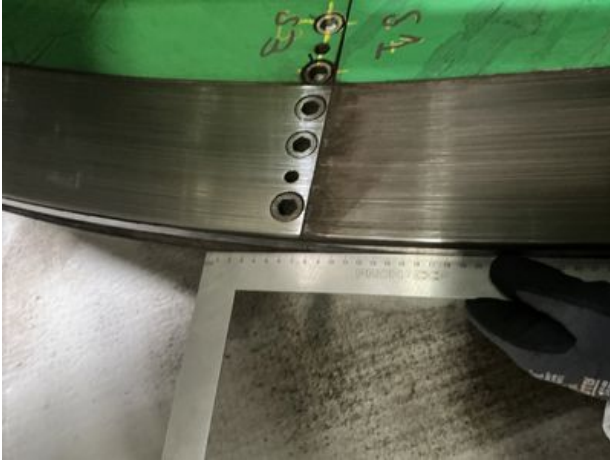
3 Figure_from Checklist 'AD 5-135_1_1_5 Preventive_year_null', Task 66 - Remarks

65		ATD000278.7: Yaw system - Yaw gear H oil level - Measure Yaw gear H oil level before refill/drain +126 mm Yaw gear H oil level in range? Yes, it was as needed			✓
66		ATD000280.00: Rotor lock - Engagement holes - Inspection	Remark 1 Paint damage. <u>See annex 'Taken_photos': 3</u> Remark 2 Paint damage. <u>See annex 'Taken_photos': 4</u>		✓
67		ATD000280.01: Rotor lock - Cylinders - Inspection			✓
68		ATD000282.1: Rotor lock - Cylinders and hydraulic hoses - Inspection			✓
69		ATD000282.2: Rotor lock - Sensor cables - Inspection			✓

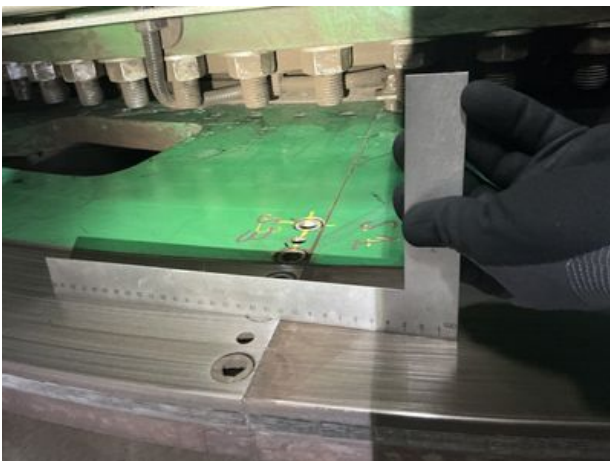
7 Figure_from Checklist 'AD 5-135_1_1_5_Preventive_year_null', Task 75 - Measuring_points

AD 5-135_1_1_5_Preventive_year_null					
#	Chapter	Measuring_points	Remarks	Tools	Status
Location:					
70		ATD000283.0: Rotor brake - Callipers and drainage circuits - Inspection			✓
71		ATD000285.0: Rotor brake - Callipers - Test			✓
72		ATD000285.1: Rotor brake - Brake pads - Inspection			✓
73		ATD000286.0: Oil supply system - HG01, pos. 190.1 - Oil sample Barcode number on bottle 5311724			✓
74		ATD000297.0: Rotor brake - Rotor brake disk (360°) - Inspection	Remark 1 Black dust. <u>See annex 'Taken_photos': 5</u> Remark 2 Paint damage. <u>See annex 'Taken_photos': 6</u>		✓
75		ATD000297.10: Rotor brake - Brake disc, bolted connection area segments 1 & 3 (rotor and generator side) - Measure and picture Rotor side - Flatness +0.15 mm Generator side - Flatness +0.15 mm Lateral side - Picture <u>See annex 'Taken_photos': 7</u> Rotor side - Picture <u>See annex 'Taken_photos': 8</u> Generator side - Picture <u>See annex 'Taken_photos': 9</u>			✓

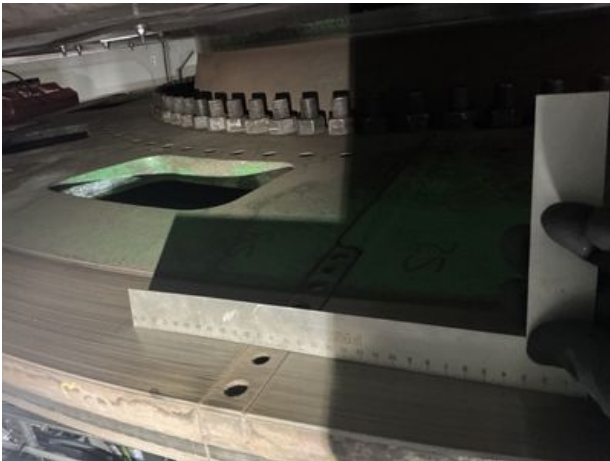
10 Figure_from Checklist 'AD 5-135_1_1_5 Preventive_year_null', Task 76 - Measuring_points

76		ATD000297.8: Rotor brake - Brake disc, bolted connection area segments 1 & 2 (rotor and generator side) - Measure and picture Rotor side - Flatness +0 mm Generator side - Flatness +0 mm Lateral side - Picture <u>See annex 'Taken_photos': 10</u> Rotor side - Picture <u>See annex 'Taken_photos': 11</u> Generator side - Picture <u>See annex 'Taken_photos': 12</u>			✓

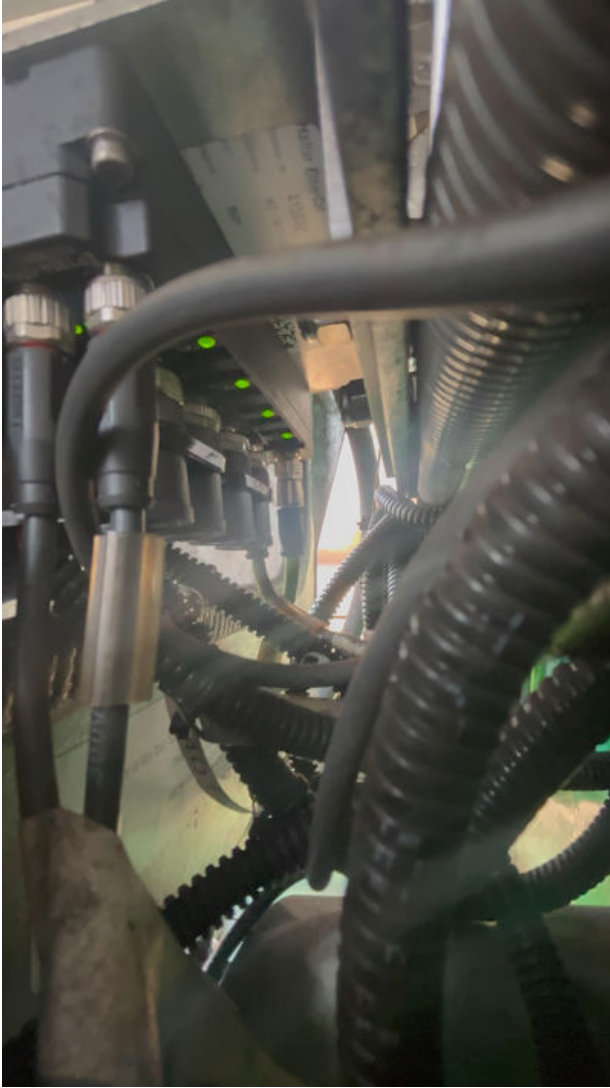
26 Figure_from Checklist 'AD 5-135_1_1_5 Preventive_year_null', Task 265 - Measuring_points

263		ATD000614.20: Rotor brake - Calliper 5 - Clean			✓
264		ATD000614.23: Rotor brake - Thickness of rotor brake pad calliper 5 (rotor side) - Measure Wear of rotor brake pad calliper 5 (rotor side) +0,05 mm Wear of rotor brake pad calliper 5 (rotor side) picture See_annex 'Taken_photos': 25			✓
265		ATD000614.24: Rotor brake - Thickness of rotor brake pad calliper 5 (generator side) - Measure Wear of rotor brake pad calliper 5 (generator side) +0,05 mm Wear of rotor brake pad calliper 5 (generator side) picture See_annex 'Taken_photos': 26			✓
266		ATD000614.25: Rotor brake - Calliper 6 - Clean			✓

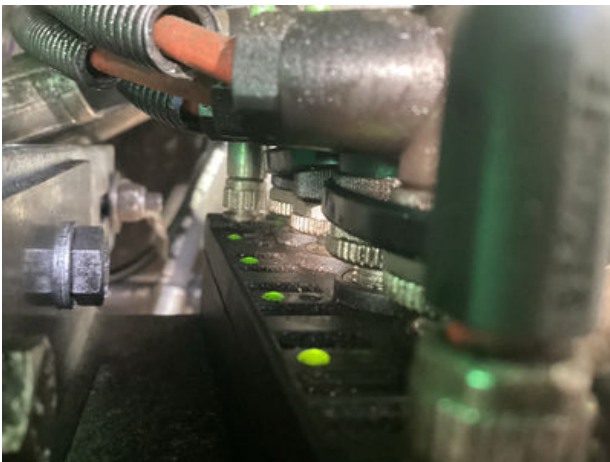
29 Figure_from Checklist 'AD 5-135_1_1_5_Preventive_year_null', Task 269 - Remarks

AD 5-135_1_1_5_Preventive_year_null					
#	Chapter	Measuring_points	Remarks	Tools	Status
Location:					
267		ATD000614.28: Rotor brake - Thickness of rotor brake pad calliper 6 (rotor side) - Measure Wear of rotor brake pad calliper 6 (rotor side) +0,05 mm Wear of rotor brake pad calliper 6 (rotor side) picture <u>See annex 'Taken_photos': 27</u>			✓
268		ATD000614.29: Rotor brake - Thickness of rotor brake pad calliper 6 (generator side) - Measure Wear of rotor brake pad calliper 6 (generator side) +0,05 mm Wear of rotor brake pad calliper 6 (generator side) picture <u>See annex 'Taken_photos': 28</u>			✓
269		ATD000614.30: Rotor brake - Rotor brake, sensors fixations to the Beckhoff module - Inspection Module of the right side picture Ok Module of the left side picture Ok Module of the upper side picture Ok	Remark 1 Right side <u>See annex 'Taken_photos': 29</u> Remark 2 Upper side. <u>See annex 'Taken_photos': 30</u> Remark 3 Left side. <u>See annex 'Taken_photos': 31</u>		✓
