Maintenance_checks_report

Checklist_name	Year
Preventive Maintenance Year 7 (new)	7

Site	Turbine_serial_number	Order_Number
Wikinger	WK10 - 1121450	61160801
Language	Revision_date_checklist	Approval_Date
en-US	3/16/2025	8/13/2025

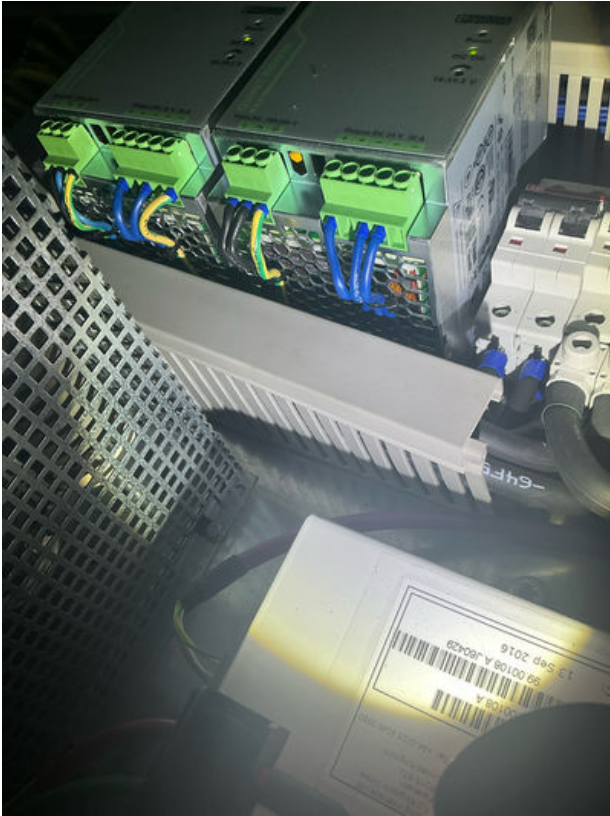
1 Figure_from Checklist 'AD 5-135_1_1_5_Preventive_year_null', Task 30 - Remarks

25		ATD000241.8: Rotor blade 3 - Blade bearing, pos. C - Grease sample Barcode number on bottle 5939741			✓
26		ATD000242.01: Rotor blade 1 - Lubricant collector bottles - Inspection and replace if level >50% Amount of replaced bottles +8			✓
27		ATD000242.02: Rotor blade 2 - Lubricant collector bottles - Inspection and replace if level >50% Amount of replaced bottles +9			✓
28		ATD000242.03: Rotor blade 3 - Lubricant collector bottles - Inspection and replace if level >50% Amount of replaced bottles +7			✓
29		ATD000243.0: Rotor blade 1 - External condition of the pitch cabinet - Inspection			✓
30		ATD000243.10: Rotor blade 1 - Wires and connectors of pitch drive converter and power supplies 26T1 and 26T5 - Inspection	Remark 1 <u>See annex 'Taken_photos': 1</u>		✓

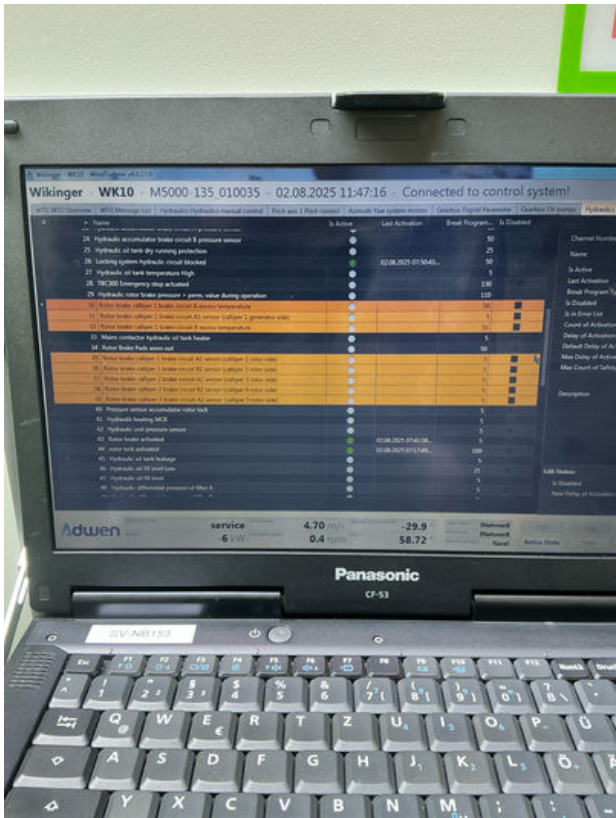
27 Figure_from Checklist 'AD 5-135_1_1_5 Preventive_year_null', Task 269 - Remarks

AD 5-135_1_1_5_Preventive_year_null					
#	Chapter	Measuring_points	Remarks	Tools	Status
Location:					
268		ATD000614.29: Rotor brake - Thickness of rotor brake pad calliper 6 (generator side) - Measure Wear of rotor brake pad calliper 6 (generator side) +0 mm Wear of rotor brake pad calliper 6 (generator side) picture <u>See annex 'Taken_photos': 26</u>			✓
269		ATD000614.30: Rotor brake - Rotor brake, sensors fixations to the Beckhoff module - Inspection Module of the right side picture Ok Module of the left side picture Ok Module of the upper side picture Ok	Remark 1 Right side. <u>See annex 'Taken_photos': 27</u> Remark 2 Upper side. <u>See annex 'Taken_photos': 28</u> Remark 3 Left side. <u>See annex 'Taken_photos': 29</u>		✓
270		ATD000614.31: Rotor brake - Rotor brake pad, resistance of the connectors - Measure Resistance between pin 1 and 2 Ohm Resistance between pin 1 and 3 Ohm Resistance between pin 1 and 4 Ohm Resistance between pin 2 and 3 Ohm Resistance between pin 2 and 4 Ohm Resistance between pin 3 and 4 Ohm	Remark 1 <u>See annex 'Taken_photos': 30</u> Remark 2 No SC activ.		NotApplicable

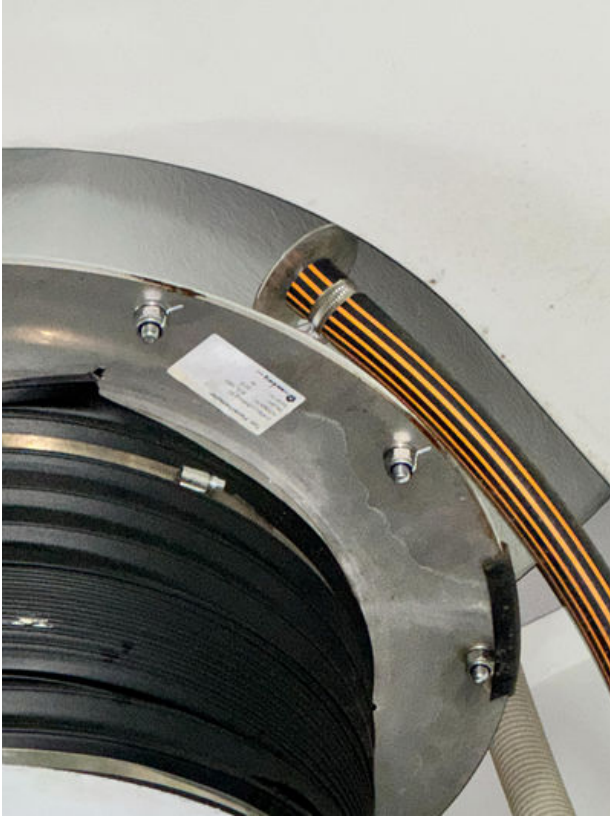
33 Figure_from Checklist 'AD 5-135_1_1_5 Preventive_year_null', Task 274 - Measuring_points

AD 5-135_1_1_5_Preventive_year_null					
#	Chapter	Measuring_points	Remarks	Tools	Status
Location:					
274		ATD000614.8: Rotor brake - Thickness of rotor brake pad calliper 2 (rotor side) - Measure Wear of rotor brake pad calliper 2 (rotor side) +0 mm Wear of rotor brake pad calliper 2 (rotor side) picture See annex 'Taken_photos': 33			✓
275		ATD000614.9: Rotor brake - Thickness of rotor brake pad calliper 2 (generator side) - Measure Wear of rotor brake pad calliper 2 (generator side) +2,55 mm Wear of rotor brake pad calliper 2 (generator side) picture See annex 'Taken_photos': 34			✓
276		ATD000615.0: Installation system - Emergency light of S3 - Test			✓
277		ATD000615.4: Installation system - Emergency light of S2 and S1 - Test			✓
278		ATD000615.8: Installation system - Emergency light of lower deck - Test			✓
279		ATD000615.9: Installation system - Emergency light of nacelle - Test			✓
280		ATD000638.0: Drive train system - Surface of the gearbox - Inspection			✓
