Maintenance_checks_report

Checklist_name	Year
Preventive Maintenance Year 7 (by days)	7

Site	Turbine_serial_number	Order_Number
Wikinger	WK11 - 1121451	61160804
Language	Revision_date_checklist	Approval_Date
en-US	6/29/2025	8/19/2025

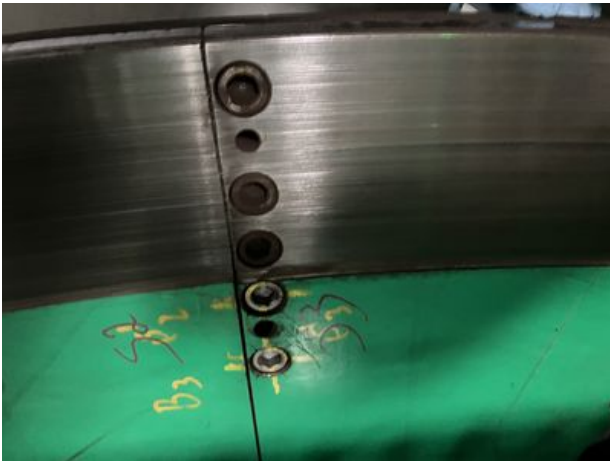
5 Figure_from Checklist 'AD 5-135_1_1_5_Preventive_year_null', Task 75 - Measuring_points

AD 5-135_1_1_5_Preventive_year_null					
#	Chapter	Measuring_points	Remarks	Tools	Status
Location:					
73		ATD000297.0: Rotor brake - Rotor brake disk (360°) - Inspection	Remark 1 All 3 Segment connections cracked. Onsite finding created		✗
74		ATD000297.10: Rotor brake - Brake disc, bolted connection area segments 1 & 3 (rotor and generator side) - Measure and picture Rotor side - Flatness Generator side - Flatness Lateral side - Picture <u>See annex 'Taken_photos': 2</u> Rotor side - Picture <u>See annex 'Taken_photos': 3</u> Generator side - Picture <u>See annex 'Taken_photos': 4</u>	Remark 1 Cracked. Onsite finding created		✗
75		ATD000297.8: Rotor brake - Brake disc, bolted connection area segments 1 & 2 (rotor and generator side) - Measure and picture Rotor side - Flatness Generator side - Flatness Lateral side - Picture <u>See annex 'Taken_photos': 5</u> Rotor side - Picture <u>See annex 'Taken_photos': 6</u> Generator side - Picture <u>See annex 'Taken_photos': 7</u>	Remark 1 Cracked		✗

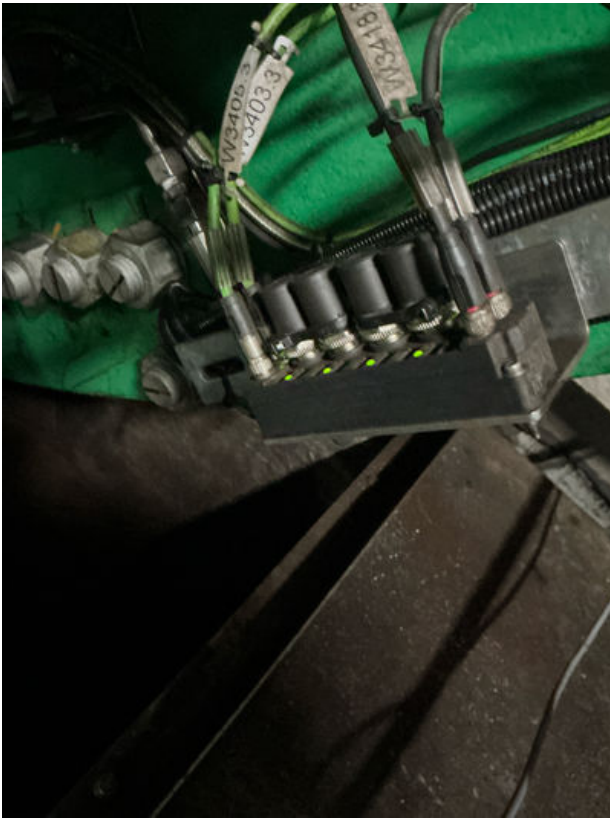
15 Figure_from Checklist 'AD 5-135_1_1_5 Preventive_year_null', Task 265 - Measuring_points

AD 5-135_1_1_5_Preventive_year_null					
#	Chapter	Measuring_points	Remarks	Tools	Status
Location:					
262		ATD000614.18: Rotor brake - Thickness of rotor brake pad calliper 4 (rotor side) - Measure Wear of rotor brake pad calliper 4 (rotor side) +0 mm Wear of rotor brake pad calliper 4 (rotor side) picture See_annex 'Taken_photos': 13			✓
263		ATD000614.19: Rotor brake - Thickness of rotor brake pad calliper 4 (generator side) - Measure Wear of rotor brake pad calliper 4 (generator side) +3,05 mm Wear of rotor brake pad calliper 4 (generator side) picture See_annex 'Taken_photos': 14			✓
264		ATD000614.20: Rotor brake - Calliper 5 - Clean			✓
265		ATD000614.23: Rotor brake - Thickness of rotor brake pad calliper 5 (rotor side) - Measure Wear of rotor brake pad calliper 5 (rotor side) +0 mm Wear of rotor brake pad calliper 5 (rotor side) picture See_annex 'Taken_photos': 15			✓
266		ATD000614.24: Rotor brake - Thickness of rotor brake pad calliper 5 (generator side) - Measure Wear of rotor brake pad calliper 5 (generator side) +0,7 mm Wear of rotor brake pad calliper 5 (generator side) picture See_annex 'Taken_photos': 16			✓

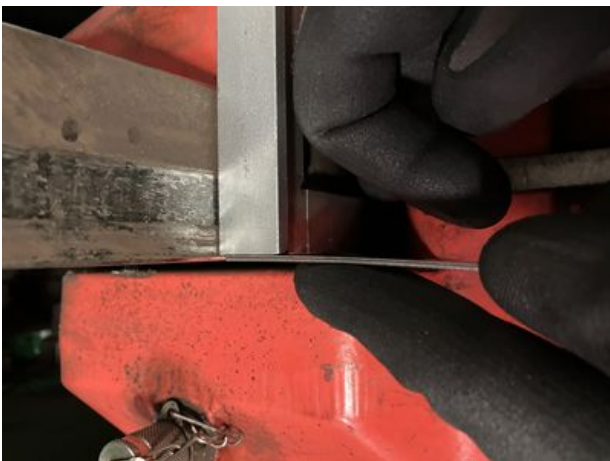
22 Figure_from Checklist 'AD 5-135_1_1_5_Preventive_year_null', Task 271 - Remarks

AD 5-135_1_1_5_Preventive_year_null					
#	Chapter	Measuring_points	Remarks	Tools	Status
Location:					
270		ATD000614.30: Rotor brake - Rotor brake, sensors fixations to the Beckhoff module - Inspection Module of the right side picture Ok Module of the left side picture Ok Module of the upper side picture Ok	Remark 1 Right side <u>See annex 'Taken_photos': 19</u> Remark 2 Upper side <u>See annex 'Taken_photos': 20</u> Remark 3 Left side <u>See annex 'Taken_photos': 21</u>		✓
271		ATD000614.31: Rotor brake - Rotor brake pad, resistance of the connectors - Measure Resistance between pin 1 and 2 +1,5 Ohm Resistance between pin 1 and 3 +2,6 Ohm Resistance between pin 1 and 4 +1,5 Ohm Resistance between pin 2 and 3 +1,6 Ohm Resistance between pin 2 and 4 +2,2 Ohm Resistance between pin 3 and 4 +1,1 Ohm	Remark 1 Caliper 5 geno site <u>See annex 'Taken_photos': 22</u>		✗
272		ATD000614.3: Rotor brake - Thickness of rotor brake pad calliper 1 (rotor side) - Measure Wear of rotor brake pad calliper 1 (rotor side) +0,65 mm Wear of rotor brake pad calliper 1 (rotor side) picture <u>See annex 'Taken_photos': 23</u>			✓
