Maintenance_checks_report

Checklist_name	Year
Preventive Maintenance Year 7 (by days)	7

Site	Turbine_serial_number	Order_Number
Wikinger	WK12 - 1121452	61160807
Language	Revision_date_checklist	Approval_Date
en-US	6/29/2025	8/10/2025

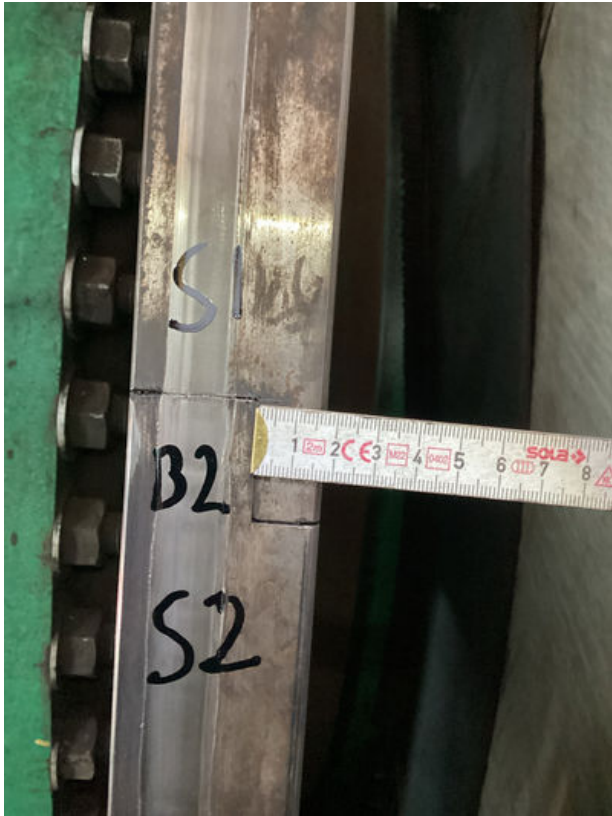
5 Figure_from Checklist 'AD 5-135_1_1_5 Preventive_year_null', Task 75 - Measuring_points

AD 5-135_1_1_5_Preventive_year_null					
#	Chapter	Measuring_points	Remarks	Tools	Status
Location:					
70		ATD000285.0: Rotor brake - Callipers - Test			✓
71		ATD000285.1: Rotor brake - Brake pads - Inspection			✓
72		ATD000286.0: Oil supply system - HG01, pos. 190.1 - Oil sample Barcode number on bottle 5604984			✓
73		ATD000297.0: Rotor brake - Rotor brake disk (360°) - Inspection			✓
74		ATD000297.10: Rotor brake - Brake disc, bolted connection area segments 1 & 3 (rotor and generator side) - Measure and picture Rotor side - Flatness +0,05 mm Generator side - Flatness -0 mm Lateral side - Picture <u>See annex 'Taken_photos': 1</u> Rotor side - Picture <u>See annex 'Taken_photos': 2</u> Generator side - Picture <u>See annex 'Taken_photos': 3</u>			✓
75		ATD000297.8: Rotor brake - Brake disc, bolted connection area segments 1 & 2 (rotor and generator side) - Measure and picture Rotor side - Flatness +0 mm Generator side - Flatness +0 mm Lateral side - Picture <u>See annex 'Taken_photos': 4</u> Rotor side - Picture <u>See annex 'Taken_photos': 5</u> Generator side - Picture <u>See annex 'Taken_photos': 6</u>	Remark 1 There is a crack of 7mm. <u>See annex 'Taken_photos': 7</u>		✓

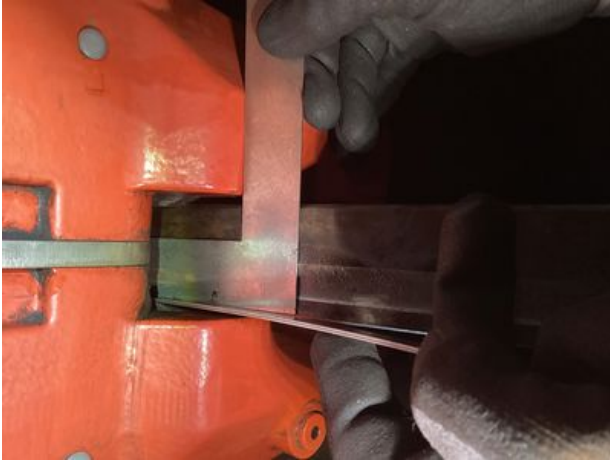
11 Figure_from Checklist 'AD 5-135_1_1_5 Preventive_year_null', Task 140 - Remarks

AD 5-135_1_1_5_Preventive_year_null					
#	Chapter	Measuring_points	Remarks	Tools	Status
Location:					
135		ATD000405.10: Hydraulic accumulator - Yaw brake 740.4 - Measure Nitrogen pressures before refill Nitrogen pressures at 120 ±2.5 bar?	+112 bar Yes, after refill		✓
136		ATD000405.12: Hydraulic accumulator - Rotor brake 920.1 - Measure Nitrogen pressures before refill Nitrogen pressures at 90 ±2.5 bar?	+62 bar Yes, after refill		✓
137		ATD000405.14: Hydraulic accumulator - Rotor brake 920.2 - Measure Nitrogen pressures before refill Nitrogen pressures at 90 ±2.5 bar?	+68 bar Yes, after refill		✓
138		ATD000405.16: Hydraulic accumulator - O-ring and connections - Inspection			✓
139		ATD000405.16: Hydraulic accumulator - O-ring and connections - Inspection			✓
140		ATD000405.17: Hydraulic accumulator - Accumulator's body and connections - Inspection	Remark 1 Bracket of 740.1 it's broken <u>See annex 'Taken_photos': 11</u> Remark 2 Bracket of 740.2 it's almost broken <u>See annex 'Taken_photos': 12</u> Remark 3 Bracket of 740.3 it's almost broken <u>See annex 'Taken_photos': 13</u>		✓

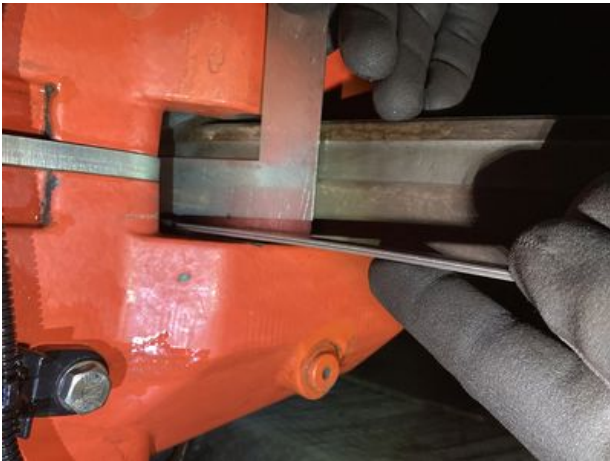
14 Figure from Checklist 'AD 5-135_1_1_5 Preventive_year_null', Task 259 - Measuring points

254		ATD000591.8-7: (WK09, WK10, WK32, WK45, WK46, WK49, WK69) Rotor blade 3 - Blade bearing 0° tooth -10 left side gap - Measure			NotAp plicab le
255		ATD000591.8-8: (WK09, WK10, WK32, WK45, WK46, WK49, WK69) Rotor blade 3 - Blade bearing 0° tooth -10 right side gap - Measure			NotAp plicab le
256		ATD000591.8-9: (WK09, WK10, WK32, WK45, WK46, WK49, WK69) Rotor blade 3 - Blade bearing 0° tooth -20 left side gap - Measure			NotAp plicab le
257		ATD000614.0: Rotor brake - Calliper 1 - Clean			✓
258		ATD000614.10: Rotor brake - Calliper 3 - Clean			✓
259		ATD000614.13: Rotor brake - Thickness of rotor brake pad calliper 3 (rotor side) - Measure Wear of rotor brake pad calliper 3 (rotor side) +2,25 mm Wear of rotor brake pad calliper 3 (rotor side) picture <u>See annex 'Taken_photos': 14</u>			✓

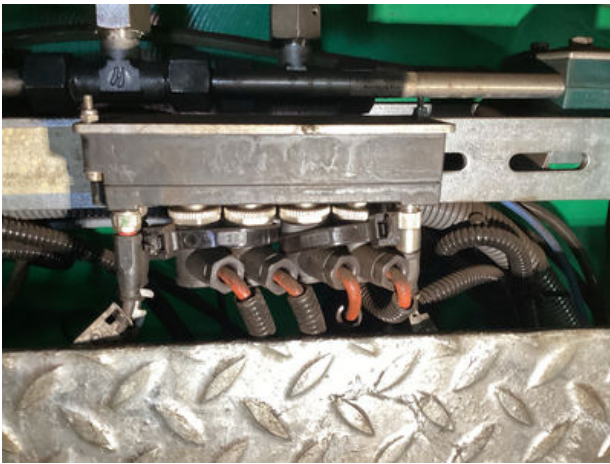
22 Figure_from Checklist 'AD 5-135_1_1_5 Preventive_year_null', Task 270 - Remarks

AD 5-135_1_1_5_Preventive_year_null					
#	Chapter	Measuring_points	Remarks	Tools	Status
Location:					
269		ATD000614.29: Rotor brake - Thickness of rotor brake pad calliper 6 (generator side) - Measure Wear of rotor brake pad calliper 6 (generator side) +0,60 mm Wear of rotor brake pad calliper 6 (generator side) picture See annex 'Taken_photos': 21			✓
270		ATD000614.30: Rotor brake - Rotor brake, sensors fixations to the Beckhoff module - Inspection Module of the right side picture Ok Module of the left side picture Ok Module of the upper side picture Ok	Remark 1 Module of the left side See annex 'Taken_photos': 22 Remark 2 Module of the right side See annex 'Taken_photos': 23 Remark 3 Module of the upper side See annex 'Taken_photos': 24		✓
271		ATD000614.31: Rotor brake - Rotor brake pad, resistance of the connectors - Measure			NotApplicable
272		ATD000614.3: Rotor brake - Thickness of rotor brake pad calliper 1 (rotor side) - Measure Wear of rotor brake pad calliper 1 (rotor side) +1,65 mm Wear of rotor brake pad calliper 1 (rotor side) picture See annex 'Taken_photos': 25			✓
