CRS Shifting Examples

Expected Behavior for Pixel Map Plots

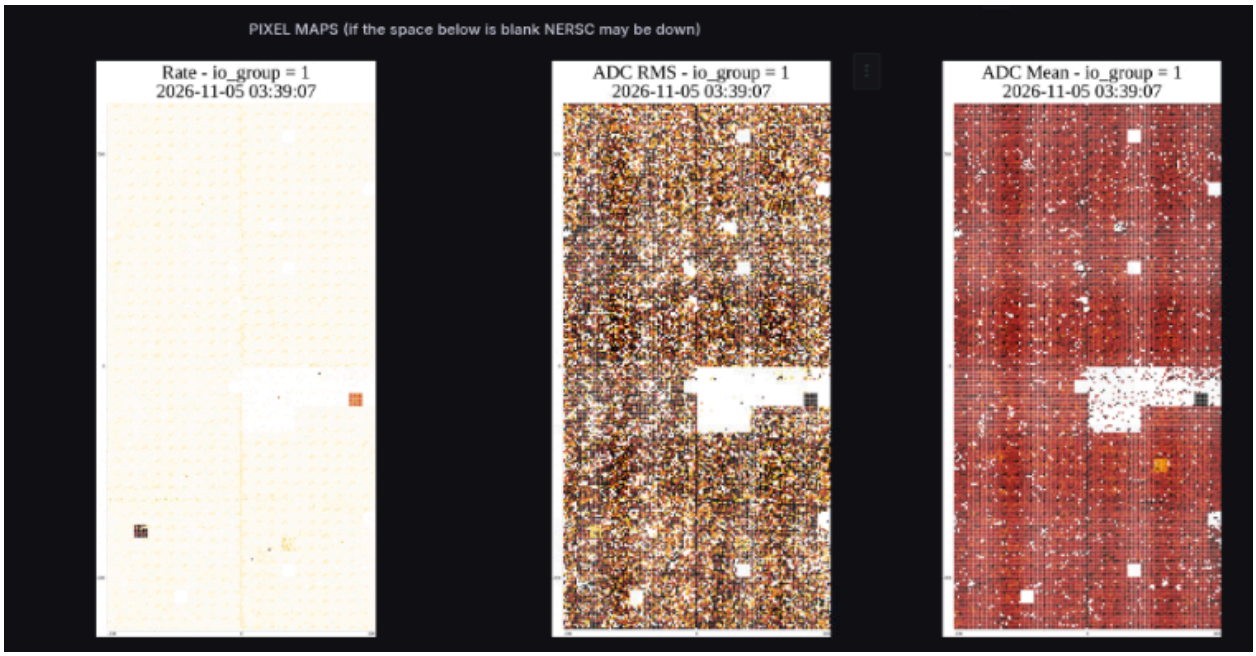
Missing IO Channel Example

In the following example, you can see a large blank area on the right side of the pixel map plot, where approximately one-fourth of a tile is missing. This is an example where an "IO channel" is missing, and if you see something similar but still with some more pixels in the mostly blank region, it is still a missing IO channel. CRO expert on shift should be contacted immediately to fix it.
