Surface Radioactivity at the Plowshare Gas-Stimulation Test Sites: Gasbuggy, Rulison, Rio Blanco

S.H. Faller Environmental Protection Agency P.O. Box 93478 Las Vegas, Nevada 89193-3478

ENVIRONMENTAL MONITORING SYSTEMS LABORATORY
OFFICE OF RESEARCH AND DEVELOPMENT
U.S. ENVIRONMENTAL PROTECTION AGENCY
LAS VEGAS, NEVADA 89193-3478

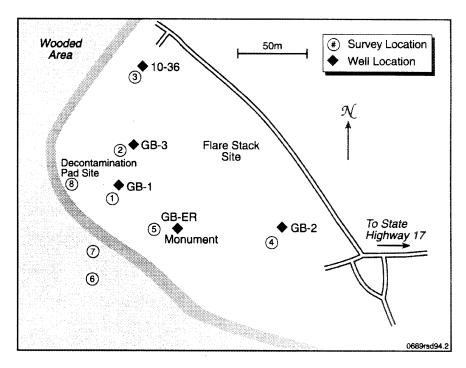
Figure 2. Project Gasbuggy Surface Ground Zero Site.

A map of the Gasbuggy site showing the locations of the only operating well (10-36) and several plugged wells, is shown in Figure 2. Eight survey locations on and near the site are also shown. Results of all surveys are given in Table 1. The area surrounding the wellheads (survey locations 1-5, and 8) is level and grass cover. Survey locations 6 and 7 were taken in a forested area with extensive pine litter cover. Survey location 9 was in a rocky area near an arroyo with sparse ground cover.

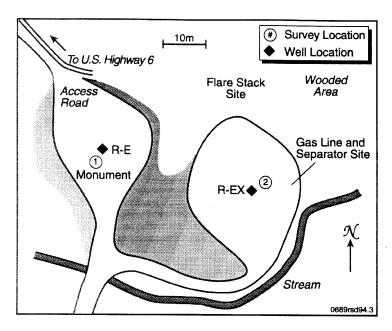
Figure 3. Project Rulison Surface Ground Zero Site.

Wells and survey locations at the Rulison site are shown in Figure 3. Results of the measurements are given in Table 2. The area surrounding plugged wells R-E and R-EX is sparsely covered with vegetation and gravel, and appears to be subject to frequent runoff. Survey location 3 (not shown) lies in a grass covered field 0.5 miles (0.8 km) west of the Rulison surface ground zero, adjacent to a pond that was used for the disposal of effluents during the project operations. Location 4 (not shown) was a graveled, sparsely vegetated field.

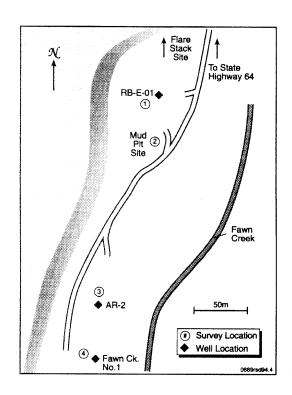
Figure 4. Project Rio Blanco Surface Ground Zero.

A map of the project Rio Blanco area is shown in Figure 4, with plugged and operating wells, and three survey site locations. Survey location 5 was in an arid wooded area uphill from the site. Results of the surveys are given in Table 3.
