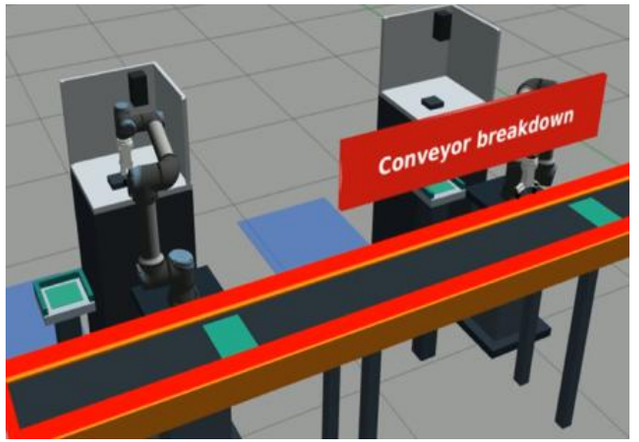
## 1 Conveyor breakdown

**Failed** **Conveyor**

**Injected** UR5e-1 holds the trimmed peg, before release onto the Conveyor

**At failure**
KET4_Square_4mm in UR5e-1
gear_small in UR5e-4

**Disrupted** transport to Buffer
